MacBook Pro 15" Touch Bar 2018 Teardown

Teardown of the MacBook Pro 15" Touch Bar 2018, performed on July 16, 2018.

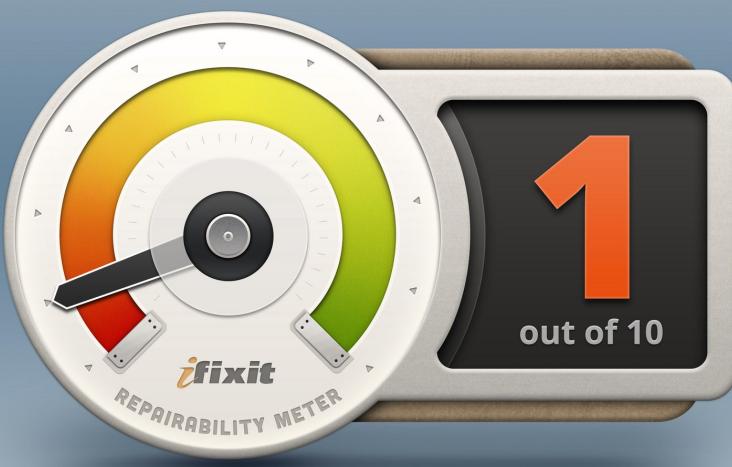
REPAIRABILITY SCORE:

- The trackpad can be replaced without removing the battery.
- The processor, RAM, and flash memory are soldered to the logic board. Repairs and upgrades will be impractical at best.
- The top case assembly, which includes the keyboard, battery, and speakers, is firmly glued in place—making all those components hard to replace separately.
- The Touch ID sensor doubles as the power switch, and is paired with the T2 chip on the logic board. Fixing a broken power switch may require help from Apple, or a new logic board.
