Meizu MX6 Teardown

Teardown of the Meizu MX6 on Monday July 25th 2016.

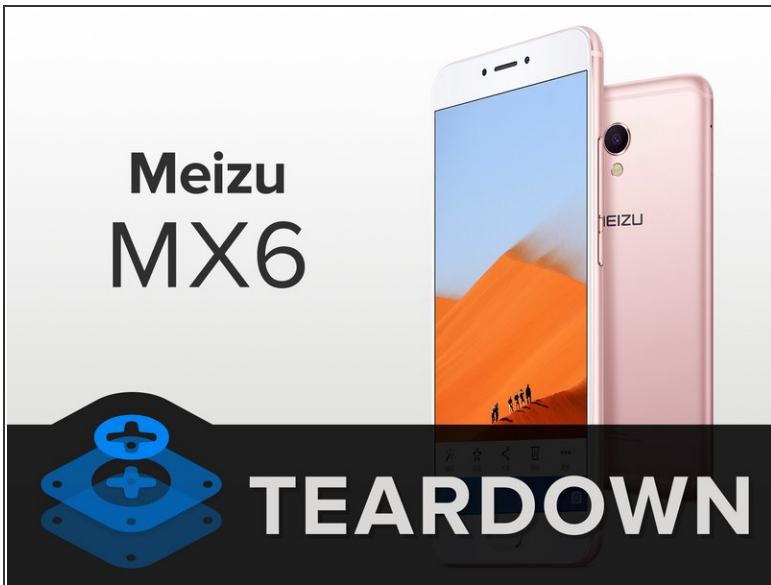
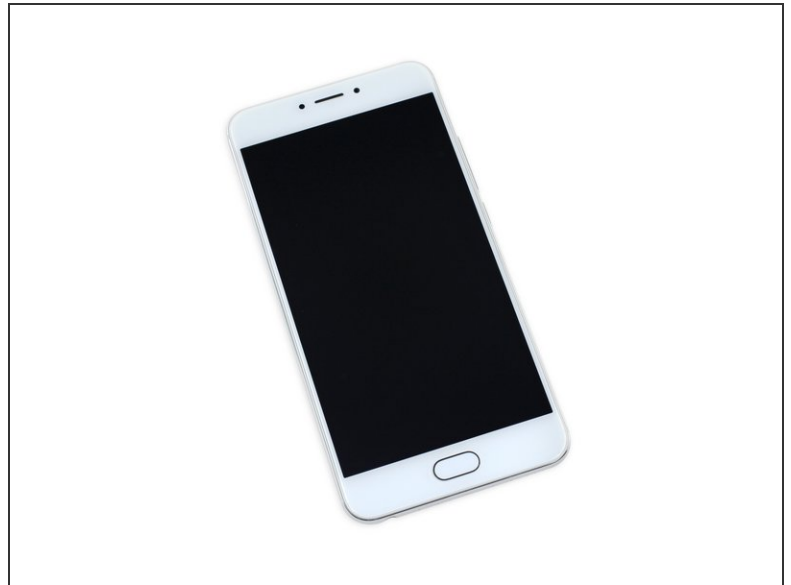
Step 1 — Meizu MX6 Teardown

- On the outside, the MX6 walks the iPhone walk, but does it talk the talk? Here's what we know so far:
 - MediaTek Helio X20 deca-core (a.k.a. *10 cores!*) CPU w/ ARM Mali-T880 GPU
 - 4 GB LPDDR3 RAM and 32 GB of storage
 - 5.5-inch, 1080p high-precision display (~401 ppi)
 - 12 MP *f*/2.0 main camera w/ 1.25 μ m pixels and 5 MP front-facing camera
 - Flyme OS 5.2 over Android 6.0 Marshmallow
 - 3,060 mAh battery with 24 W fast charging
 - USB-C port, Dual SIM support, and Meizu mTouch fingerprint sensor

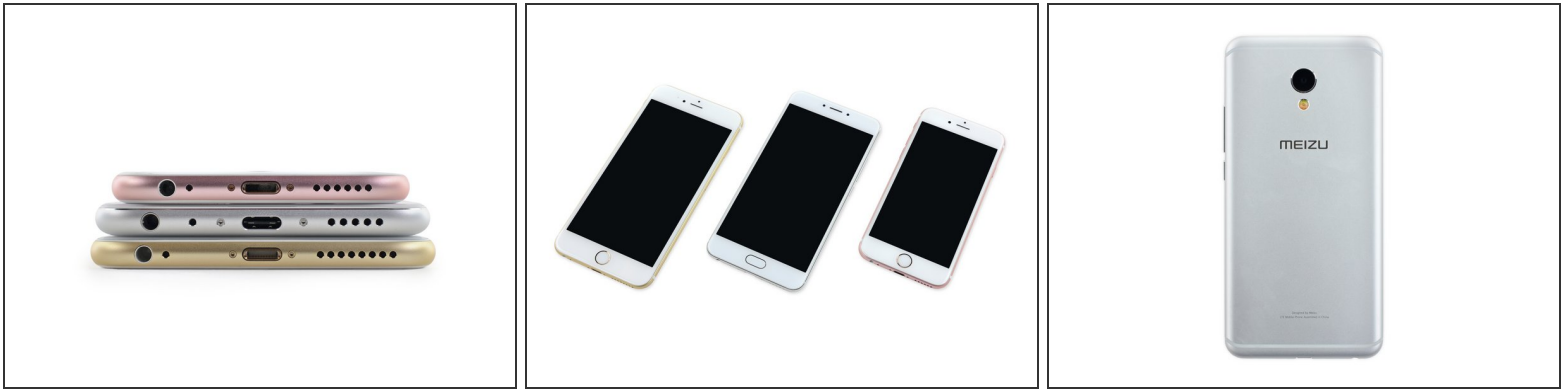
Step 2

- It's a three-phone pile-up as we pull over to take a cursory look at how the MX6 compares to its iPhone idols.
- A quick comparison reveals...not a whole lot. Apart from the USB-C connector and a slightly shifted microphone port, we're hard pressed to distinguish the MX6 from its Cupertino-based counterparts.
- It's a similar story topside. Aside from the oval home button and different side button configuration, the MX6 fits right into the iPhone lineup—what with its metal unibody design and [2.5D glass panel](#).
- The MX6 differentiates itself with a centered rear camera and dual flash assembly, but those subtle antenna bands are reminiscent of [certain iPhone 7 rumors](#).

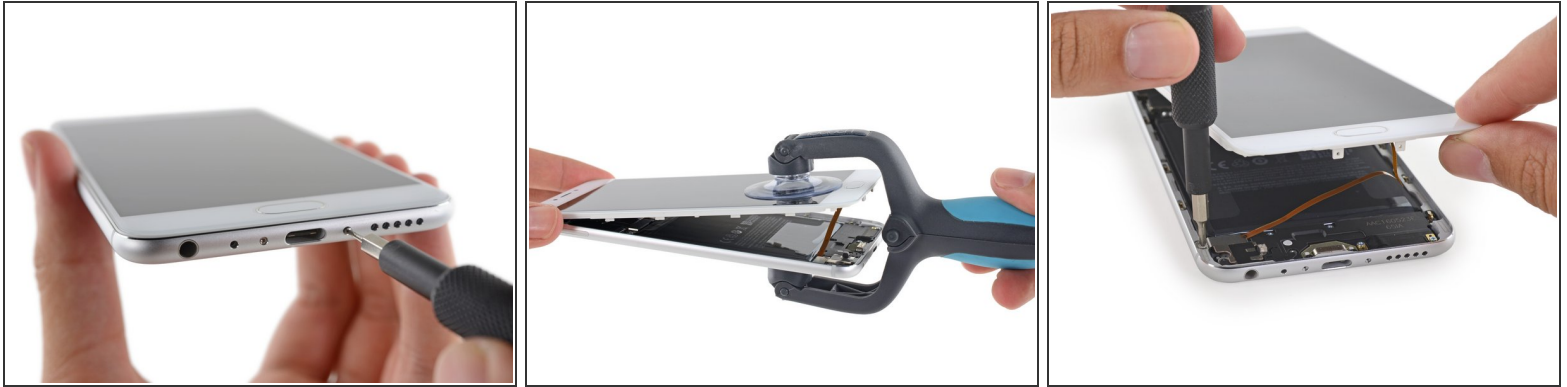
Step 3

- Like the [Huawei P9](#), the MX6 seems inspired by the iPhone in more than just looks: two Pentalobe screws secure the MX6's display assembly to the chassis.
- We're still baffled as to why manufacturers would copy Apple's screw design, when a regular ol' Phillips or Torx screw does the same job better with less hassle.

⚠ *Ruh Roh, Raggy!* We also find a [fingerprint reader cable booby trap](#) like in the iPhone 5s/SE!

- Not to worry, Scooby Doo— Meizu cut us some slack (literally), so the cable is unlikely to rip when opening the phone.
- ① The cable's connector lies under a screwed-down, tamper-evident bracket that's arguably simpler than Apple's [awful spring clip](#).

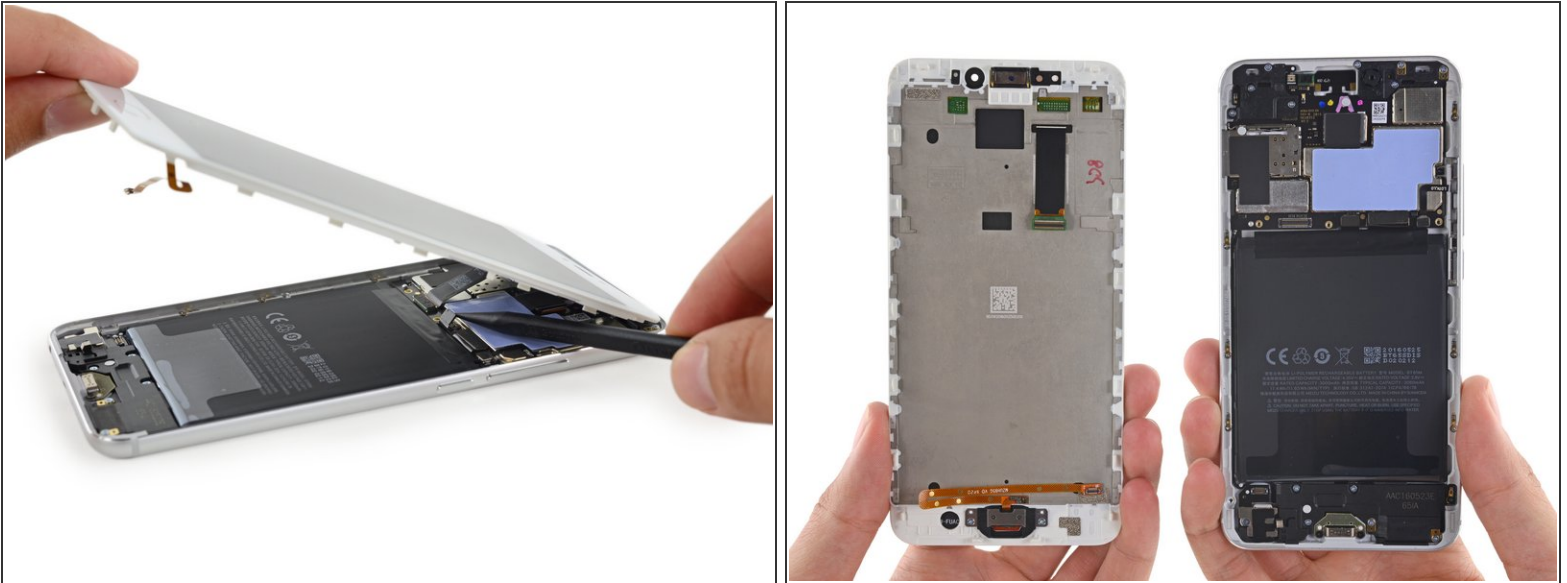
Step 4

- Before diving in, we pause to disconnect the battery; its small connector releases with a flip of the spudger. [Safety first.](#)
- With the MX6 safely de-electrified, we pop the display cable free and peer inside.
 - First observation: *Phillips screws— everywhere!* A small celebration breaks out around the teardown table.
 - Second observation: Looks like the iPhone mold is mostly skin-deep, look at that big ol' battery. We just can't wait to dig in.

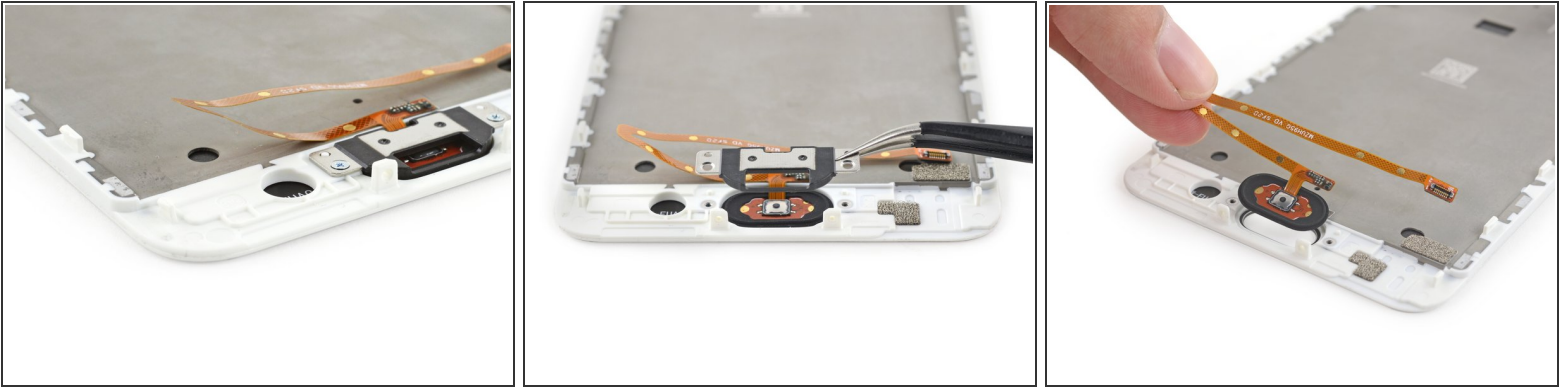
Step 5

- Interestingly, the display's perimeter is all plastic, including its clips and edges. This may be a durability concern, but there's no risk of [display bracket separation](#).
 - Out comes the bracket securing the fingerprint sensor—followed by the sensor itself, with its long [switchback](#) cable in tow.
- i** This display assembly is a much simpler affair than you'll find in a comparable iPhone (or Android phone!), thanks to some handy spring contacts and a motherboard-mounted front-facing camera.
- ★** That means a cheaper, simpler repair!

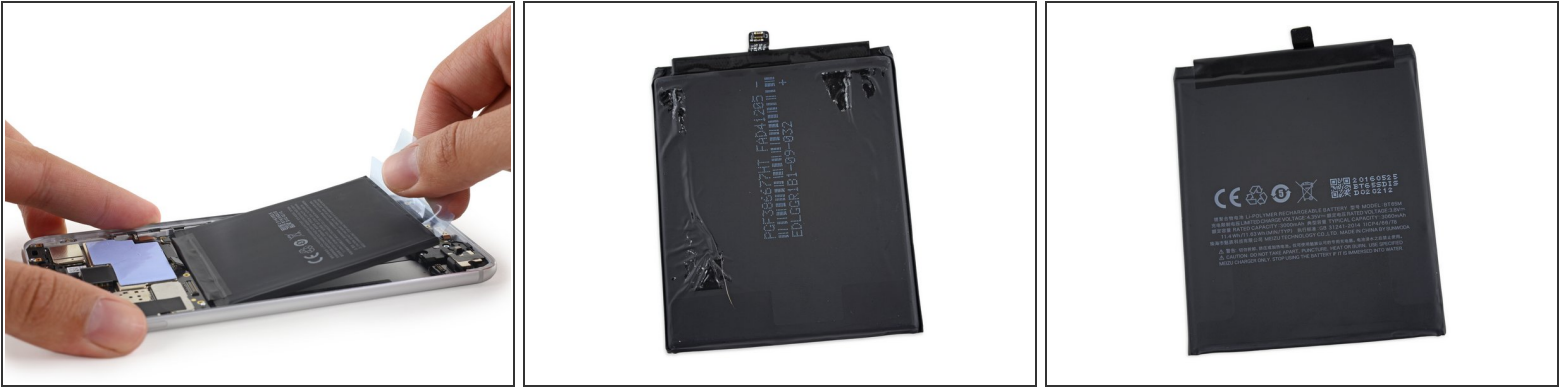
Step 6

- With the display assembly out of the way, we carefully excavate the MX6's stubbornly-adhered battery. Luckily, the battery features an [iPhone 4-esque battery pull tab](#) that makes the job a bit easier.
- The MX6 packs a non-user-removable, 3.8 V, 11.63 Wh Li-poly battery.
 - ⓘ This puts the MX6's battery ahead in the power struggle, topping the [iPhone 6s Plus](#)'s 10.45 Wh battery, and just barely surpassing the [Samsung Galaxy S7](#)'s 11.55 Wh battery.
 - ⓘ Meizu claims that their mCharge 24 W (12 V at 2 A) fast charging technology will fully charge the MX6's battery in only 75 minutes, compared to [90 minutes](#) for the Galaxy S7.

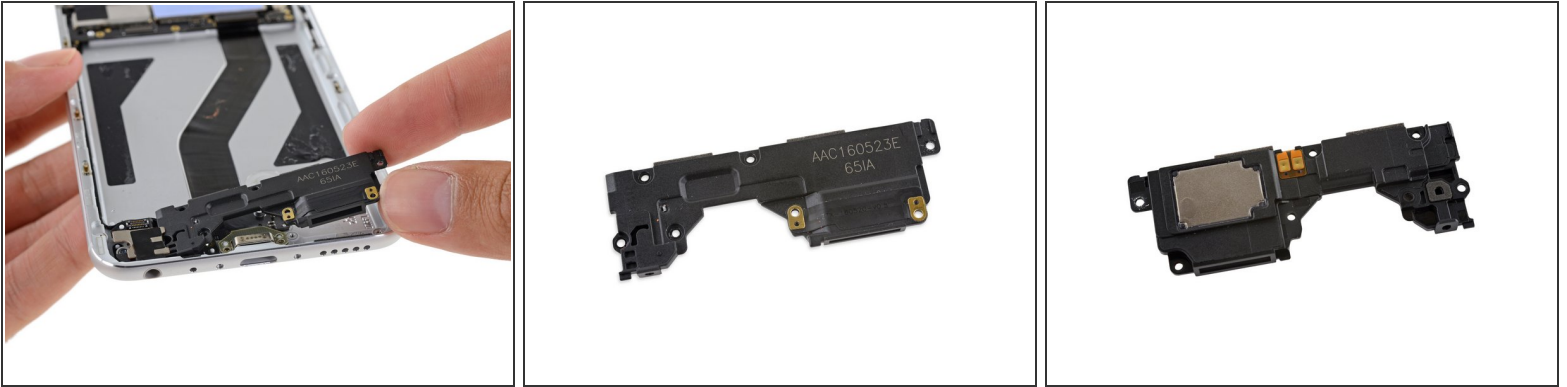
Step 7

- Next to come out? The speaker assembly, complete with spring contacts and what appears to be an antenna sticker of some kind.
- Part of the assembly lines up with the lower microphone hole—but if you go looking for a mic here, you'll be disappointed!
- This assembly has a tiny acoustic tube channel with a 90-degree bend, passing sound from the outside world to a mic located elsewhere...

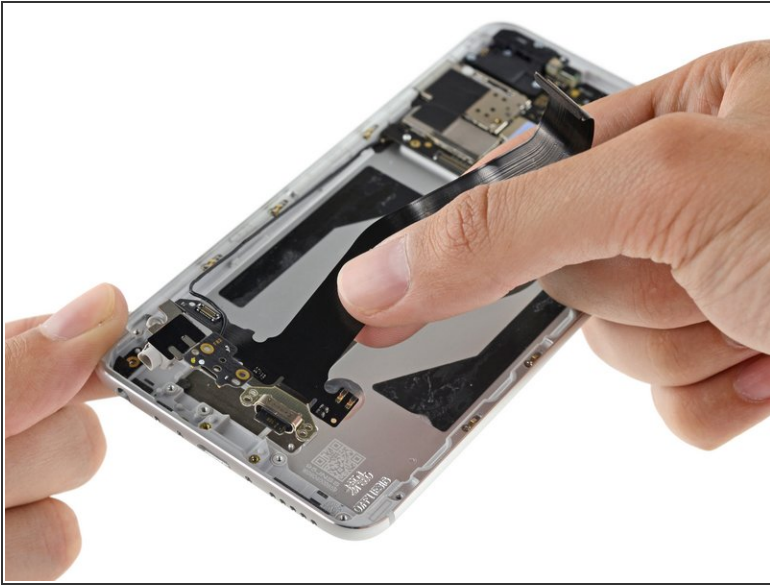
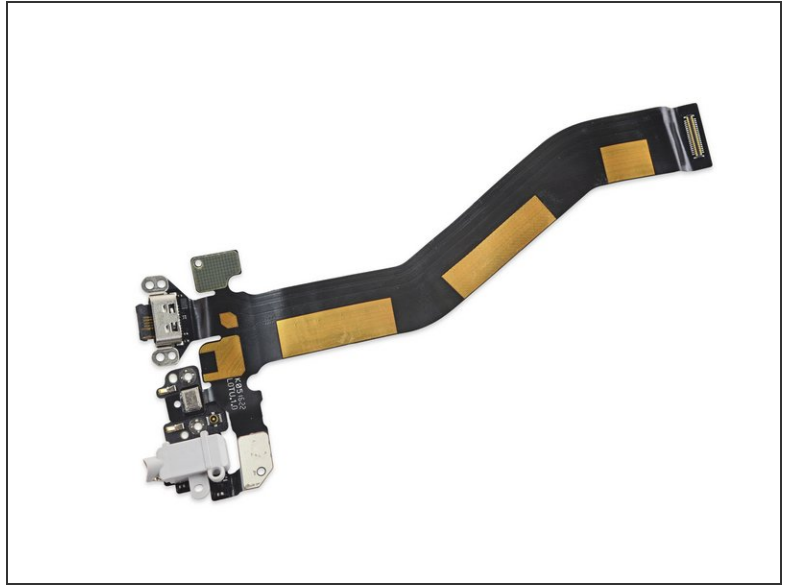
Step 8

- "Elsewhere" turns out to be a combined USB-C, headphone jack, and microphone assembly—which we dutifully peel out of the chassis of the MX6.
- ⓘ A small amount of adhesive secures the cable to the chassis, but it presents no problem for our teardown engineer.
- Upon inspection, we find antenna connections on the bottom of the cable, as well as on the bottom of the motherboard.
- ☑ Manufacturers seem to be in competition to cram [as much](#) as they [possibly can](#) onto the charging port cable. (Which means a pricier repair when your port eventually gets loose.)

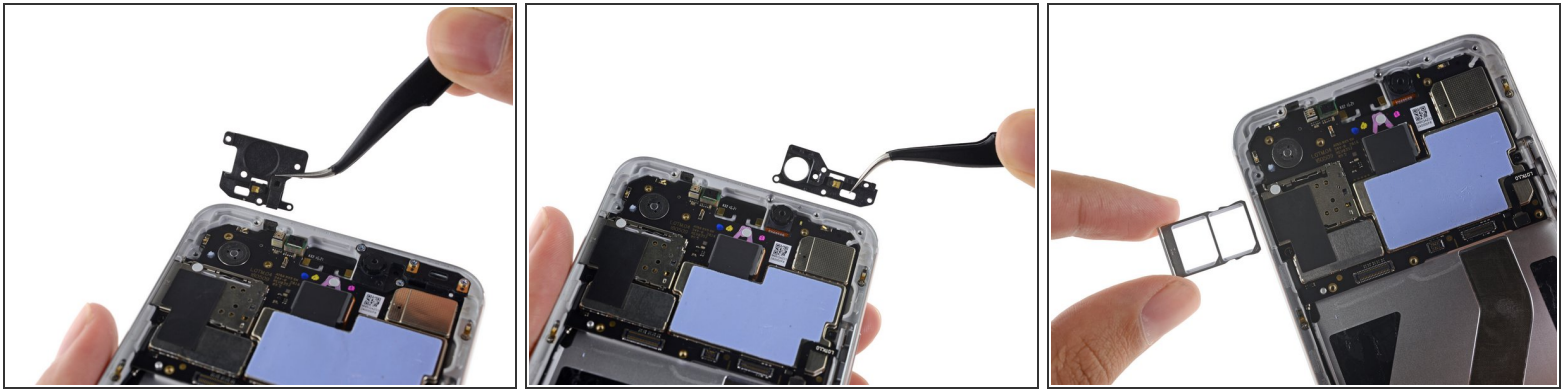
Step 9

- With tweezers in hand, we deftly pluck out several bits 'n pieces:

- Antenna/vibrator bracket
- Antenna/front-facing camera bracket
- Dual SIM card tray
- [Turbo-encabulator](#)

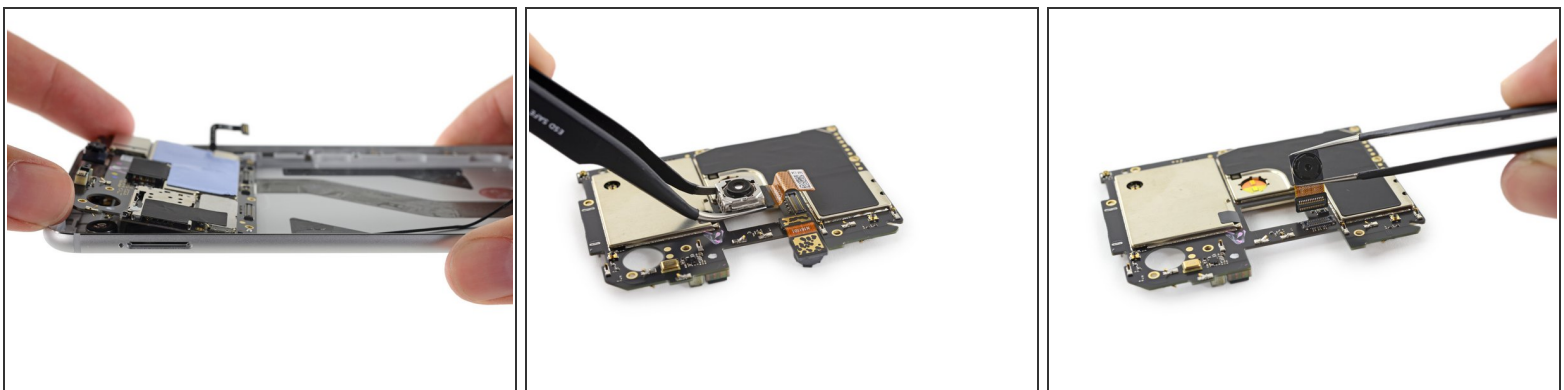
Step 10

- With those bits out of the way, we lift the motherboard out and get a closer look at the cameras.
 - ❗ The rear-facing camera features Sony's 12 MP [Exmor RS IMX386](#) CMOS image sensor along with a 6-element $f/2.0$ lens, while the front-facing camera features a 5 MP sensor with a 4-element $f/2.0$ lens.

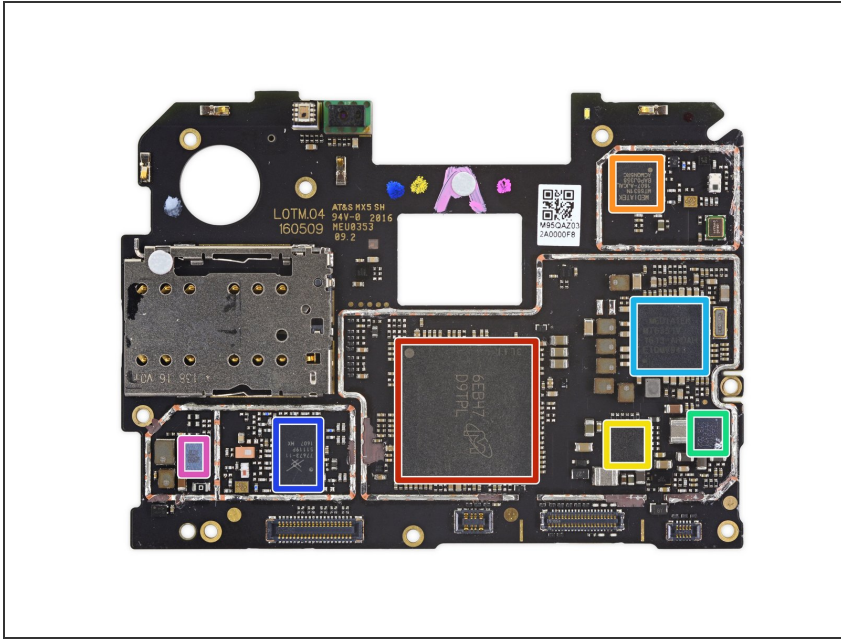
Step 11

- With the motherboard plucked from the the rear case, we take a second to explore the MX6's silicon situation. Highlights include:
 - Micron [D9TPL](#) 32 Gb (4 GB) Mobile LPDDR3 SDRAM with MediaTek [Helio X20](#) SoC layered underneath
 - MediaTek [MT6631N](#) Wi-Fi Module
 - Texas Instruments [BQ25892](#) Fast Charging IC
 - NXP [TFA9911](#) Audio Amplifier
 - MediaTek MT6351V PMIC
 - Skyworks SKY77673-11
 - MediaTek MT6300P (Possibly an iteration of the [MT6302](#) dual SIM card controller)

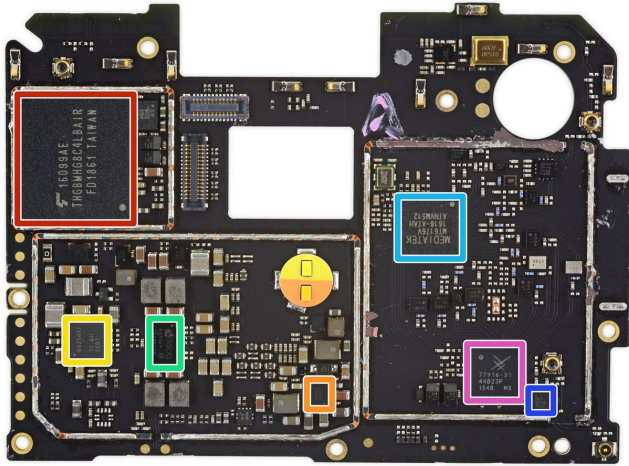
Step 12

- On the flip side:
 - Toshiba [THGBMHG8C4LBAIR](#) 32 GB eMMC 5.1 NAND Flash
 - Texas Instruments [LM36272](#) LCD Backlight Driver
 - Texas Instruments [BQ25892](#) Fast Charging IC
 - Dialog Semiconductor [DA9214](#) PMIC
 - MediaTek [MT6176V](#) RF Transceiver
 - Skyworks [SKY13596-397LF](#) RF Switch
 - Skyworks [SKY77916-31](#) RF PAM

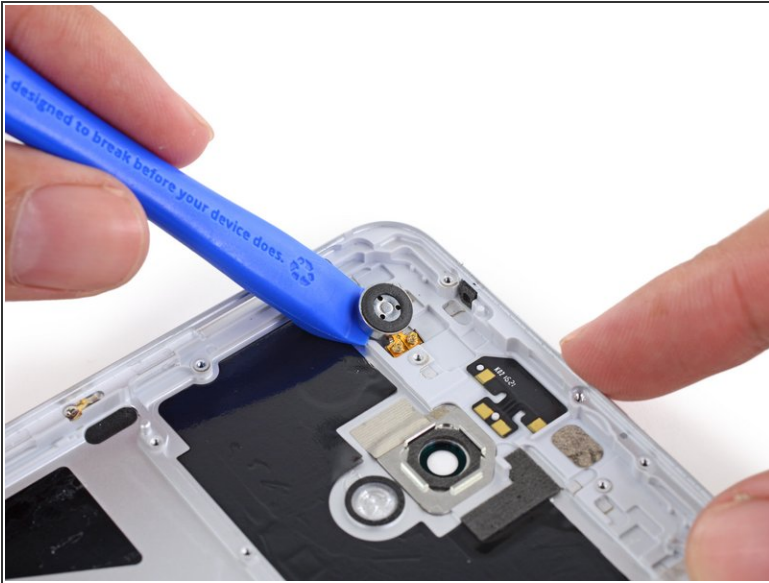
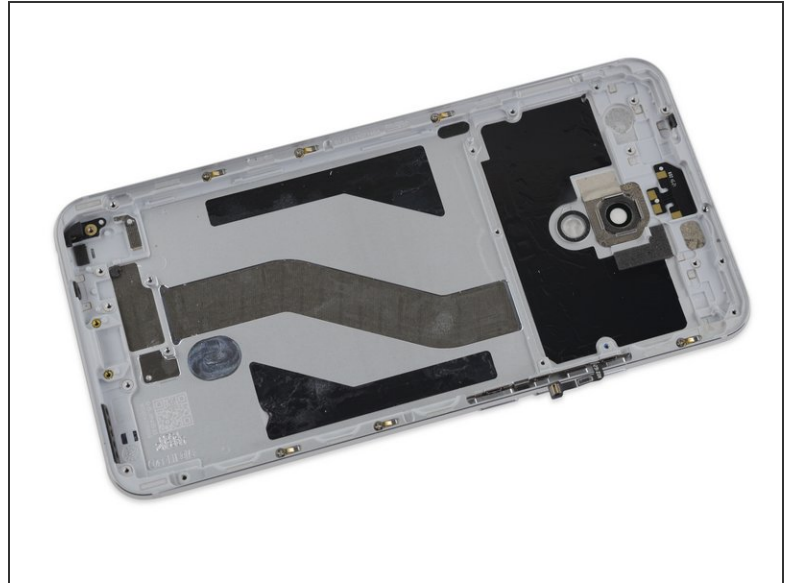
Step 13

- The final few pickings come from the MX6's chassis.
- We pry out the (tiny!) rotational vibrator motor. It's different from the linear oscillating motors and "Taptic Engines" used in many ([not all](#)) iPhone models, but also takes less space.
- The chassis itself is peppered with spring contacts, which no doubt made our teardown journey that much easier.

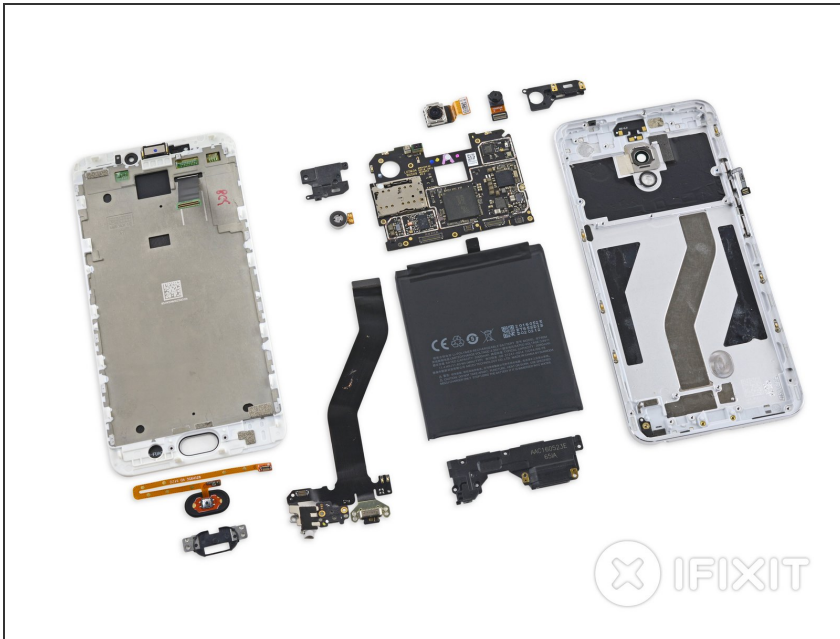
Step 14

- Though the exterior design looks undeniably iPhone-esque, the hardware layout calls to mind [another recent Android hit from China](#).
- And that's a wrap! Time to give this phone a score.
