# Microsoft Band 2 Battery Replacement

Removing the Microsoft Band 2 battery

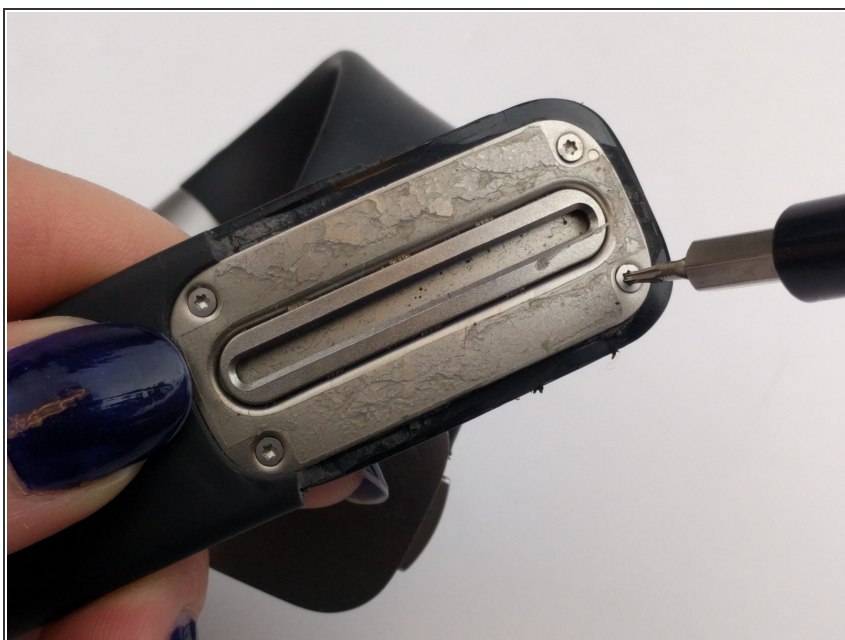
## Step 2

- Use a T3 Torx screwdriver to unscrew the four 6 mm screws on the corners of the metal cover plate.

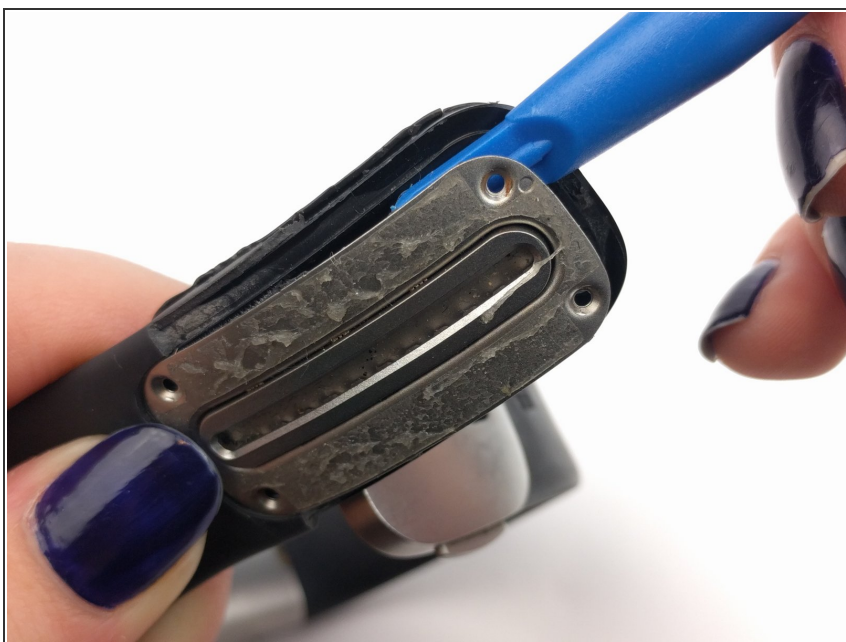
### Step 3

- Use the plastic opening tool to pry off the metal cover plate.

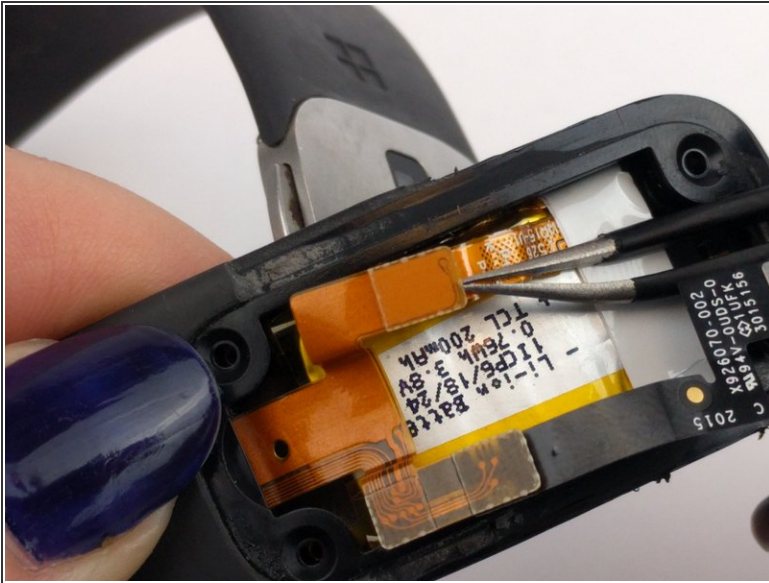
## Step 5

- Detach the orange press-fit (or "pop") connector by using the tweezers.

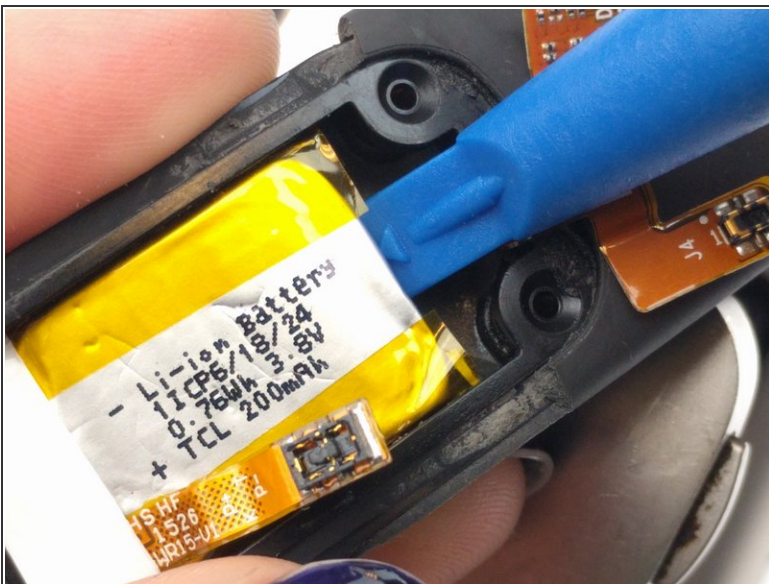
## Step 6

- Pry out the battery using the plastic opening tool.
