# Microsoft Band 2 Buttons Replacement

This guide will show you how to remove the side buttons on the Microsoft Band 2.

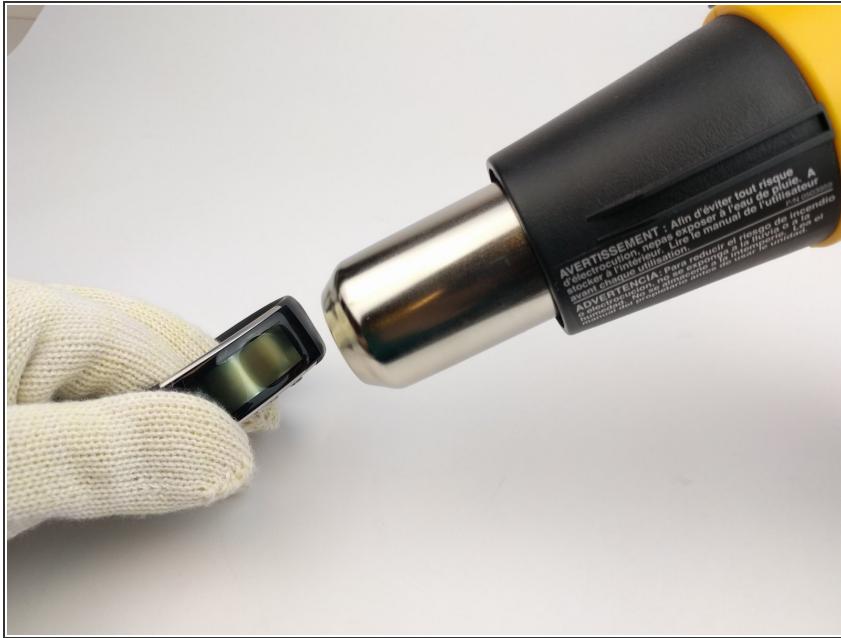
## Step 1 — Screen

- Use a heatgun to melt the adhesive beneath the screen. Heat the metal around edges of the screen.
-

Avoid heating the rubber watch band as it will quickly melt.
-

Heating the LCD screen may damage it. Avoid this procedure unless you intend to replace the screen.

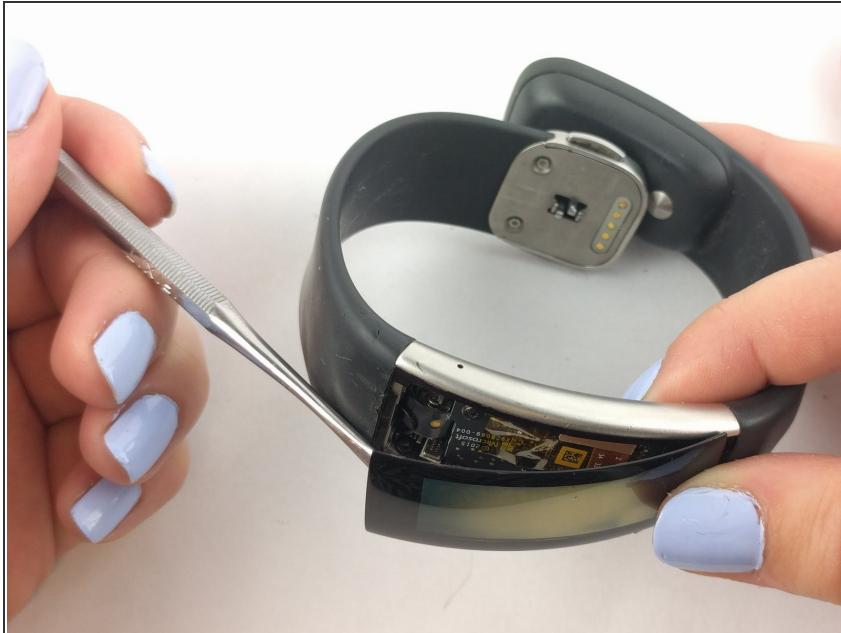
## Step 2

- Use a [spudger](#) and plastic [opening picks](#) to pry the screen away from the Band 2.

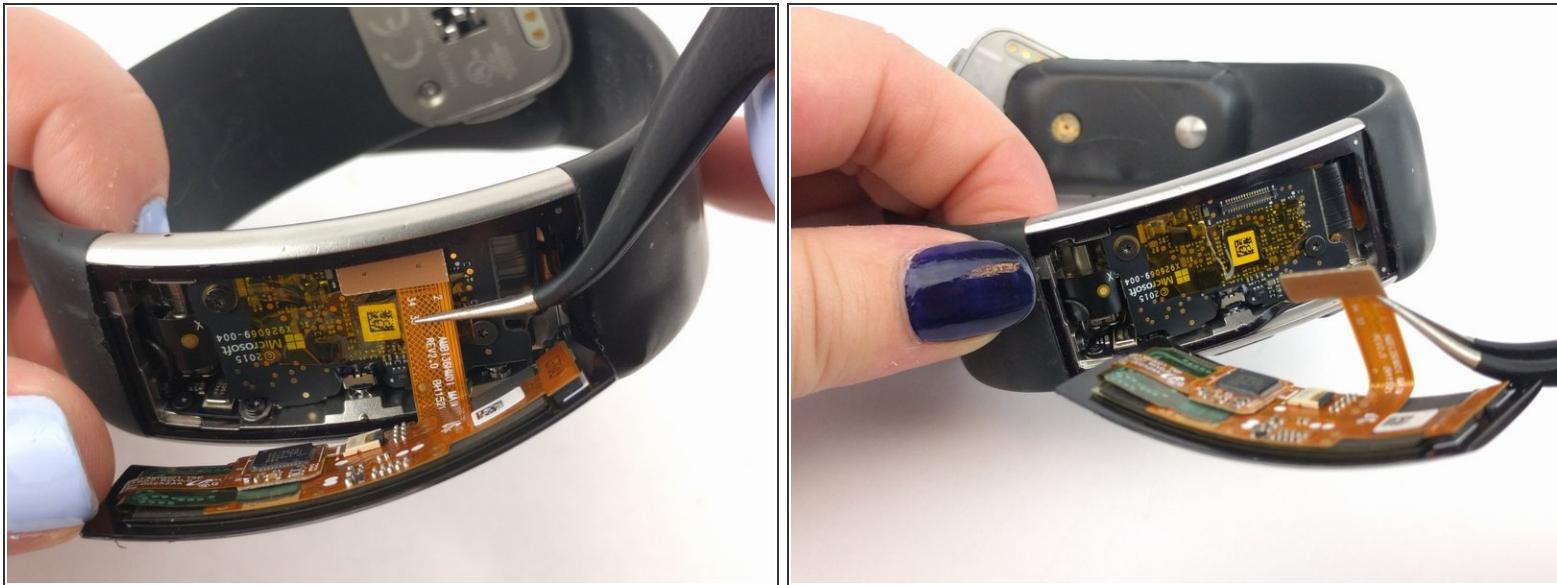
## Step 3

- Use metal tweezers to gently detach the orange press-fit (or "pop") connector.

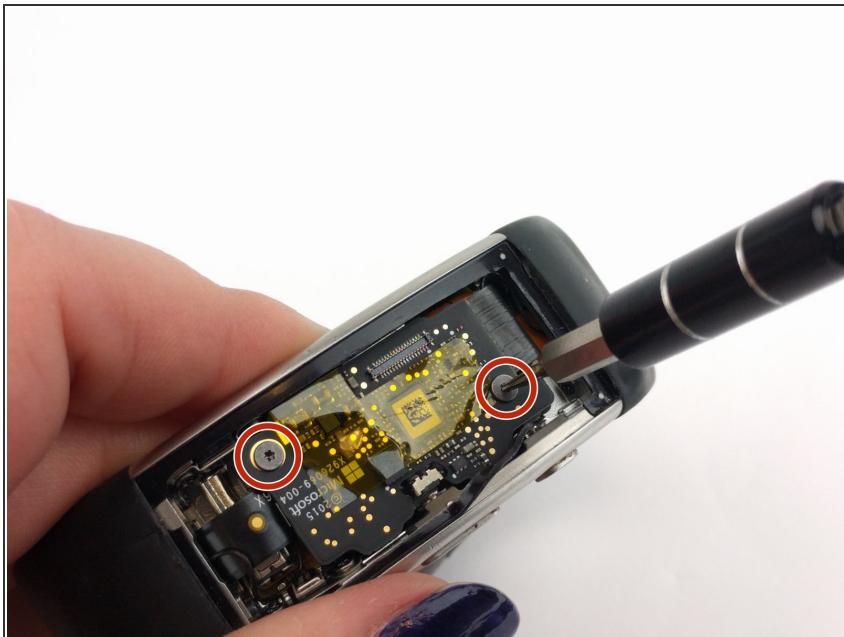
## Step 4 — Buttons

- Use the T3 Torx Screwdriver to remove the two 2.7 mm screws
