Microsoft Band Battery Replacement

You will be replacing one or both batteries located in the side panels.

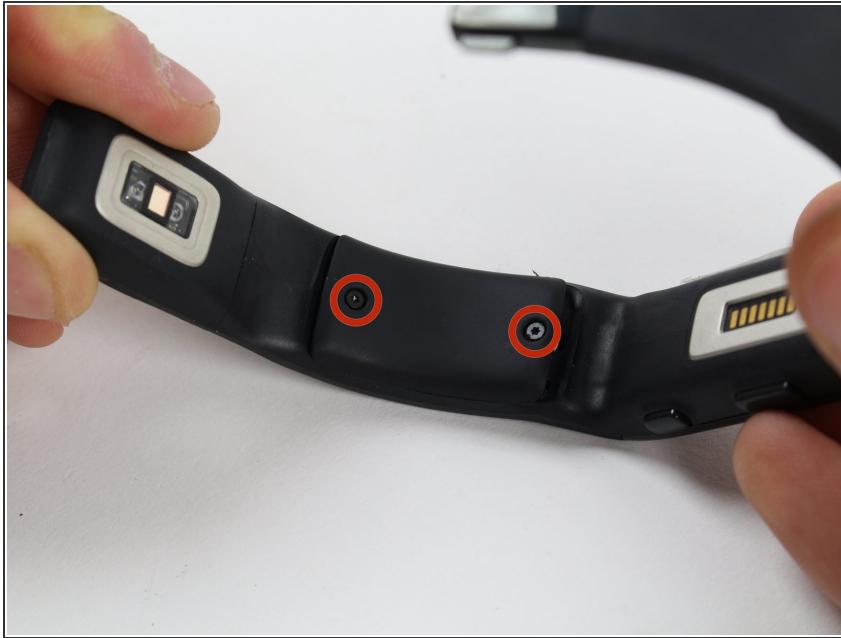
Step 1 — Battery

- Unscrew both side panel 2mm screws using the T3 Torx screwdriver.

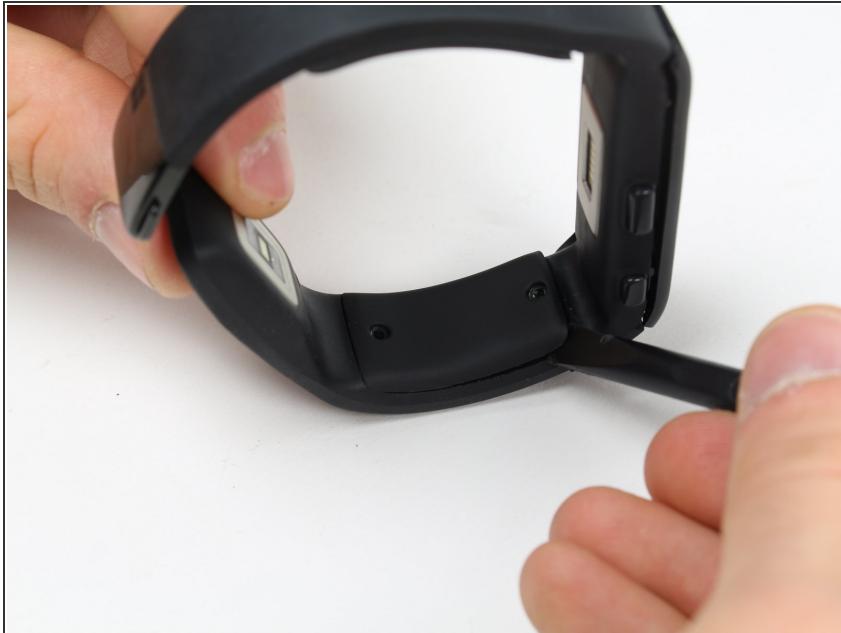
Step 2

- Firmly pry up the side panel using the plastic spudger to break the waterproof seal and lift the battery panel.

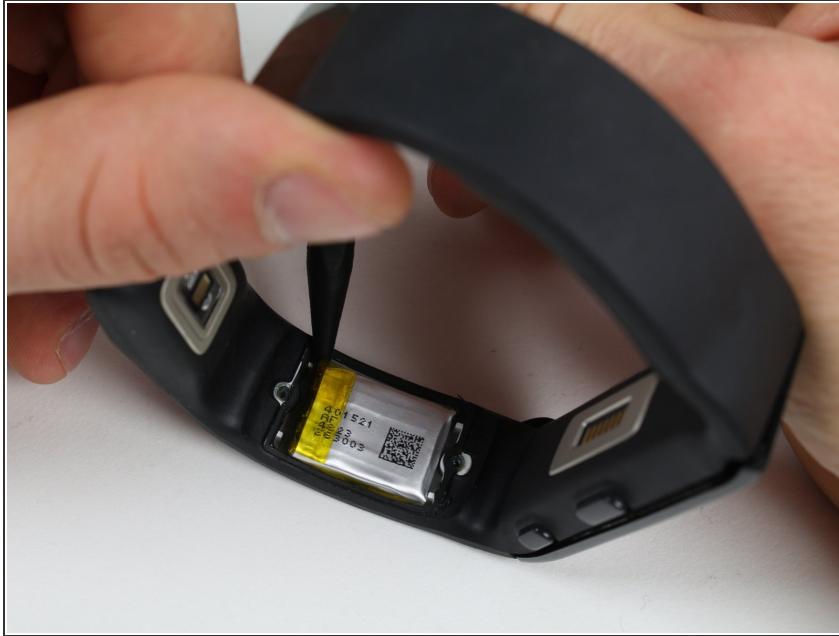
Step 3

- Gently pry up one edge of the battery with the plastic spudger.

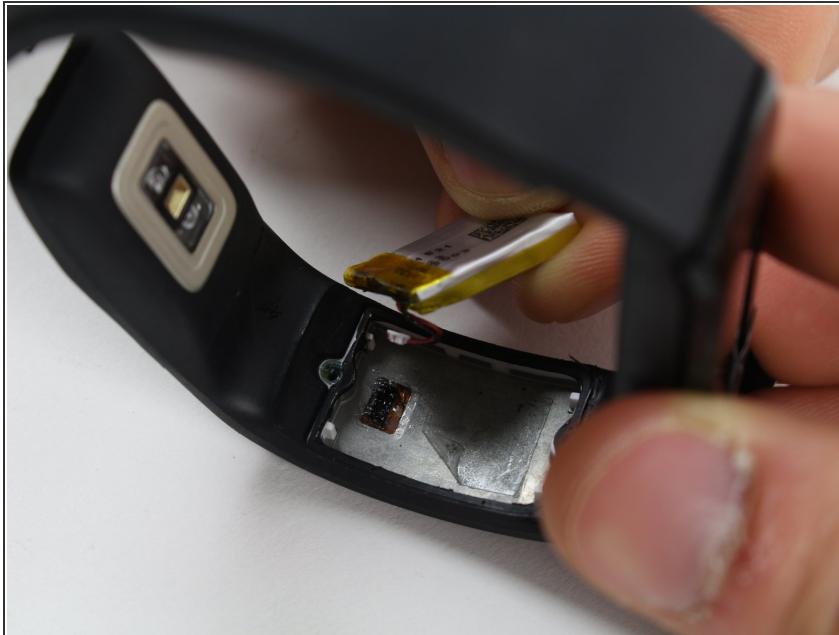
Step 4

- Remove battery from its compartment with your fingers.

To reassemble your device, follow these instructions in reverse order. Replace the vibrator in its original compartment.
