Microsoft Surface Laptop 3 (13.5-inch)

Teardown

Teardown of the Surface Laptop 2 performed on October 23, 2019.

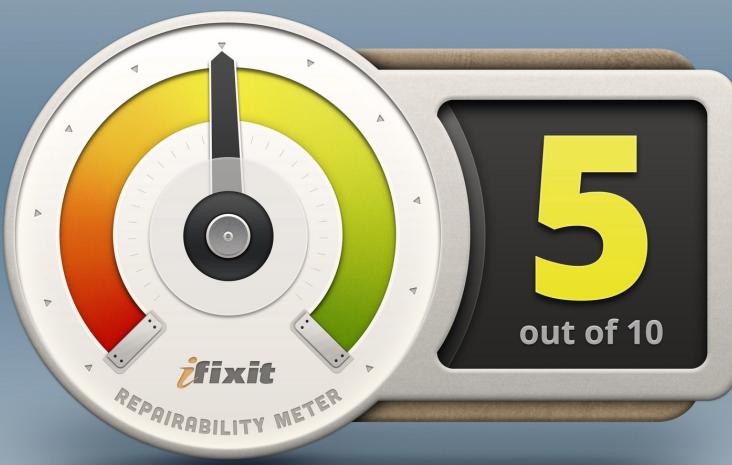
REPAIRABILITY SCORE:

- The opening procedure is straightforward, with a clever design that represents a dramatic improvement over its predecessors.
- The M.2 SSD is fully modular and easy to access.
- Torx Plus screws call for relatively rare drivers, but our standard Torx drivers worked in a pinch.
- Display access is well-prioritized, but must be replaced as an (expensive) complete unit—subcomponents aren't modular.
- While many components are modular, intricate layered construction makes them difficult to service.
- The firmly glued-down battery will be very difficult to service when it inevitably goes kaput.
