Microsoft Surface Pro 2 SSD Replacement

Written By: Ronnie

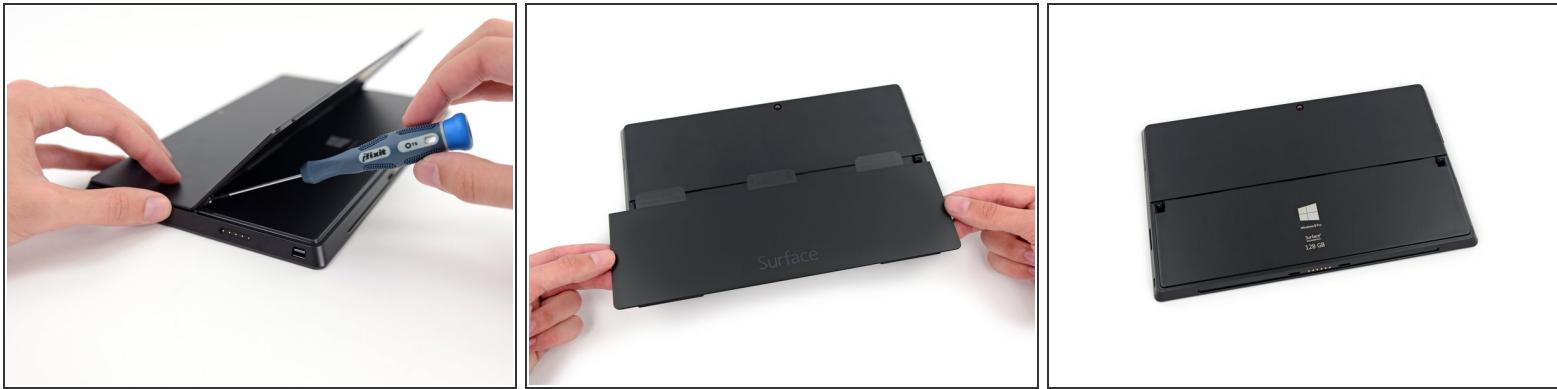
Step 1 — SSD

- Remove the two T5 Torx screws, then take off the kickstand.

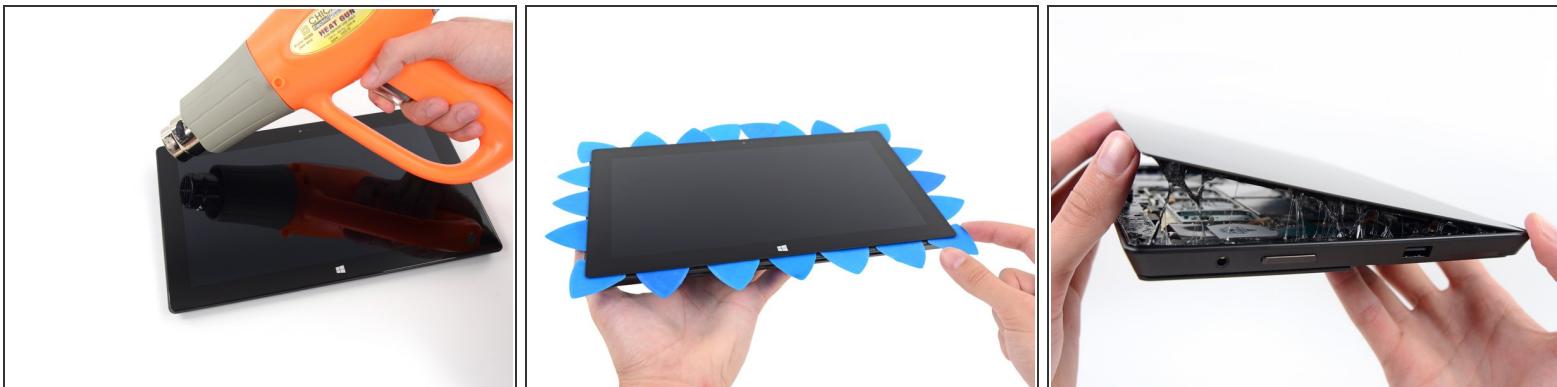
Step 2

- Use an iOpener or heat gun to melt the adhesive.
- Insert 21 opening picks under the display.
- Slowly lift off the display.

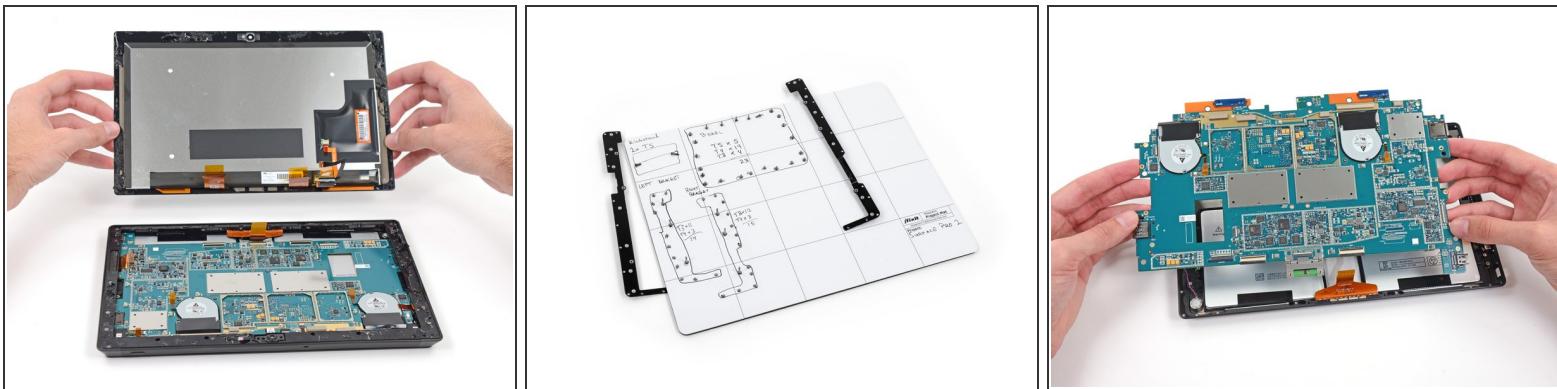
Step 3

- Remove the four ribbon cables connecting to the motherboard with a spudger.
- Remove the 52 screws securing the motherboard to the metal plates and the plastic bezel.
- Lift off the motherboard.

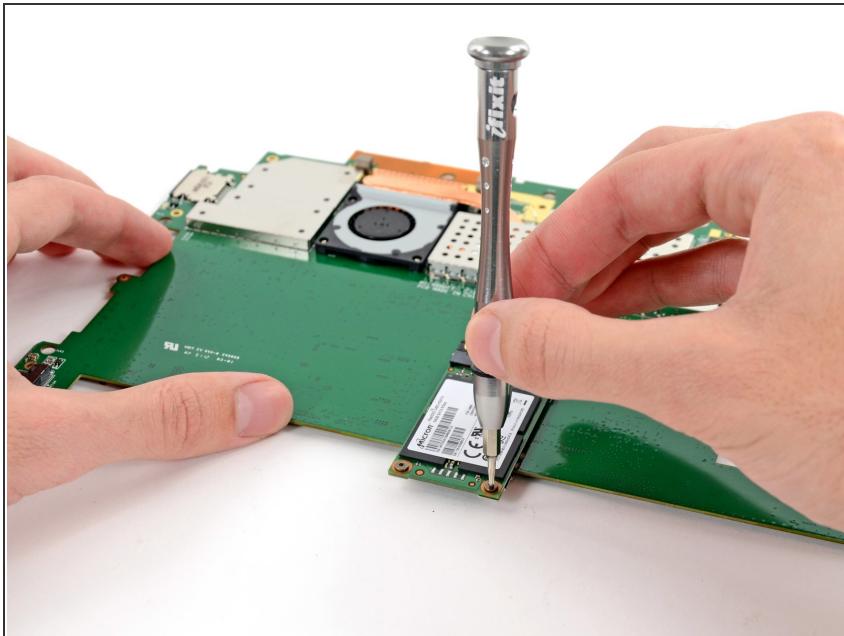
Step 4

- Unscrew the two screws on the mSATA SSD and remove the SSD.
(Note: This image is from a first generation Surface Pro, but it works)
