Microsoft Surface Pro 6 Teardown

Teardown of the Microsoft Surface Pro 6, performed on October 16, 2018.

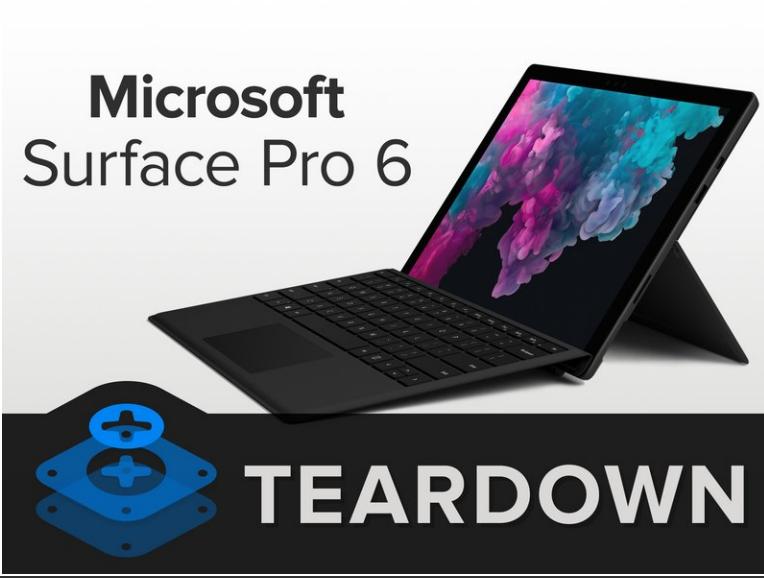
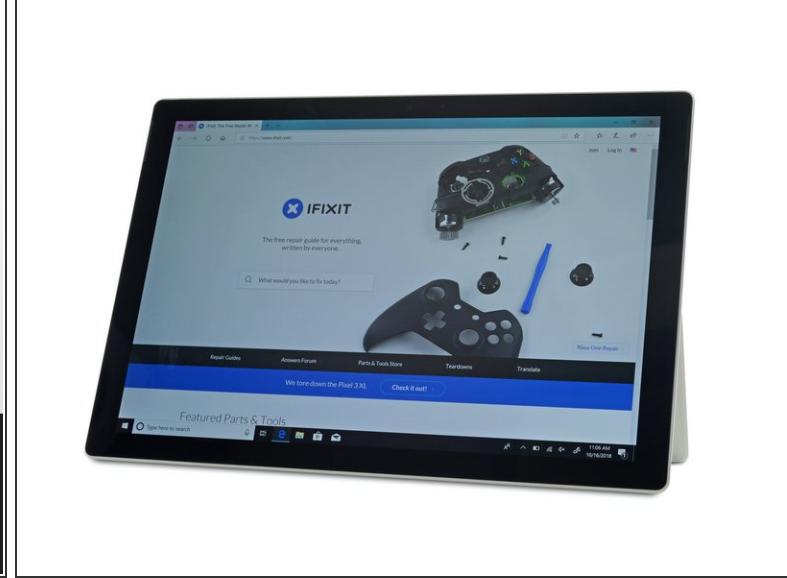
Step 1 — Microsoft Surface Pro 6 Teardown

- New Surface, new specs (sorta):
 - 12.3" PixelSense display with 2736 × 1824 resolution (267 ppi)
 - 8th-Gen (Kaby Lake R) quad-core Intel Core i5 processor with Intel UHD Graphics 620
 - 8 GB RAM (16 GB optional)
 - 128 GB solid-state storage (256 GB, 512 GB, and 1 TB configurations optional)
 - 8 MP rear-facing camera with 1080p video, and 5 MP / 1080p front-facing Windows Hello camera
 - USB 3.0, microSDXC, Mini DisplayPort, SurfaceConnect, and 3.5 mm audio ports
 - 802.11a/b/g/n/ac Wi-Fi, Bluetooth 4.1

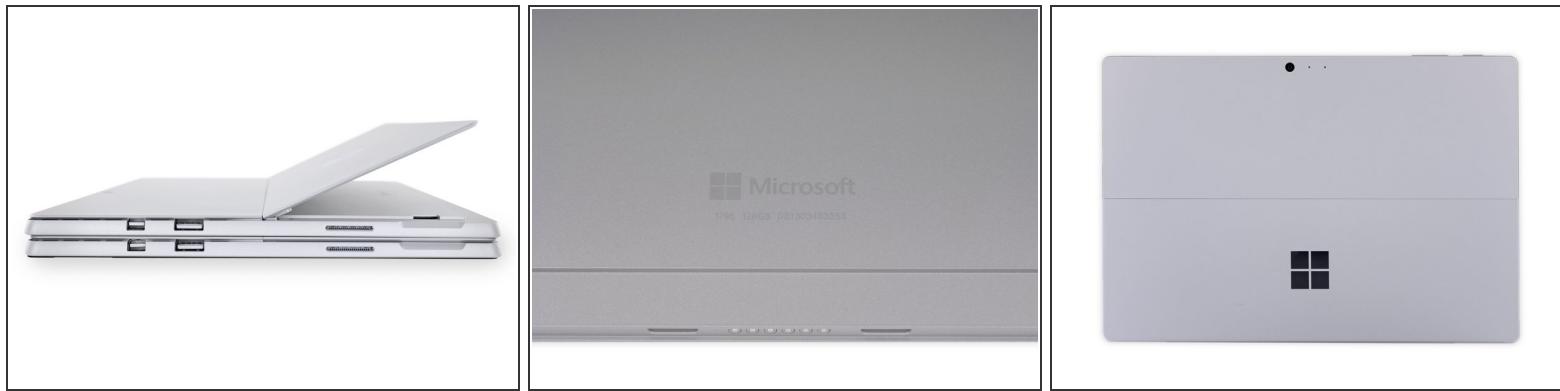
Step 2

- Looks like we have an extra Surface Pro 6—err, wait, one of those is [last year's Surface Pro](#).
- Well, on the outside not much has changed from last year. Still the same case, hinge, and relatively healthy number of ports.
- **(i)** Noticeably absent for 2018, however, is the ever-popular [USB-C port](#) that found its way onto the [Surface Go](#).
- We have to look pretty close to tell these Surfaces apart. Even the model number under the kickstand is the same as last year: 1796.

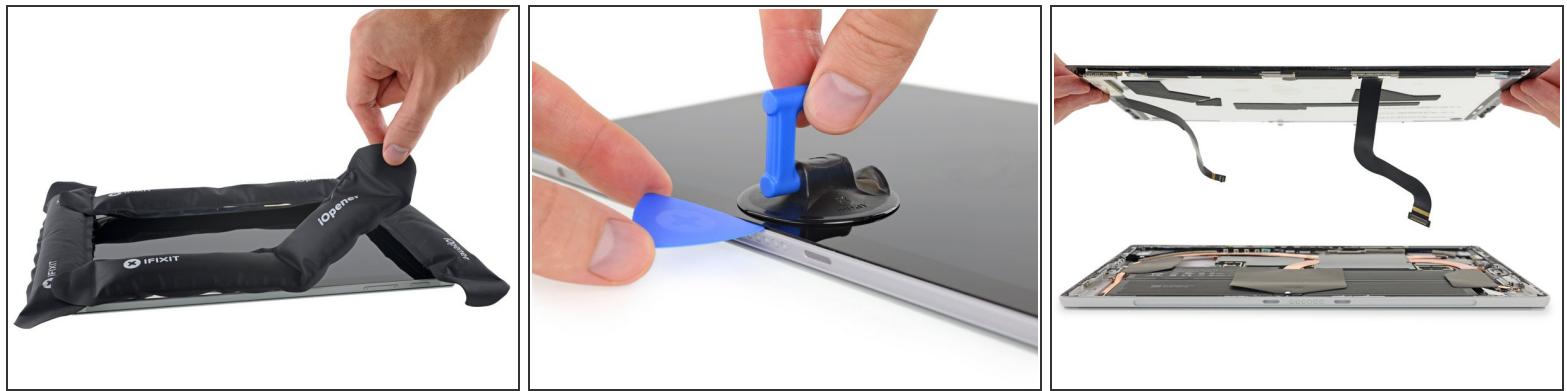
- The Surface Pro series has a few different configurations, and they all come standard with upgraded adhesive.
- Fortunately, we've got a [tried-and-true](#) recipe for Surface screen separation success:
 - Step 1: apply [iOpener](#) liberally.
 - Step 2: grab an [Opening Pick](#) and a [Suction Handle](#), and fight for dear life through Microsoft's gauntlet of adhesive.
 - Step 3 (optional): get impatient, break screen.
- Luckily, we don't run into any surprises as we free the display—everything's pretty much the same as [before](#), save for an extra display cable compared to the [Surface Go](#).

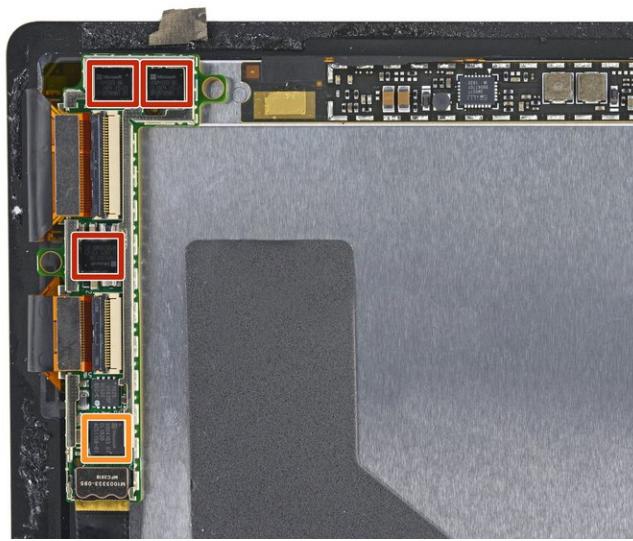
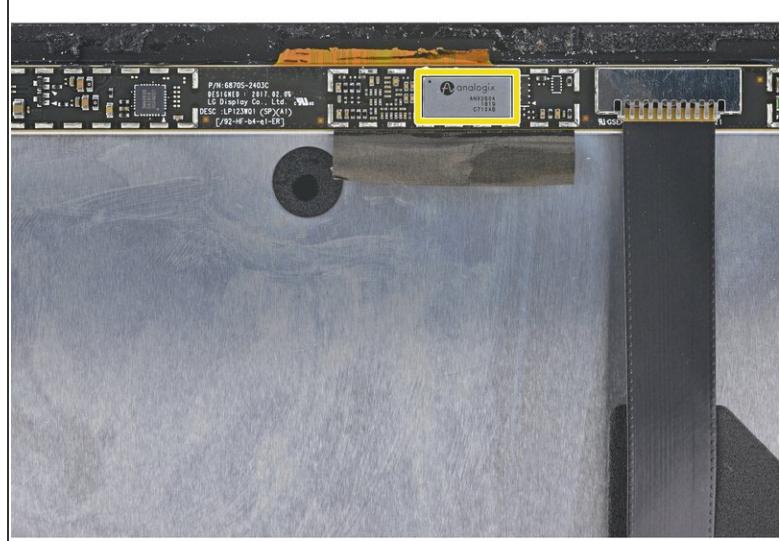
Step 4

- We interrupt this disassembly to bring you display chips!
 - Microsoft X904169 06 CL1706, possibly N-Trig's Surface Pen controller.
 - Microsoft X904163 01 CL1708
 - Analogix ANX2604, possibly a DisplayPort converter.
- LG makes this display, which seems suspiciously similar to the one we found on the [Surface Pro 5](#).
 - Could they be cross-compatible? Yes they could—we dropped last year's display into our Surface Pro 6, and it worked almost like someone planned it that way.

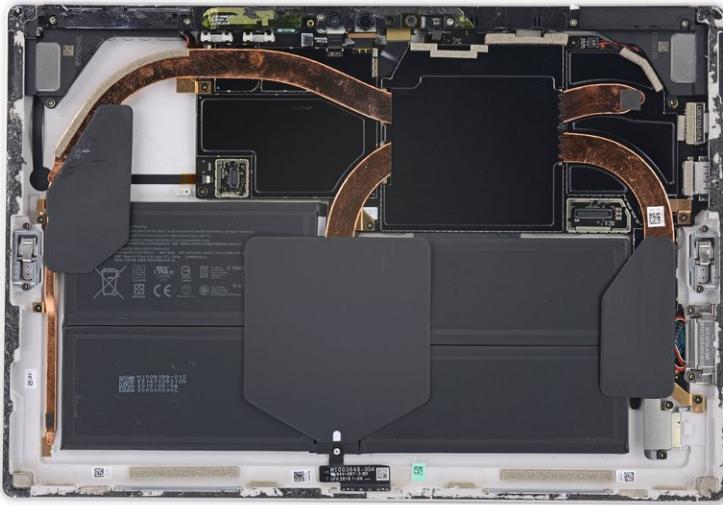
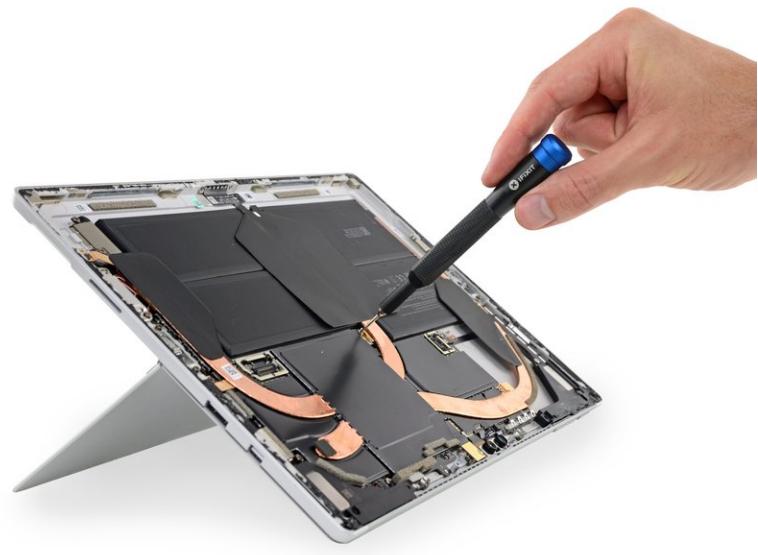
Step 5

- With the display out of the way, we can get to the good stuff.
- It seems Microsoft has been meddling with their passive cooler a bit—it looks like [last year's](#), but with an extra little pipe down the left side—plus some funky heat-spreading pads.
- *(i)* It's impressive to see Microsoft continue to bump up processing power without much additional heat management. It will be interesting to see how well this new setup handles the heat under load.
- Looking south, the similarities continue, with a quad-cell battery taking up most of the case.
- On the plus side, all the screws so far are standard Torx. Let's get to twirling them out!

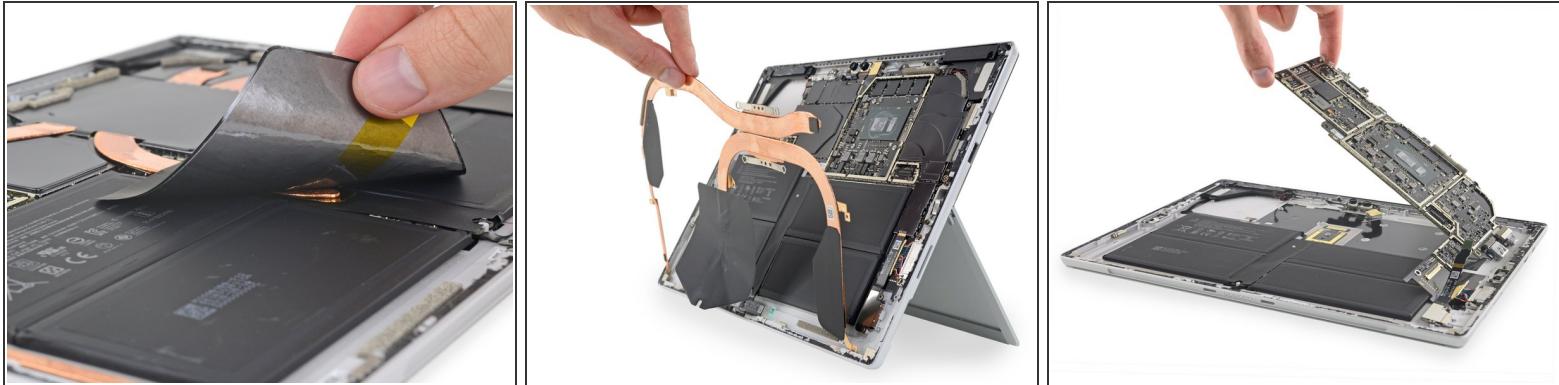
Step 6

- Searching for the gold at the end of the heatsink, we peel back some ... things. The [Surface Pro 4](#) had a copper heat spreader, but these look like graphite.
- Looking under those heat spreaders didn't lead to any gold, but we're free to remove the heatsink now.
- With the heatsink dispatched, we have access to the heat generators—all that silicon!

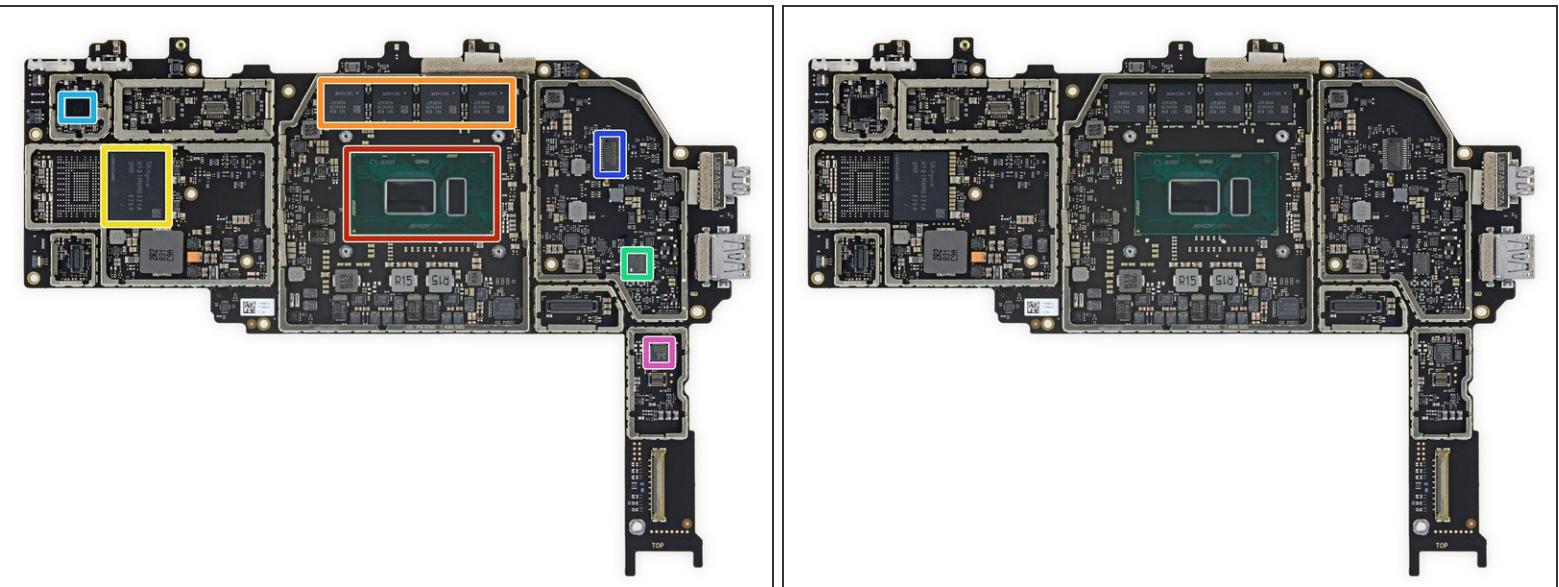
Step 7

- New chips and stale chips (mostly the latter):
 - Intel Core [i5-8250U](#) processor
 - Samsung [K4E6E304EB-EGCF](#) 2GB LPDDR3 DRAM (4 chips for 8 GB total)
 - SKhynix [HFB1M8M0331A](#) (BC501) 128 GB NVMe SSD
 - Winbond [25Q128JVPQ](#) 128Mb serial flash memory
 - Marvell [W8897](#) 802.11ac, NFC, and Bluetooth SoC
 - Nuvoton [NPCT650SBCWX](#) Trusted Platform Module
 - RTS5343 microSD card reader controller

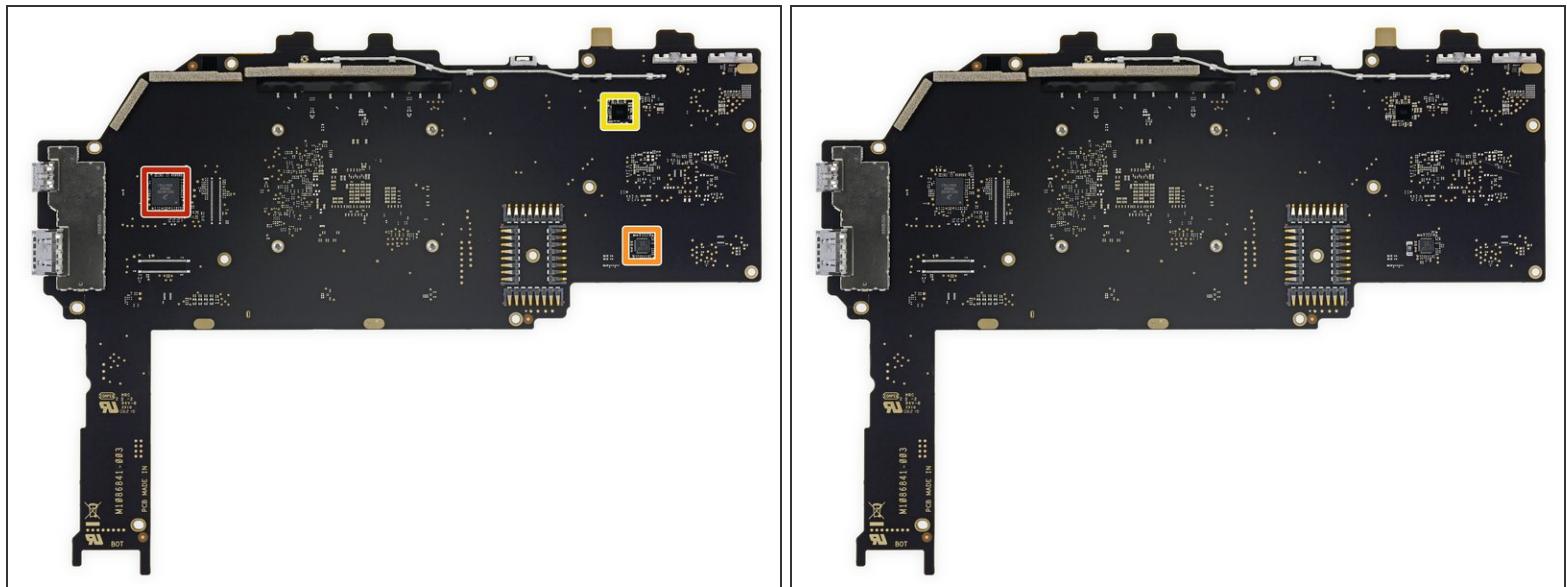
Step 8

- On the flip side:
 - Freescale/NXP [M22J9VDC](#) Kinetis K22F 512KB 120 MHz ARM Cortex-M4 based MCU
 - Texas Instruments [BQ25700A](#) battery buck-boost charge controller
 - Realtek ALC3269 audio codec

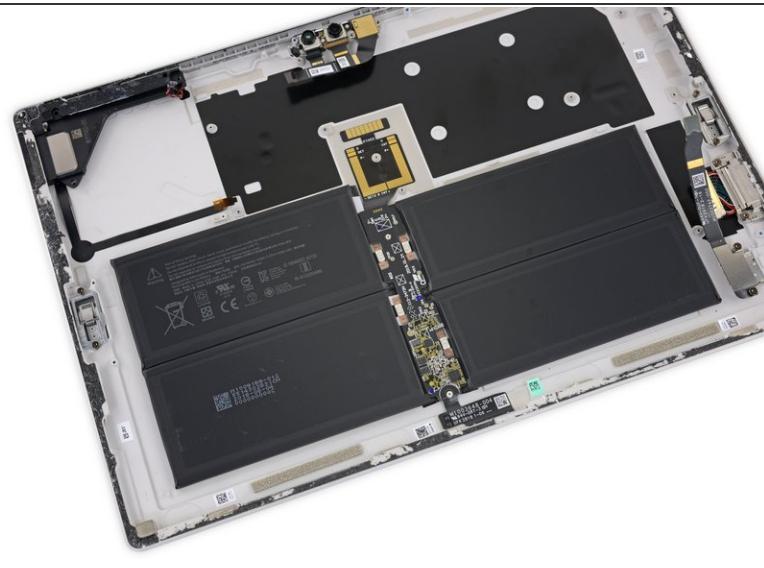
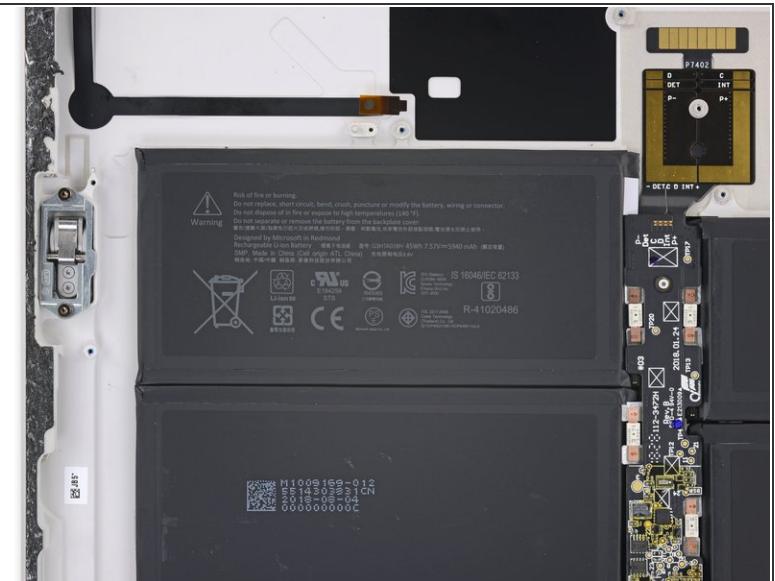
Step 9

- We've once again come to that inevitable junction in any Surface teardown: take out the heavily-glued battery, or leave it be?
 - Considering there are no stretch release battery tabs, and we've had our fill of prying, we opt to let the beast slumber for now.
- This battery weighs in at 45 Wh (7.57 V x 5940 mAh), exactly the same as [last year](#).
- That's expectedly larger than its more [mobile sibling](#), and even a little larger than the [most recent iPad](#).

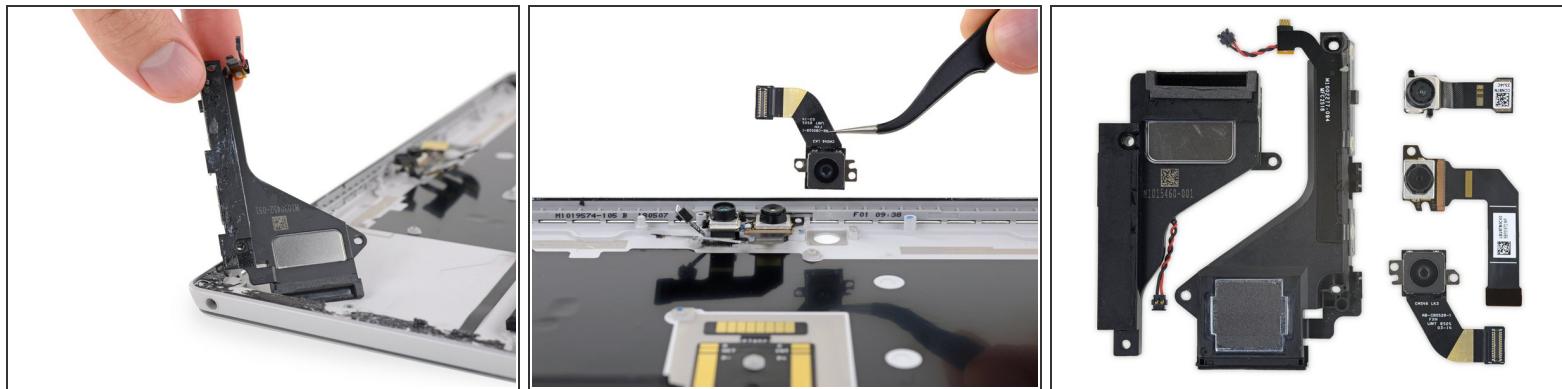
Step 10

- Really scraping the bottom of the ~~barrel~~ case, hoping for *something* new, we pull out the speakers and cameras.
 - The cameras are *still* hidden under the bracket holding the antennas (which are incredibly easy to mangle upon opening).
 - The speakers are *still* corner mounted triangles for that surround sound feel.
- I guess there's not much this tablet could do to raise its repairability score at this point.... But a fixer can dream...

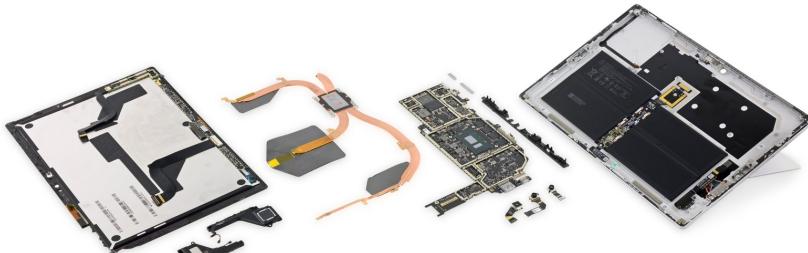
Step 11

- Here's a shucked Surface for your viewing pleasure! In theory this is a tablet, but in our reality it was a pain in the butt!
- The Surface Pro 6 brings more processing power (and heat) without changing its cooling solution much. Will the new thermal spreaders on the heat sink be enough to handle the power boost? Only time will tell.
- After hearing rumors of a modular Studio, we were hoping this generation of Surface Pro would steer that direction. Alas, it's just as un-upgradable and un-repairable as ever, and it doesn't even get a USB-C port.

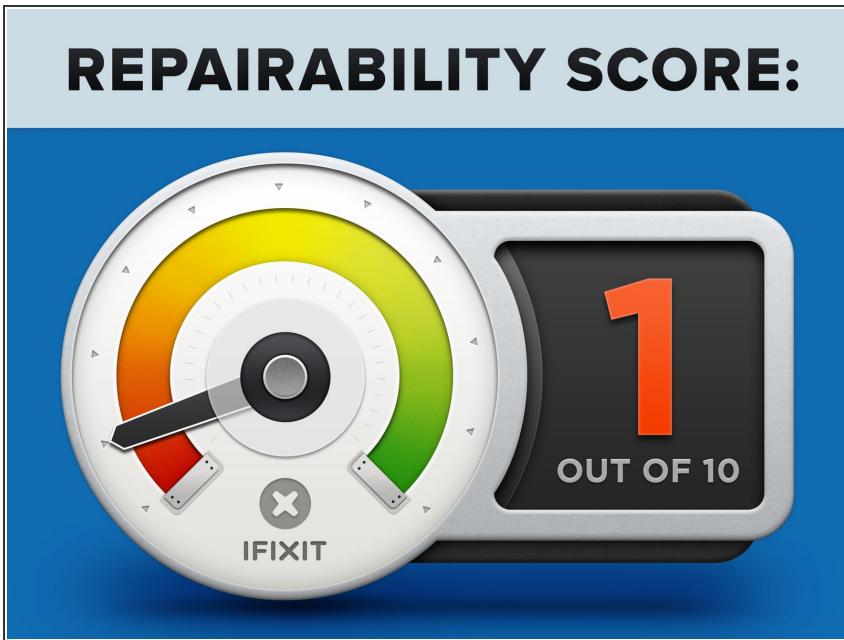
Step 12 — Final Thoughts

- Microsoft's Surface Pro 6 earns a **1 out of 10** on our repairability scale (10 is the easiest to repair):
 - To the extent that screws are used, they are all standard Torx fasteners.
 - This tablet still has a headphone jack, which is modular and replaceable, if you can get to it.
- All repairs require first removing the display assembly—which is stubbornly glued in place, expensive, and prone to shattering.
- The battery is firmly glued in place, with its connector pinned under the motherboard—requiring near-total disassembly for service.
- Once upon a time, Surface Pro storage was removable—but not in this version.
- Complex construction makes all disassembly and reassembly tedious in comparison to other tablets.
