# Microsoft Surface Pro 7 Teardown

A teardown Microsoft's Surface Pro 7 performed on 11/12/2019.

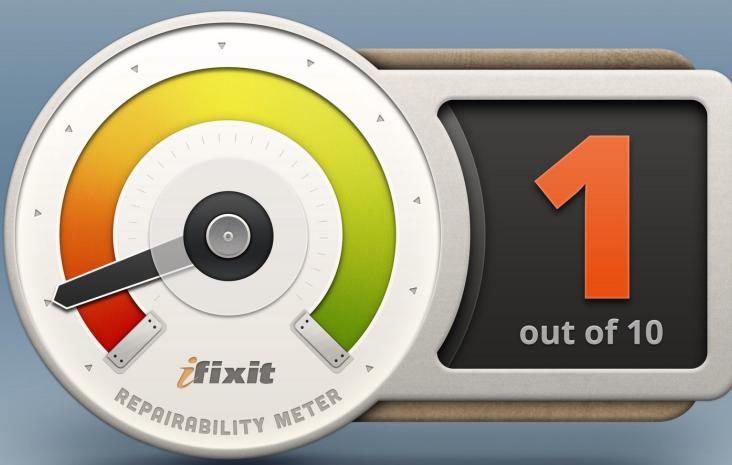
### REPAIRABILITY SCORE:

- To the extent that screws are used, they are all standard Torx fasteners.
- All repairs require first removing the display assembly—which is stubbornly glued in place, expensive, and prone to shattering.
- The battery is also firmly glued in place, requiring tons of heat and prying or solvents to remove.
- The RAM, SSD and CPU are all soldered to the motherboard. Replacing any of those components requires a full motherboard replacement.
