# Milwaukee Hex Impact Driver 2750-20 Output Shaft Bearing Replacement

This informative guide explains the process of replacing the output shaft bearing for a Milwaukee Hex Impact Driver 2750-20.

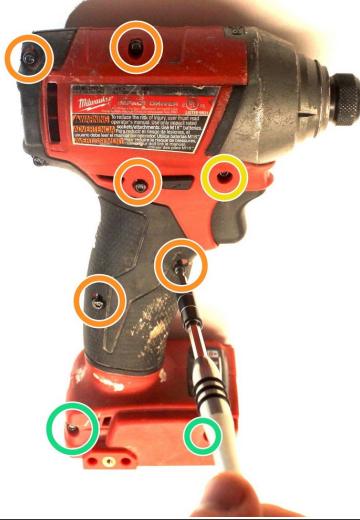
## Step 1 — Outer Casing

- Remove the five T9 15.5 mm screws.
- Remove the single T9 19.5mm screw.
- Remove the two T9 37mm screws.

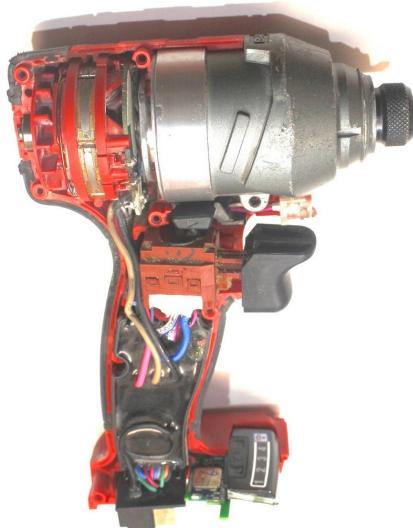
## Step 2

- Remove the drill casing to expose the drill's interior parts.

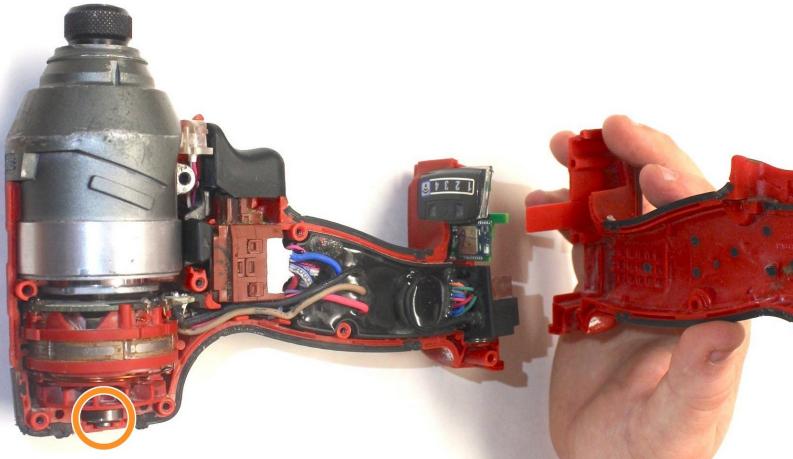
## Step 3 — Output Shaft Bearing

- Once the interior is open locate the output shaft driver pictured at the left of the screen.

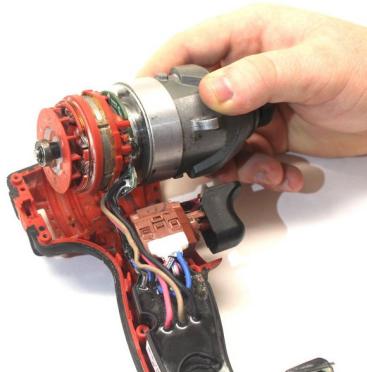
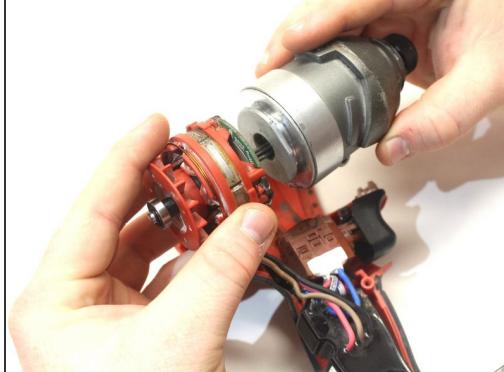
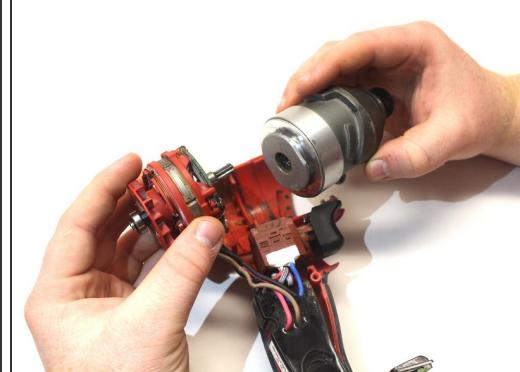
## Step 4

- Lift the driver head and motor assembly directly out of the outer casing.
- Pull the driver head away from the motor assembly, separating the two.

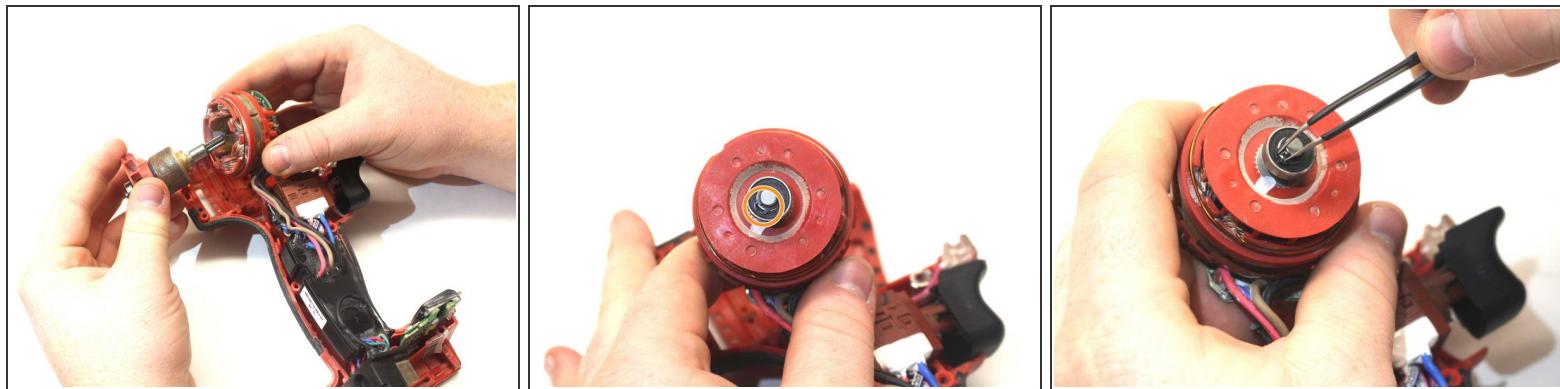
## Step 5

- Remove the fan and the drive shaft assembly from the motor core assembly.
- Using a pair of tweezers, remove the retaining ring.
- Remove the old bearing and reinstall the new retaining clip.
