Milwaukee Impact Wrench 9070-20 Power Cord Replacement

Use this guide to replace the power cord in your Milwaukee Impact Wrench 9070-20.

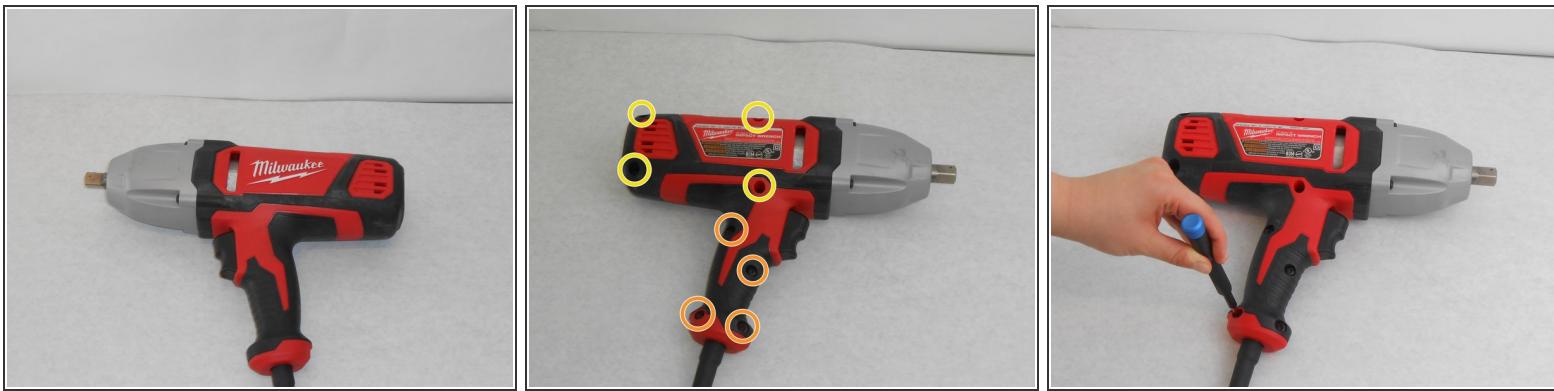
Step 1 — Power Cord

- Flip the device and remove four 18mm screws using the T20 Torx screwdriver.
- Remove the four 14mm screws using the same screwdriver.

⚠ Ensure that the device is unplugged from any power source to avoid electrical shock.

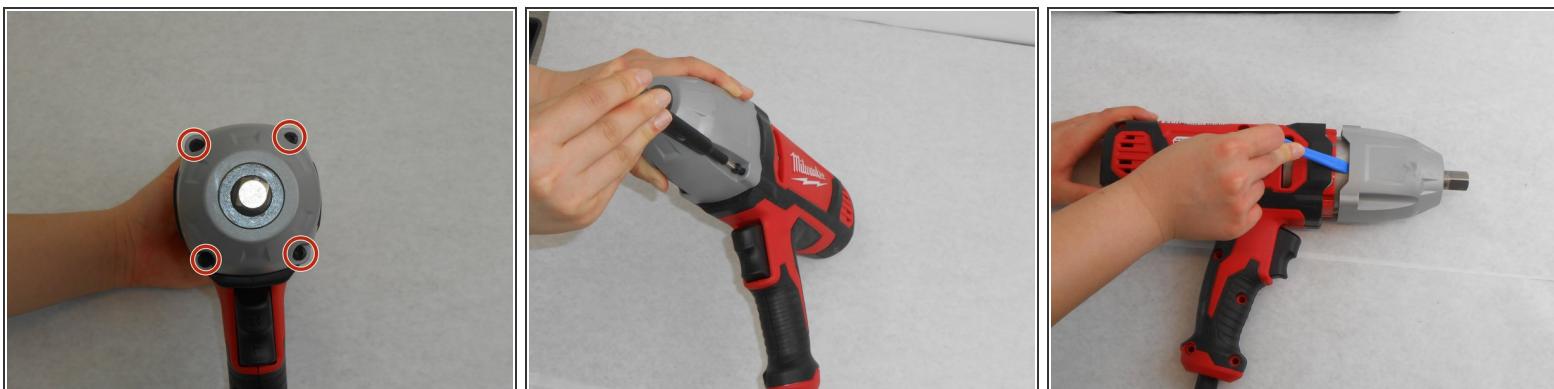
Step 2

- Hold the device so the gray part faces directly towards you.
- Remove the four screws on the sides using the T20 Torx screwdriver.
- After removing all screws, use a small plastic pry bar to slide the gearbox assembly forward slightly.

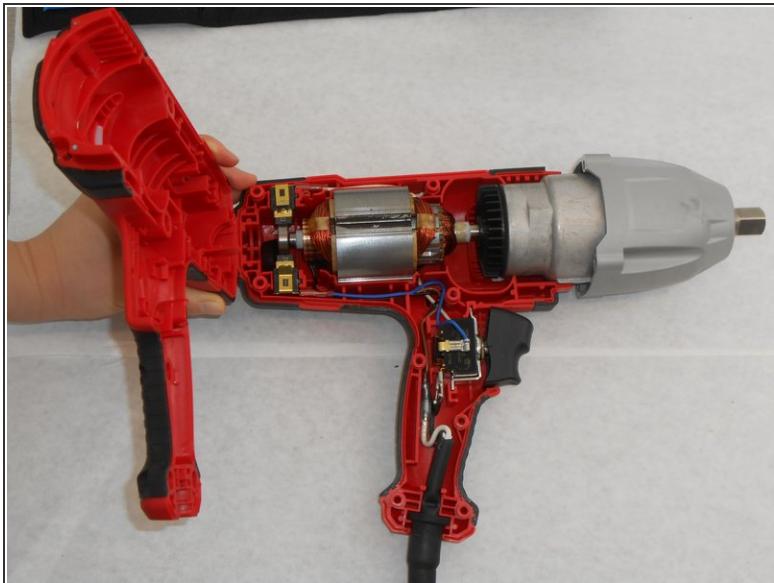
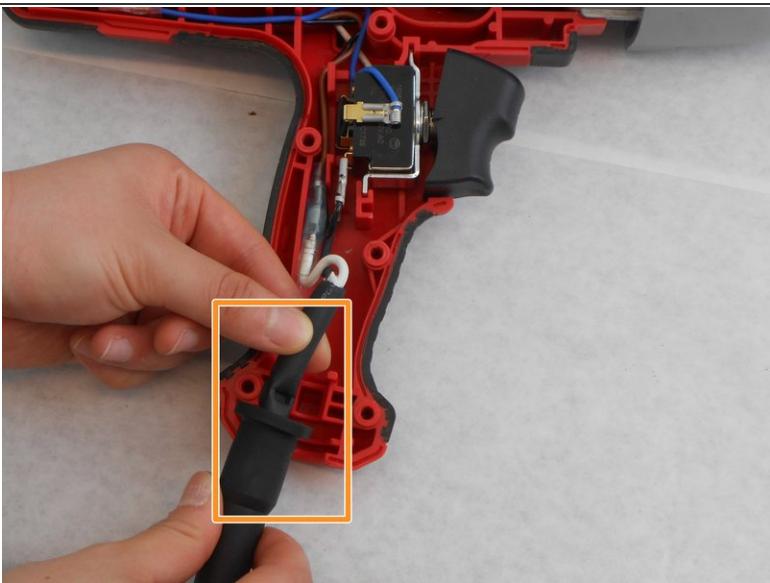
Step 3

- Gently remove the upper clam shell from the device.
- Lift a black colored power cord from its mount at the bottom of the device, so it can move freely.

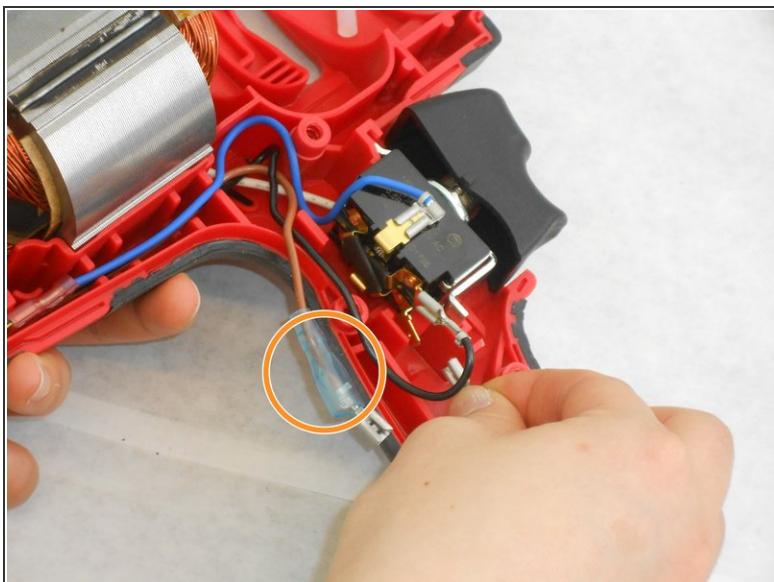
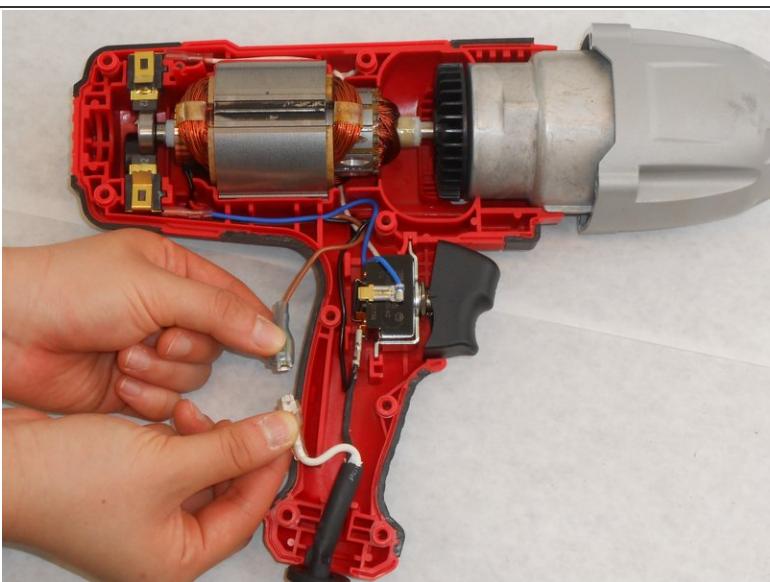
Step 4

- Disconnect the brown field winding wire from the white ac power cord wire.

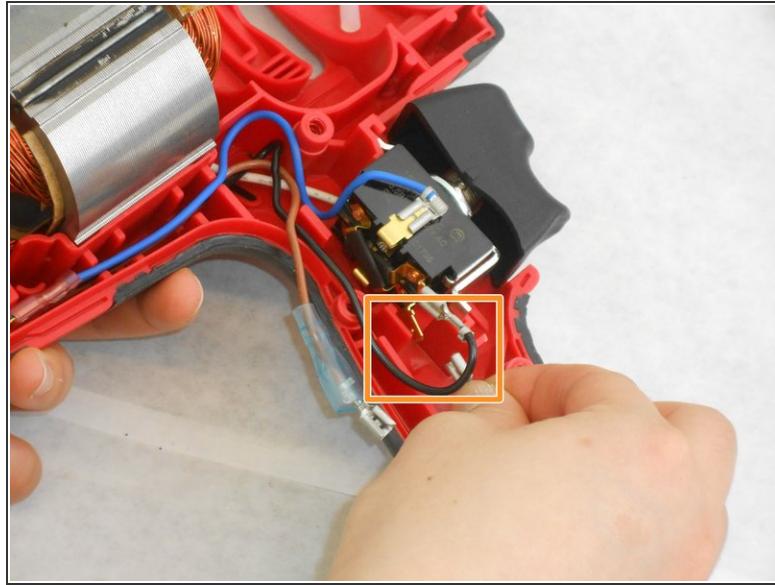
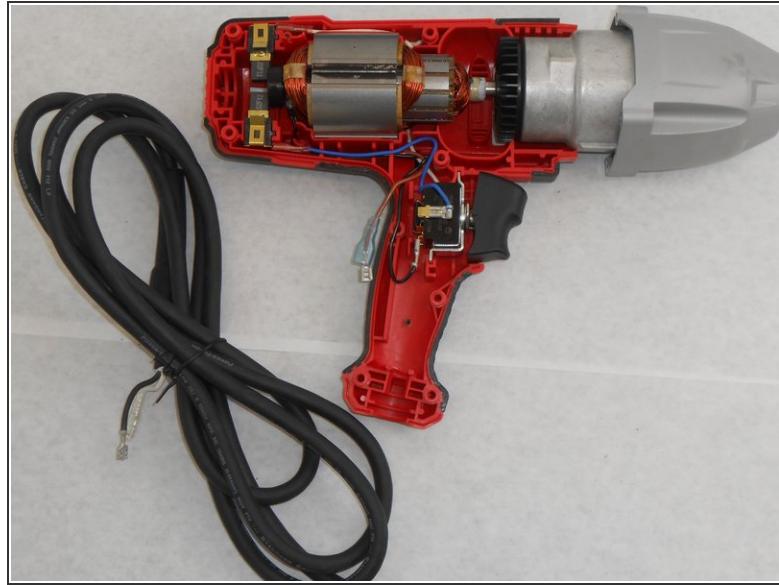
Step 5

- Disconnect the black ac power wire from the connector on the bottom of the forward / reverse switch.
- Remove the AC power cord and replace it with a new one.

To reassemble your device, follow these instructions in reverse order.
