# Minolta Maxxum STsi Back Clock Button Replacement

This guide consists of removing the back clock button.

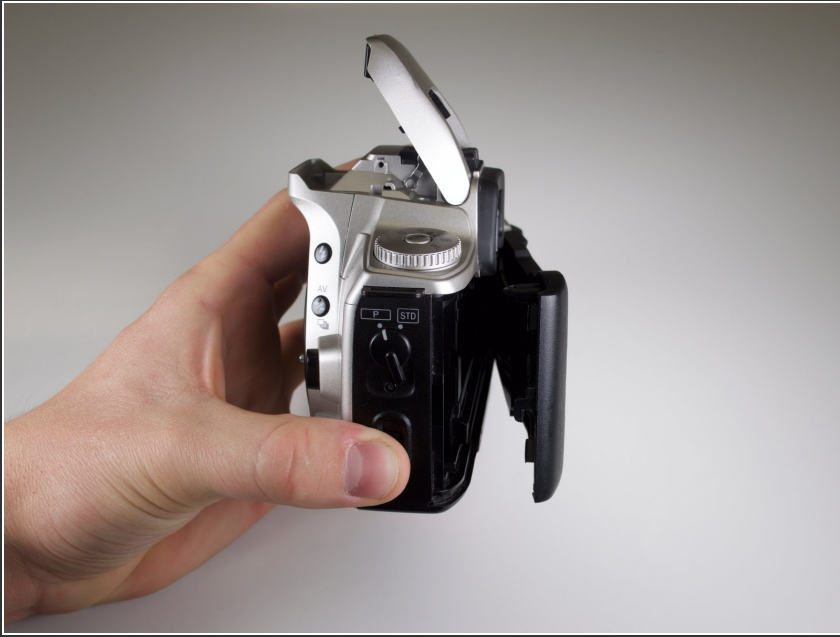
## Step 1 — Back Clock Button

- Open the back panel by firmly pressing up on the back-cover release on the lower right side of the camera.

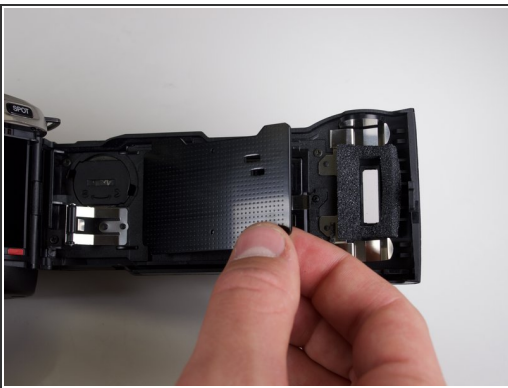
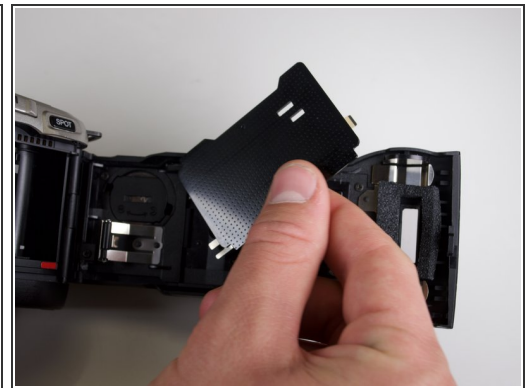
## Step 2

- Remove the black case by gently lifting it with your fingers and rotating counterclockwise.

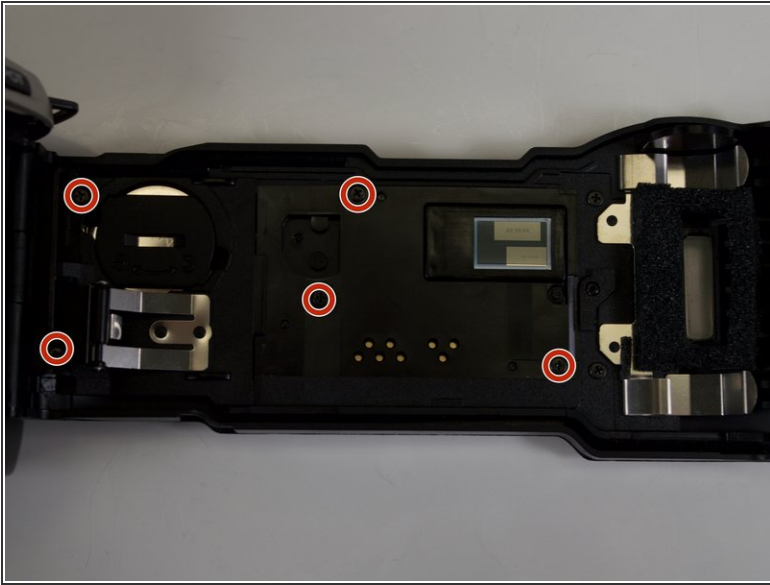
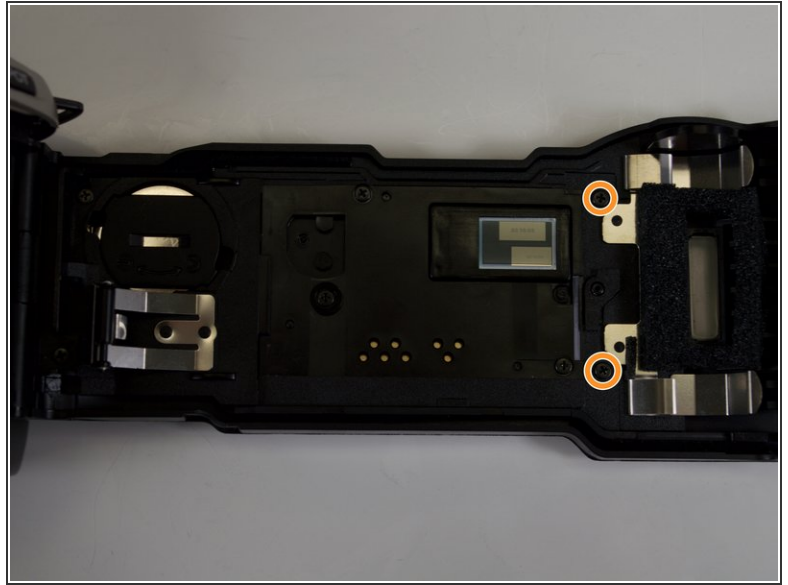
### Step 3

- Remove the five black Phillips #00 2.5 mm screws from the back panel.
- Also remove the two black Phillips #00 5.0 mm screws from the back panel.

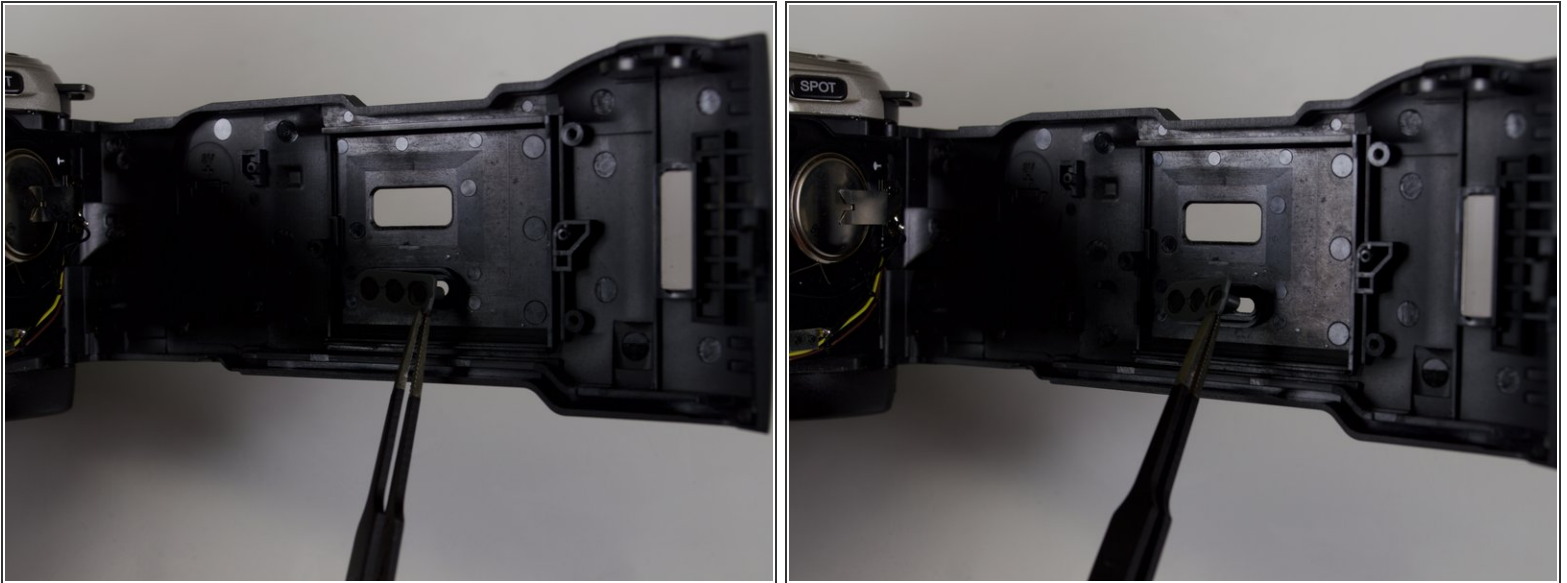
## Step 5

- Use the tweezers to carefully peel off the rubber clock button.

To reassemble your device, follow these instructions in reverse order.
