Mio ALPHA 2 Battery Replacement

Changing the battery to fix if the watch doesn't stay charged.

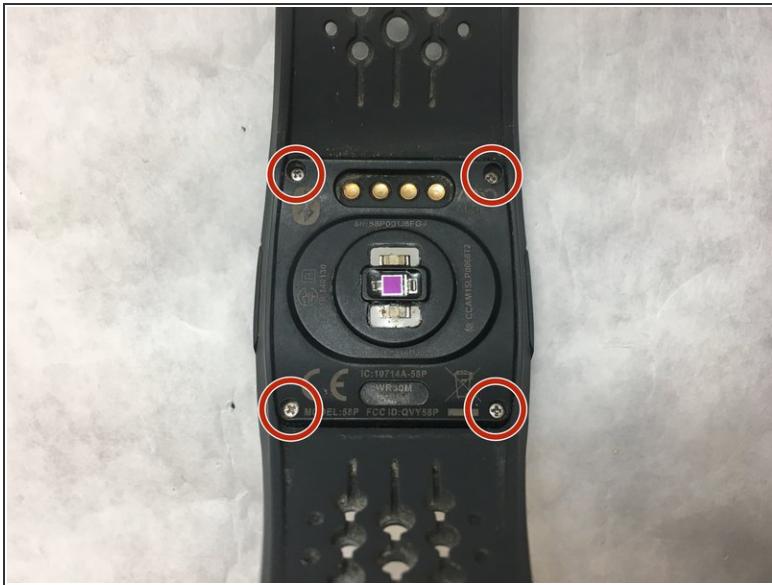
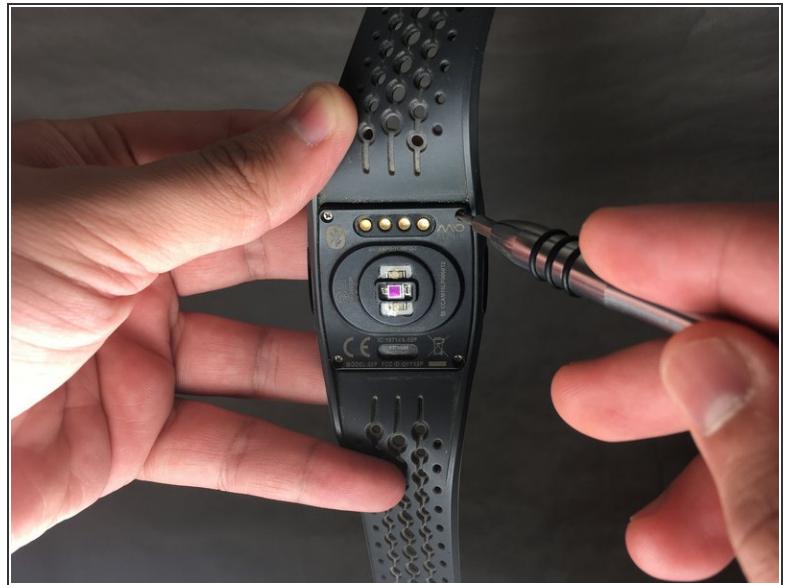
Step 1 — Battery

- Remove the 4 JIS 00 6.71 mm screws.
