Monster DNA Wire Replacement

One or both of the speakers on the Monster DNA headphones is not working. The problem could be the wiring on the speaker part.

Written By: Kevin Costello

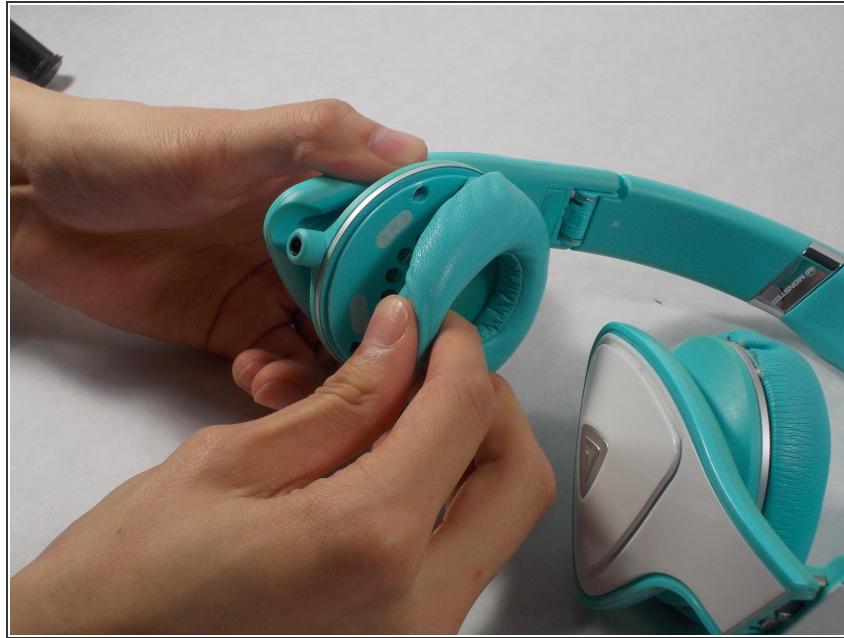
Step 1 — Wire

- Take off the ear cushions by pulling on the sides.

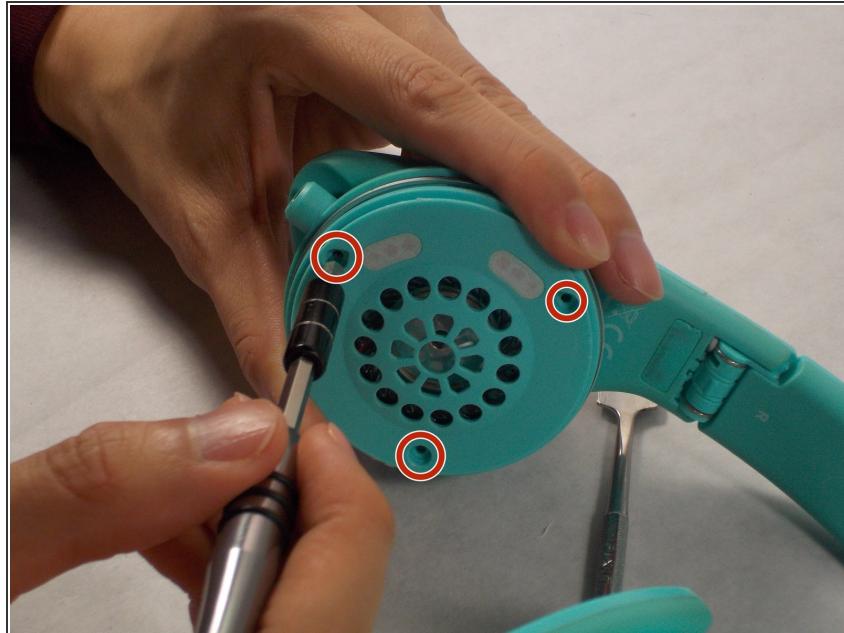
Step 2

- Use a Phillips #2 screwdriver to unscrew the three 5mm screws that secure the speaker cover.

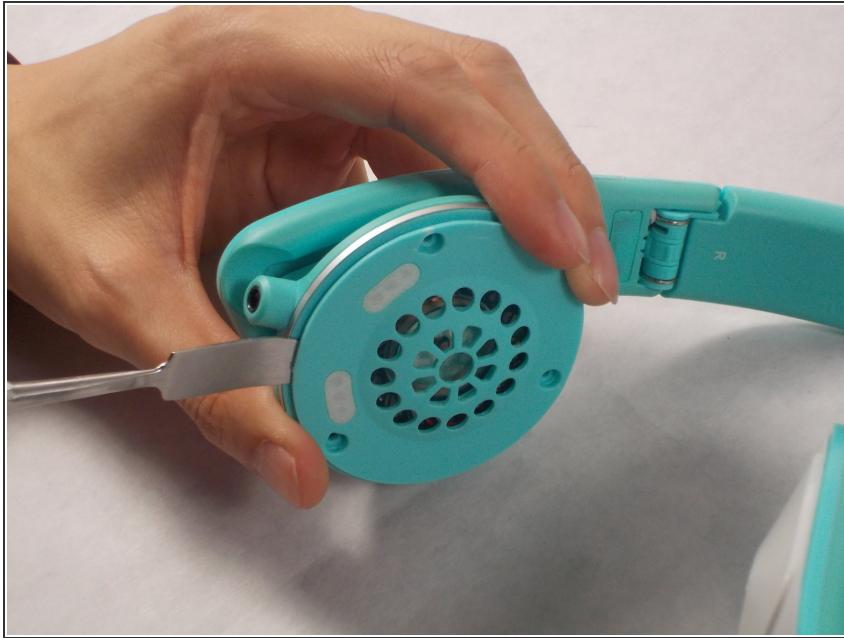
Step 3

- Use a plastic opening tool or a metal spudger to pry off the plate

⚠ Be careful as too much force may cause damage to your headphones.

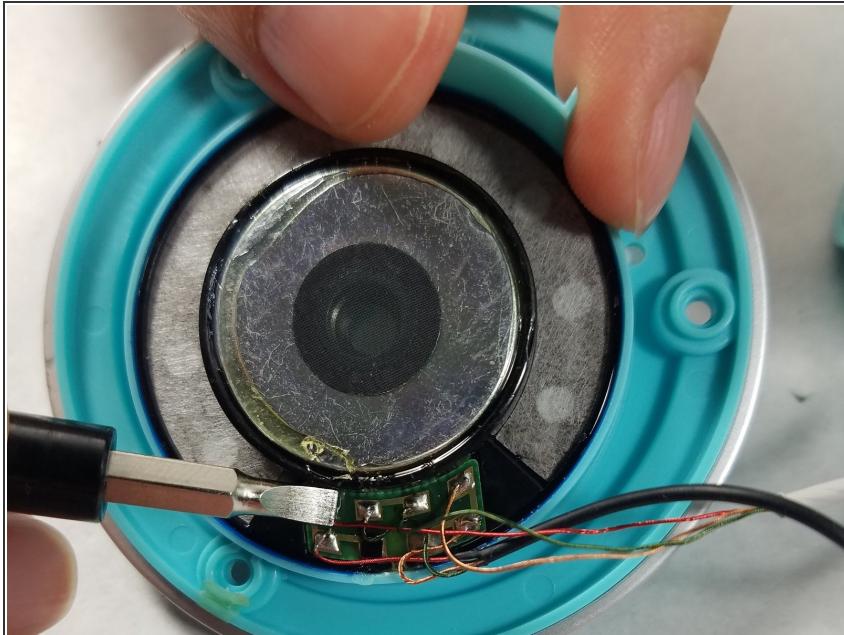
Step 4

- Once the loose wire or wires are located on the back of the speaker, use a soldering iron to attach the loose wire back onto the speaker.

To reassemble your device, follow these instructions in reverse order.
