Motorola Moto 360 2nd Gen Vibration Motor Replacement

This guide will instruct the user to replace the Vibration Motor in their Motorola Moto 360 2nd Gen device.

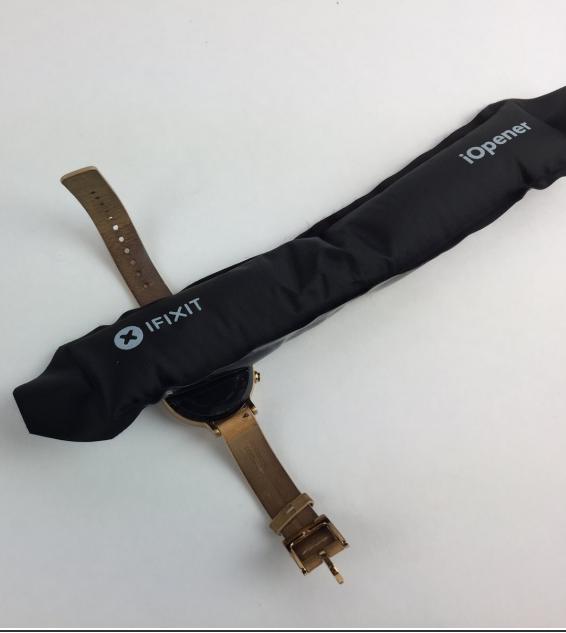
Step 1 — Vibration Motor

- Set the watch face down on a flat surface.
- Place the heated iOpener on the face of the rear cover to loosen the adhesive underneath.

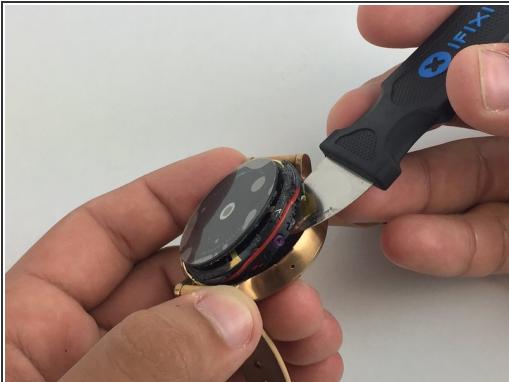
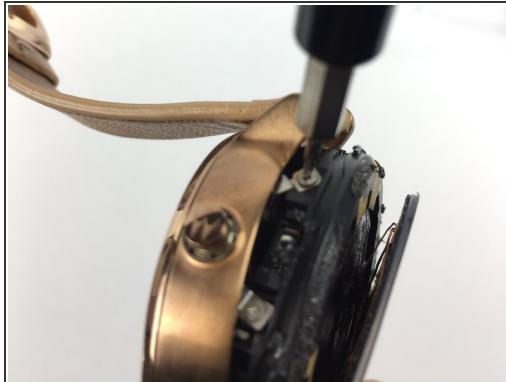
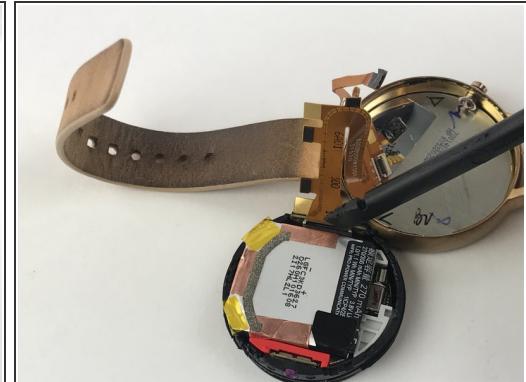
Step 2

- Carefully remove the inside of the watch.
- Carefully unscrew the two screw using the using the T3 Torx Screwdriver.

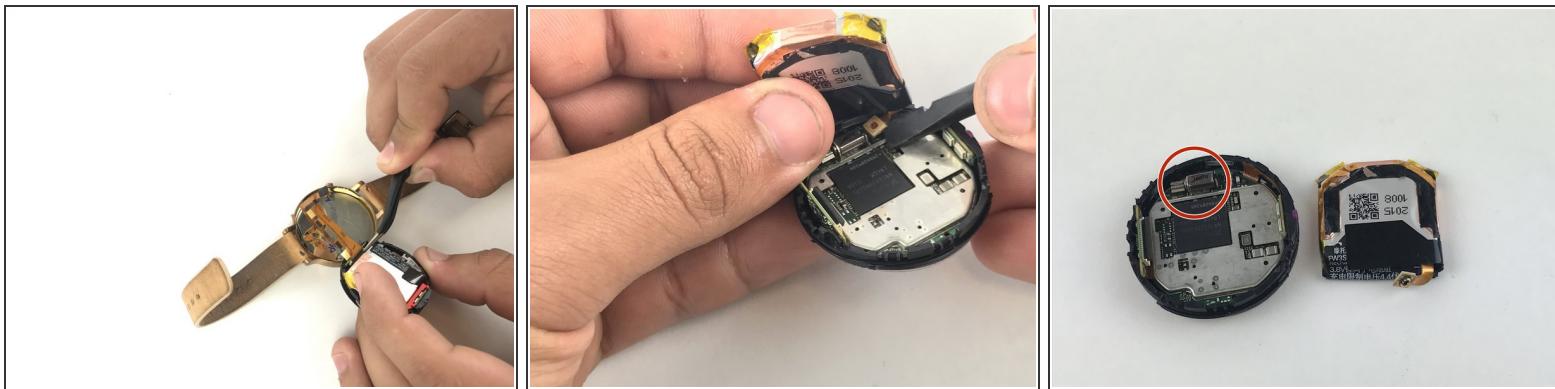
Step 3

- Remove any connectors on the motherboard using the tweezers and spudger.
- Carefully remove the battery by disconnecting the connector.

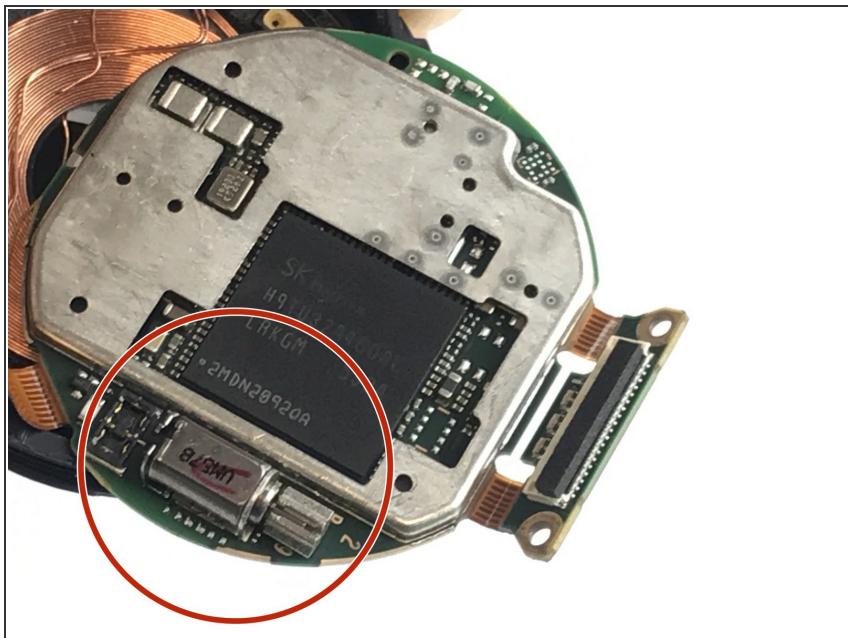
Step 4

- After removing the battery the vibration motor will be visible.

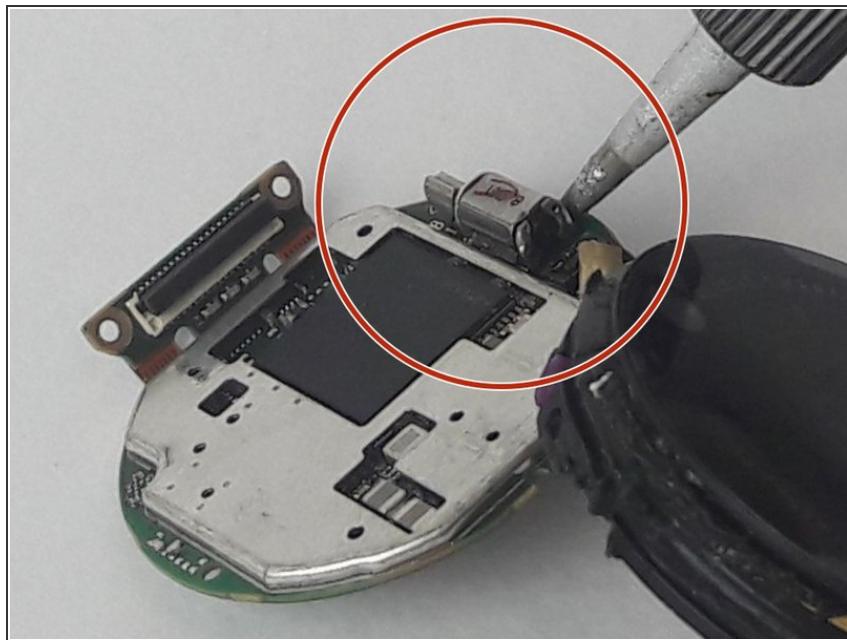
Step 5

- Using a soldering iron, carefully remove the vibration motor by applying the tool under the vibration motor.
