Nexus 6P Daughterboard/Charging Port Replacement

Written By: Witrigs

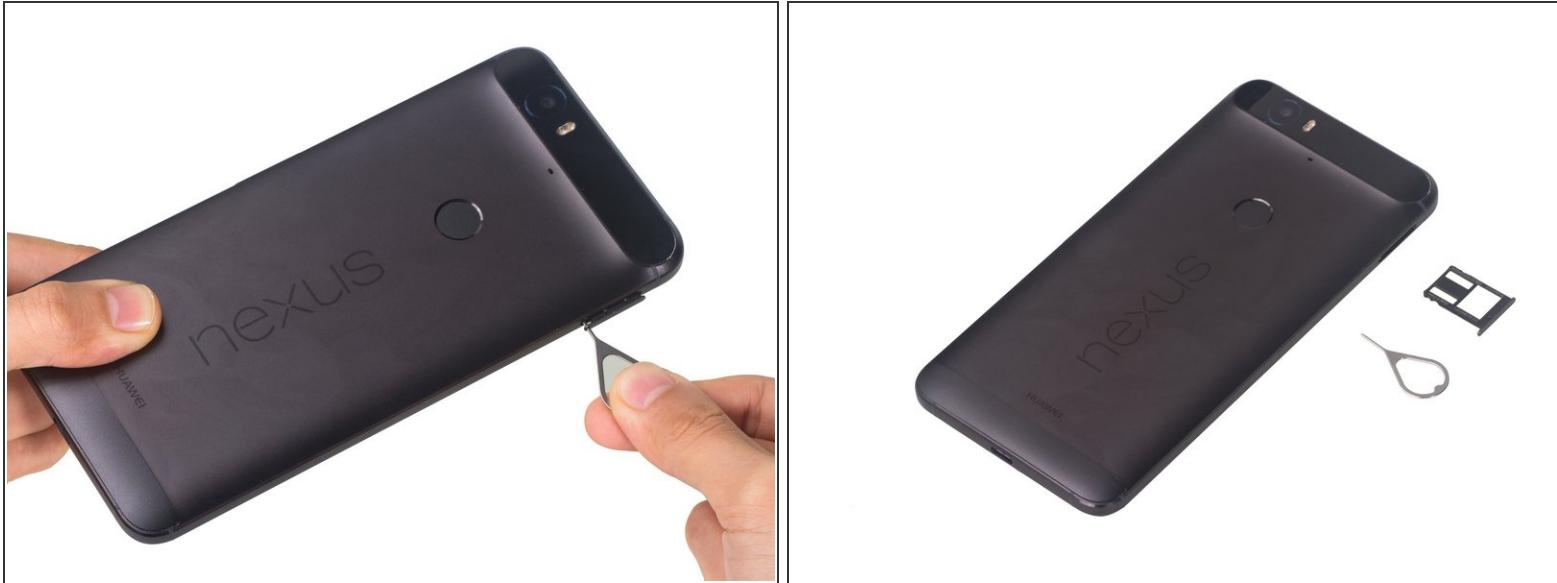
Step 1 — Daughterboard/Charging Port

- Remove SIM card tray.

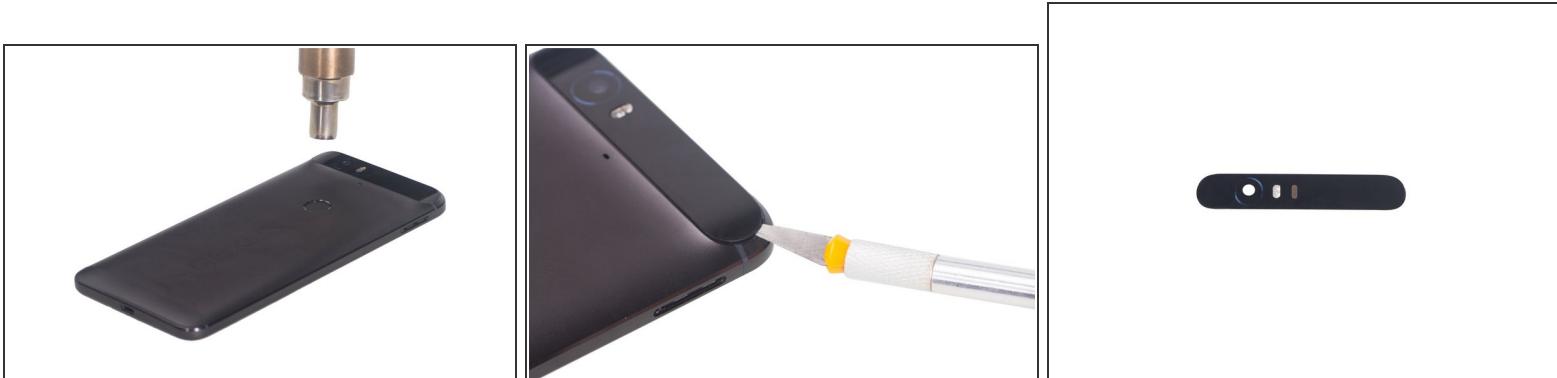
Step 2

- Heat up back glass panel.
- Use hobby knife to open a gap and cut the fierce sticker underneath rear glass panel.

! The back glass panel is easily shattered and the adhesive underneath is fierce. So be careful to pry this part.

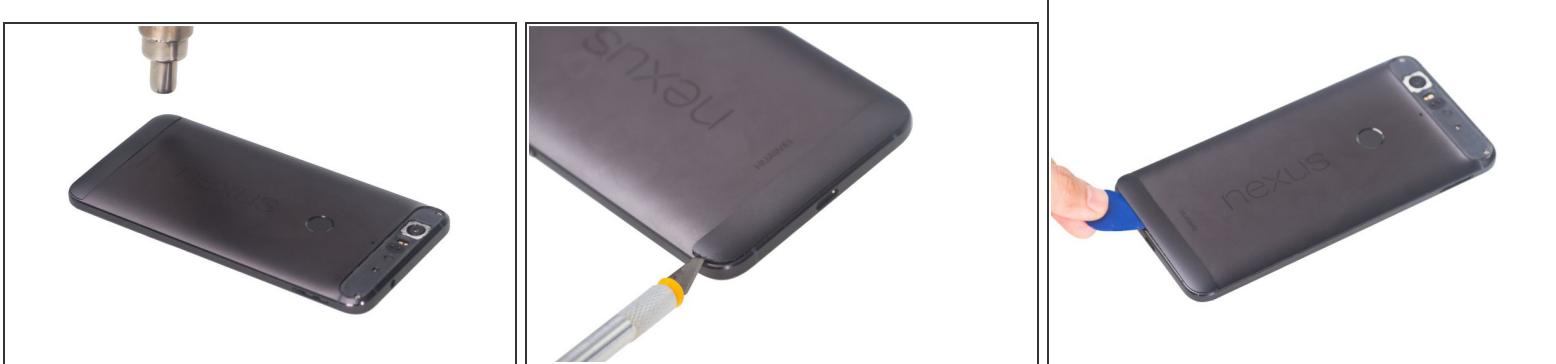
Step 3

- Heat up bottom plastic panel.
- Use hobby knife to open a gap and insert guitar picks to cut adhesive underneath.

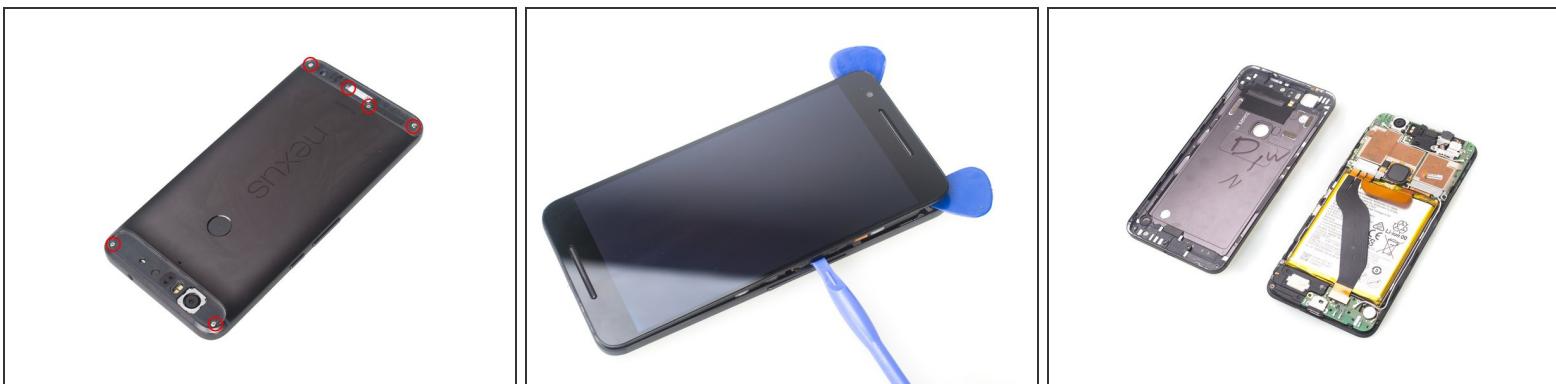
Step 4

- Twist off 6 Phillips screws together.
- Insert guitar picks and plastic opening tool to separate front assembly from back cover.

⚠ Attention: These two parts fit tightly. It is the toughest part to separate. You can also try using heavy-duty suction cup to disassemble them.

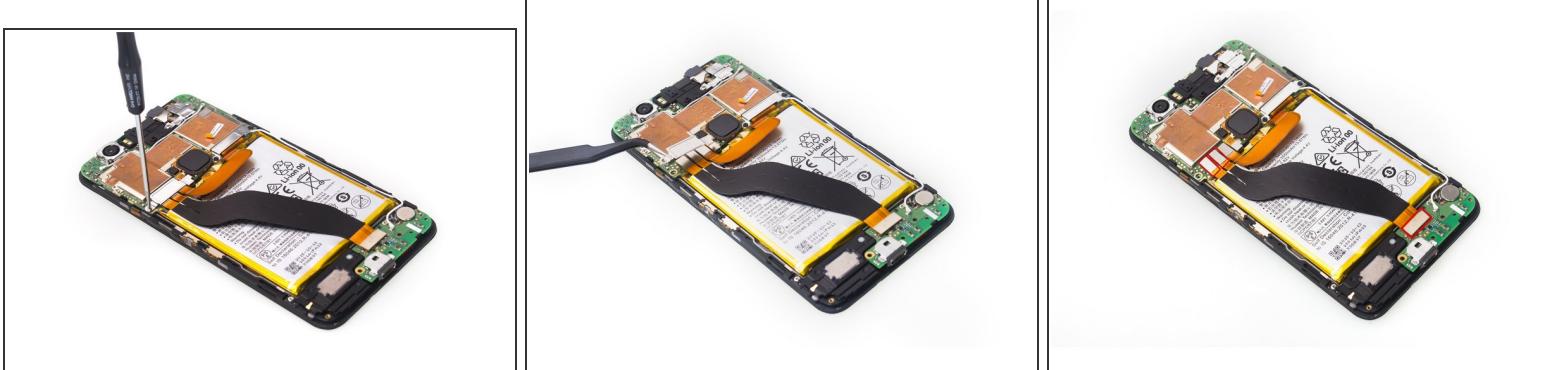
Step 5

- Unscrew one Phillips screw.
- Remove metal bracket securing flex contactors.
- Release 3 flex contactors and remove it .

(i) This flex is used to connect motherboard and daughterboard.

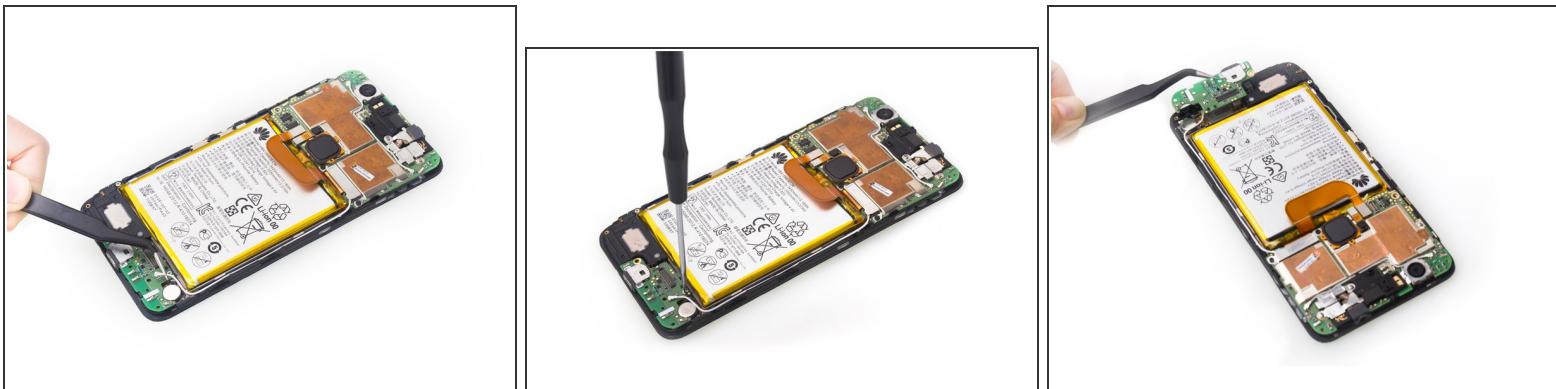
Step 6

- Disconnect signal cable contactor and twist off one Phillips screw.
- Remove daughterboard.
