# Ninja Coffee Bar® Single-Serve System Valve Tubes Replacement

Changing the tubes when the device is leaking water from the bottom of the device.

Written By: Naser Aldousari

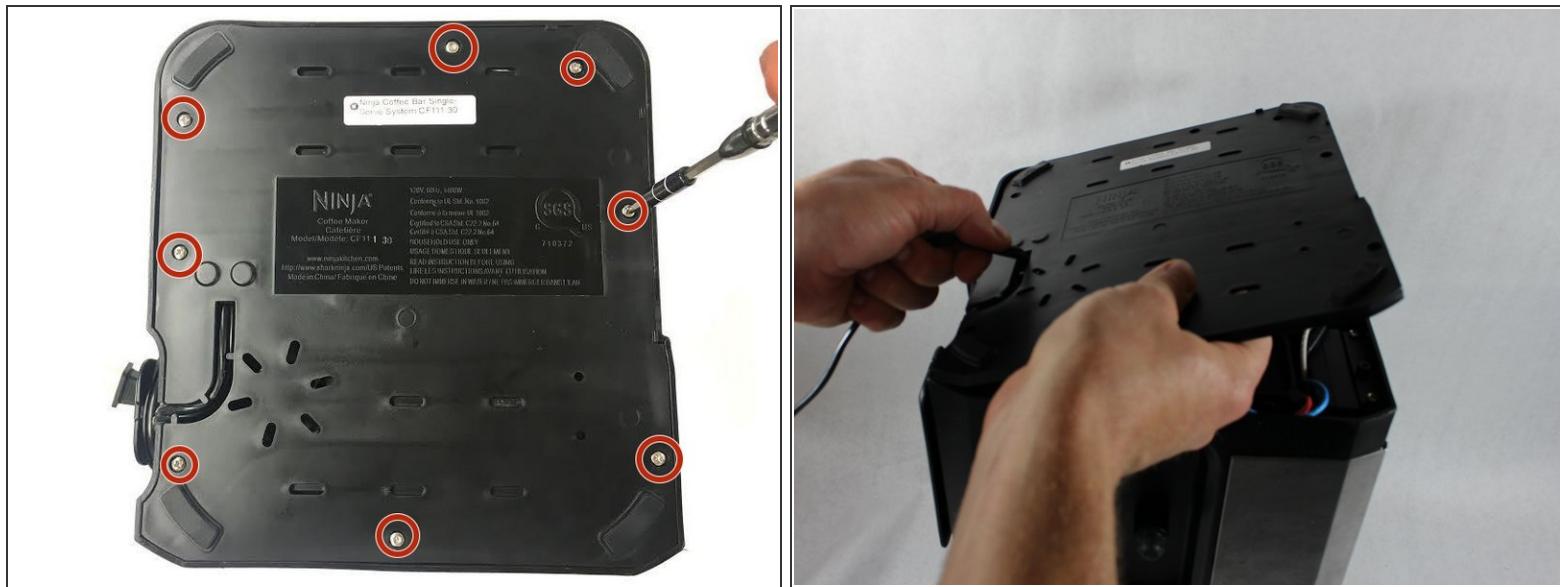
## Step 1 — Valve Tubes

- Unscrew (8) 6mm screws using Phillips head #1 screwdriver
- Remove bottom cover

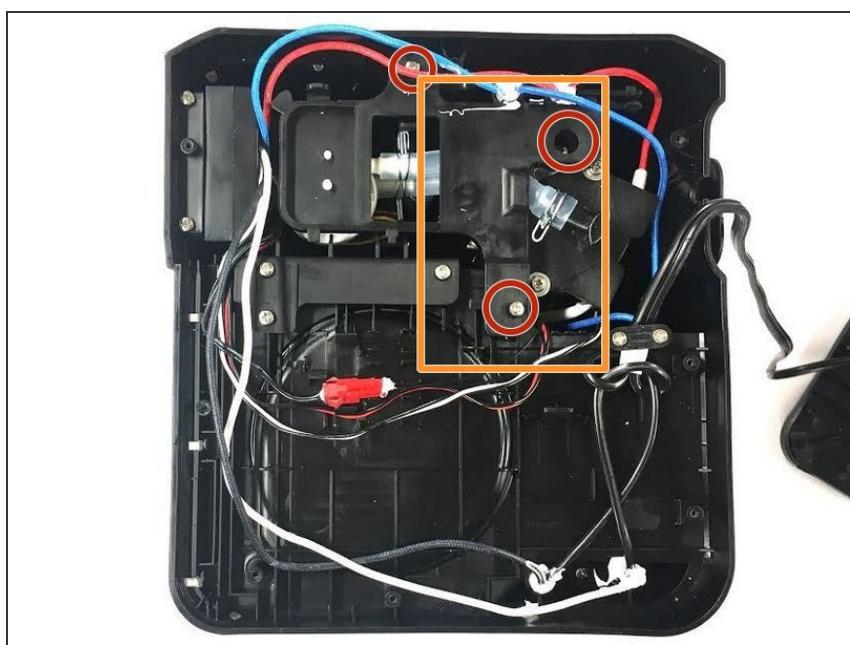
## Step 2

- Unscrew (3) 6mm screws with Phillips head #1 screwdriver
- Remove tube protection plate

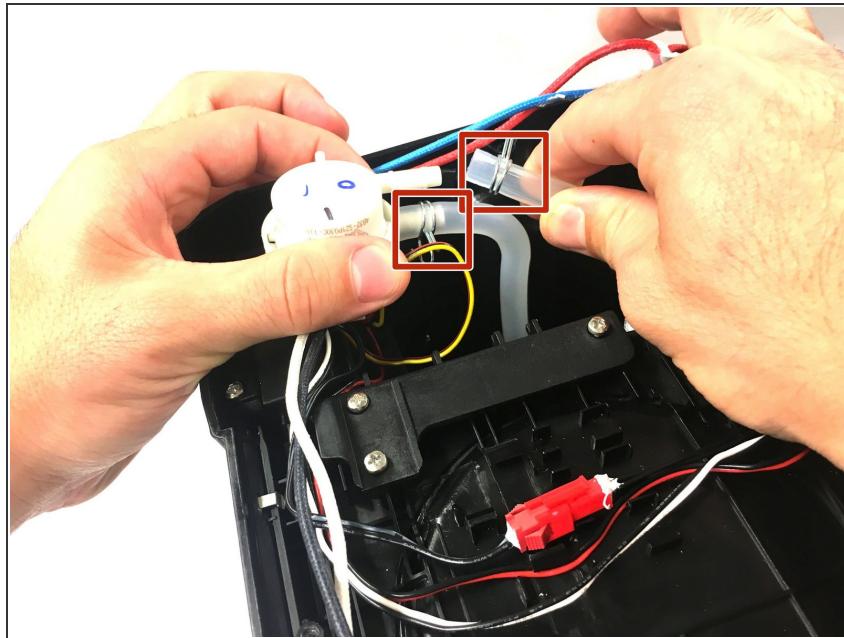
## Step 3

- Detach valve tubes from valve by squeezing pins and pull tubes away from valve

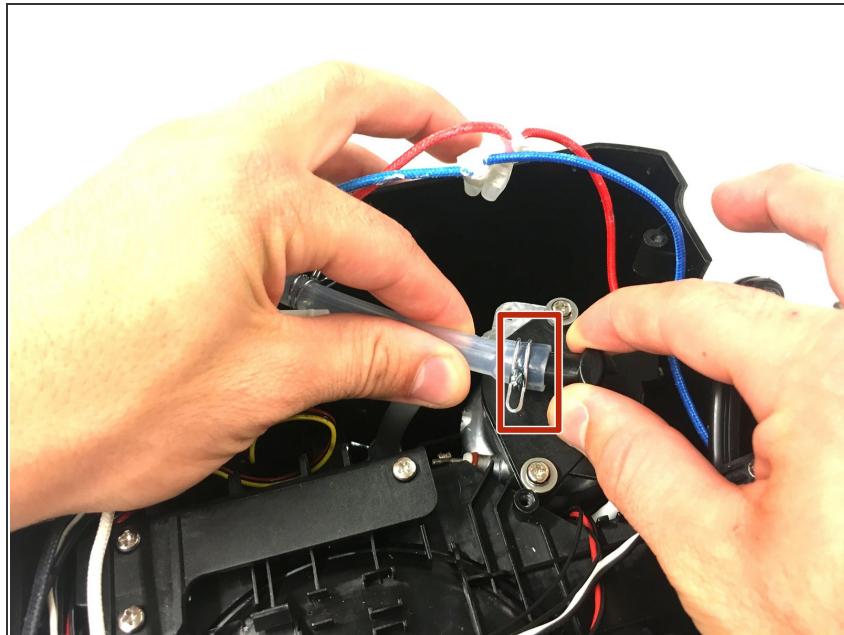
## Step 4

- Detach valve tubes from device by pinching pins and sliding the tubes off

To reassemble your device, follow these instructions in reverse order.
