Nintendo GameCube Lens Recalibration

Recalibration of the optical drive lens to fix 98% of DRE (Disc Read Error) messages.

Written By: Christopher Cox

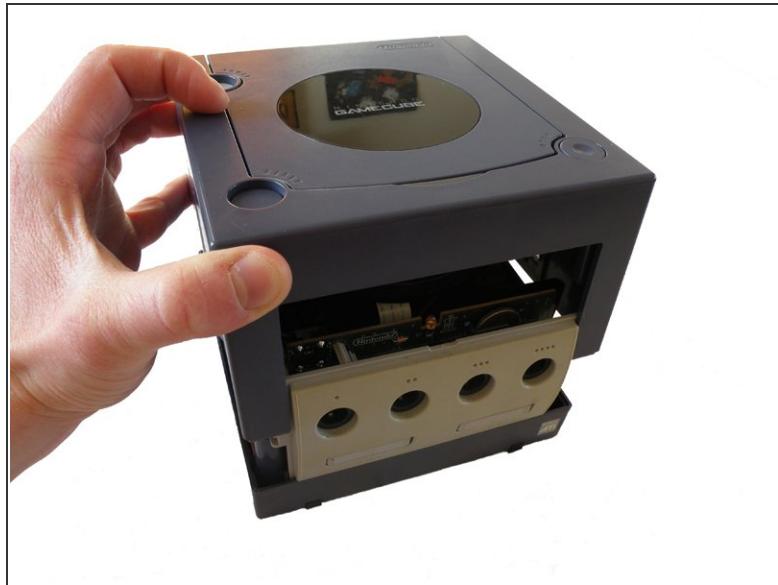
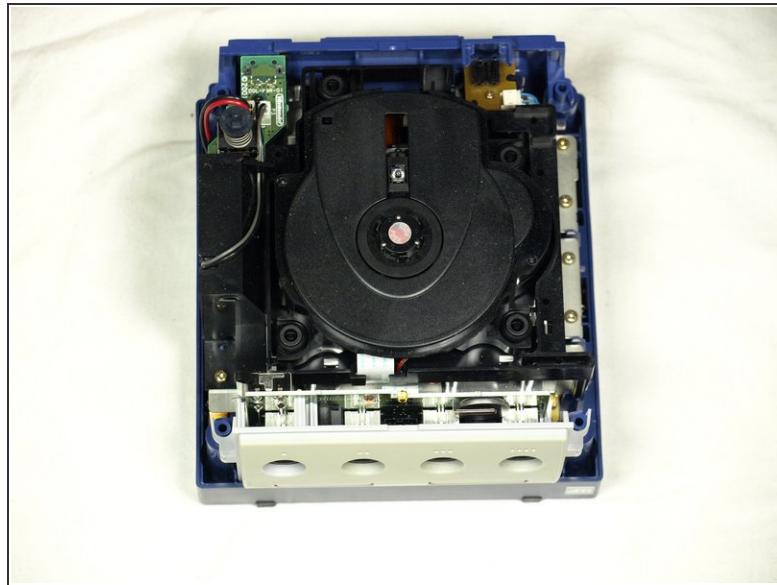
Step 2

- Using both hands, grasp the top of the Gamecube and carefully slide off the top wall exposing the inside of the unit.
- Set aside the top wall.

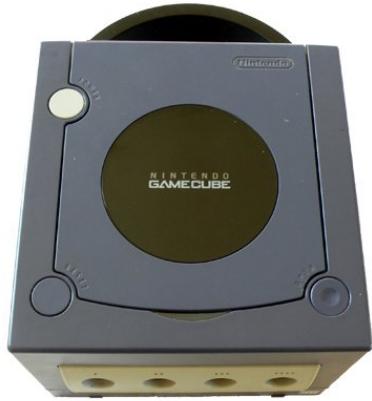
Step 10 — Testing and further adjustments

- To test the lens calibration reassemble the console up to the ground springs near the memory card slots.

⚠ The memory card ground springs **MUST** be put back on prior to restarting your console.
- If any further adjustments are necessary just turn the potentiometer no more than 1 or 2 degrees more per readjustment. Eventually you'll start to see less DRE messages.
 - **i** Once there are no more DRE messages, turn the potentiometer a further 1 degree to "future-proof" your lens from DRE messages in the future.
 - **i** As stated in the title of this guide. This procedure may not fix your DRE problems if the fault lies elsewhere in the system. But this will cover about 98% of DRE messages.
