Nokia Lumia 610 Touchscreen Glass / Digitizer Assembly Replacement

Opening up the Lumia 610 to change the Digitizer Assembly.

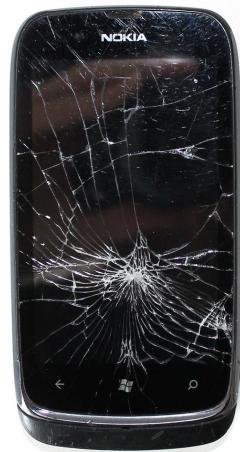
Step 1 — Touchscreen Glass / Digitizer Assembly

- The first thing you'll need is a Nokia Lumia 610 with a broken front glass
