Nokia Lumia 900 Front Camera Replacement

How to replace the front facing camera in your Nokia Lumia 900.

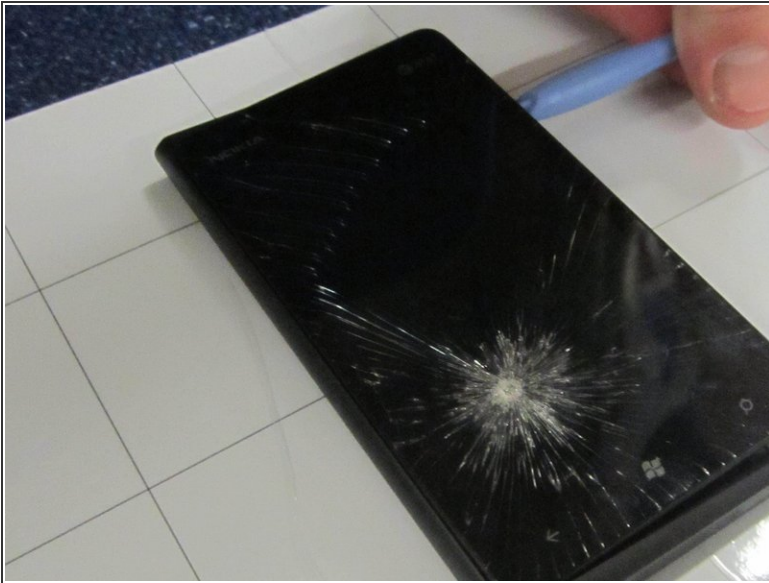
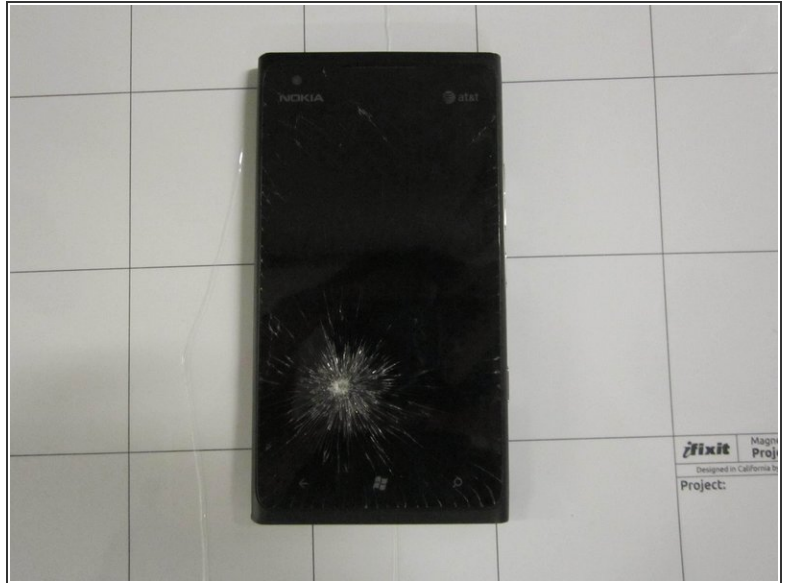
Step 1 — Opening The Phone

- Remove the Sim card tray and locking bar, before applying pressure to to the top right corner of the plastic casing.
- Using the opening tool, pry the screen from the casing until they are separated from each other.

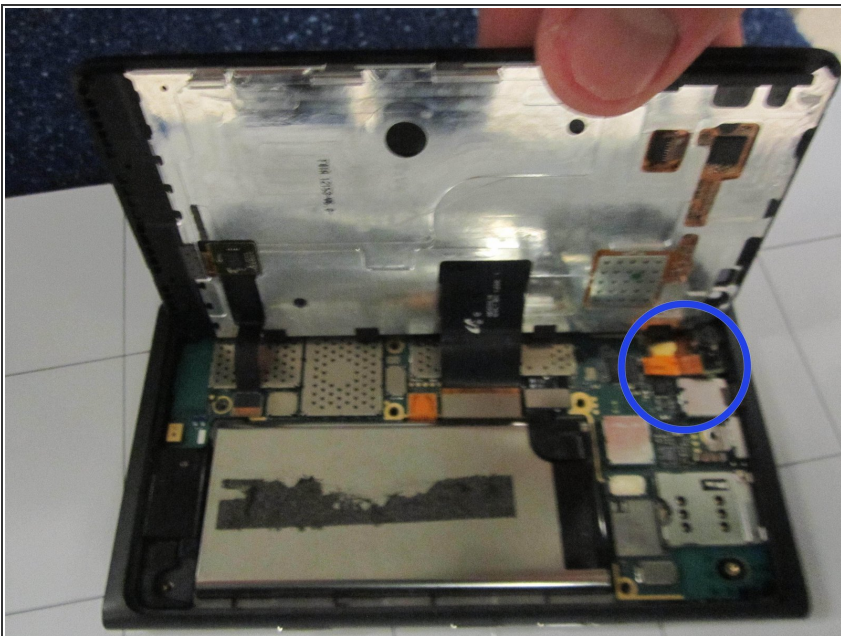
Step 2 — Detach Ribbon

- Detach camera ribbon from motherboard

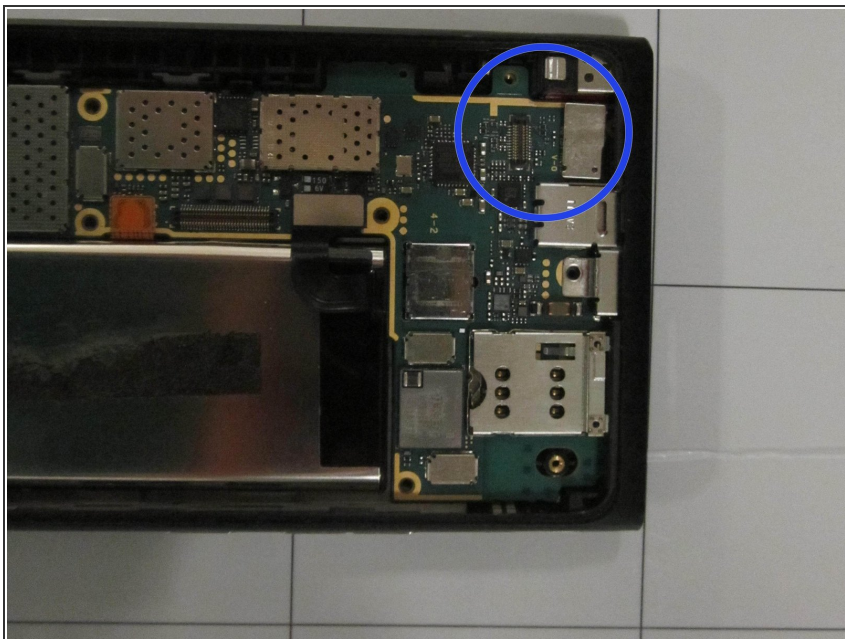
Step 3 — Remove Camera

- Peel camera off of adhesive surface

⚠ Use caution when removing camera as it is fragile

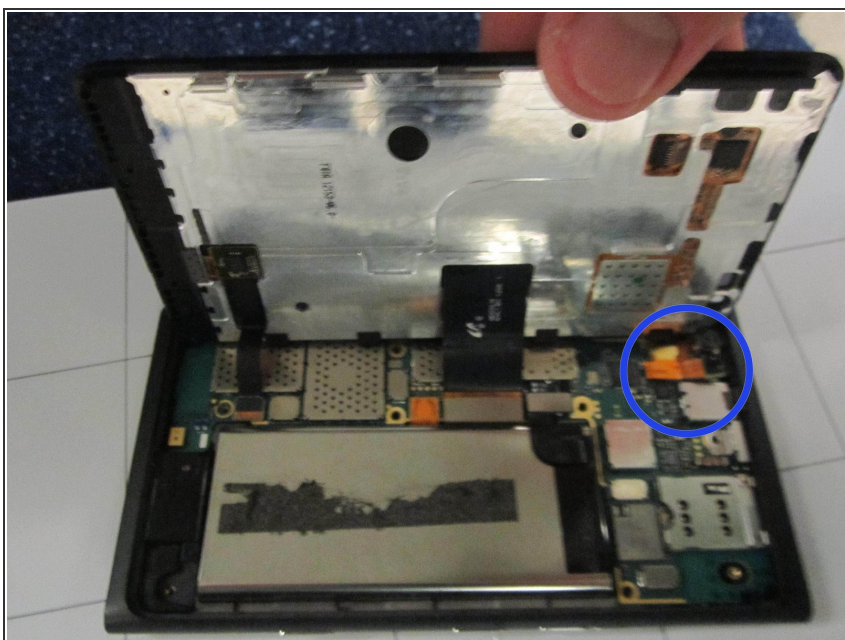
Step 4 — Installing New Camera

- Apply adhesive to back of camera
- Attach ribbon to motherboard
- Press down on camera for 60 seconds
- Let dry for 5 minutes

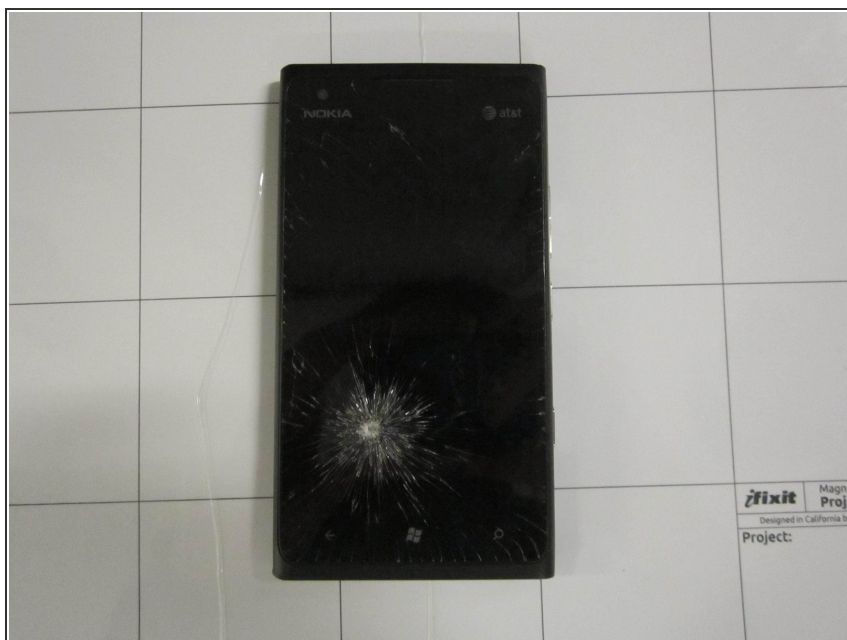
Step 5 — Reassembling Screen

- Slide the hinges of the left side of the screen under the left side of the plastic case
- Clamp the right side of the screen down and make sure screen is flat
- The screen should "click" into place
