# Nokia Lumia 920 Back panel Replacement

Replace the back panel if: cracked, charging port is broken, panel is cracked.

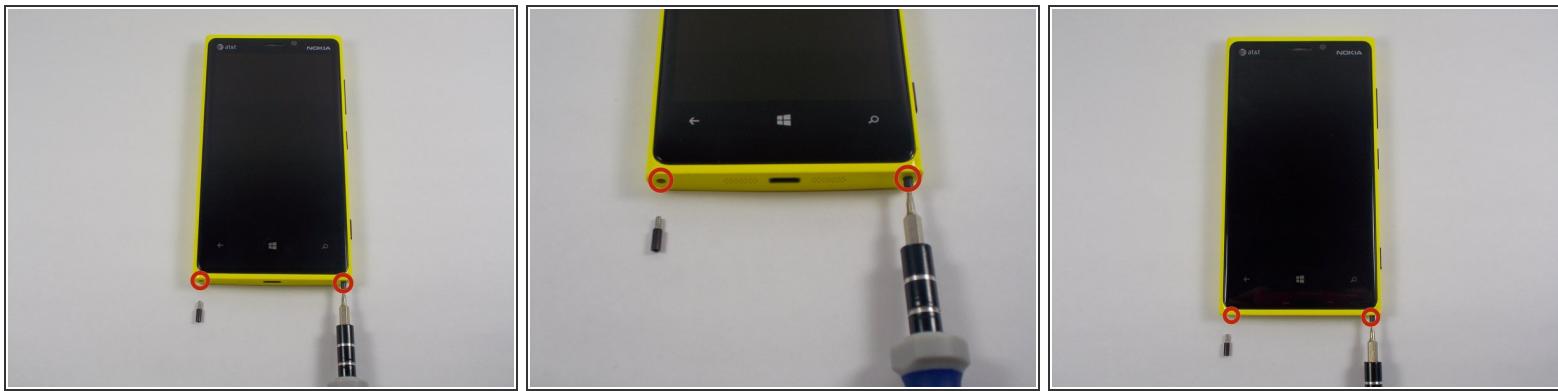
## Step 1 — Remove the Bottom Screws

- Use the T5 screwdriver to remove the two 8.6mm long screws, located at the bottom of the phone. (Head size is 2.5mm)

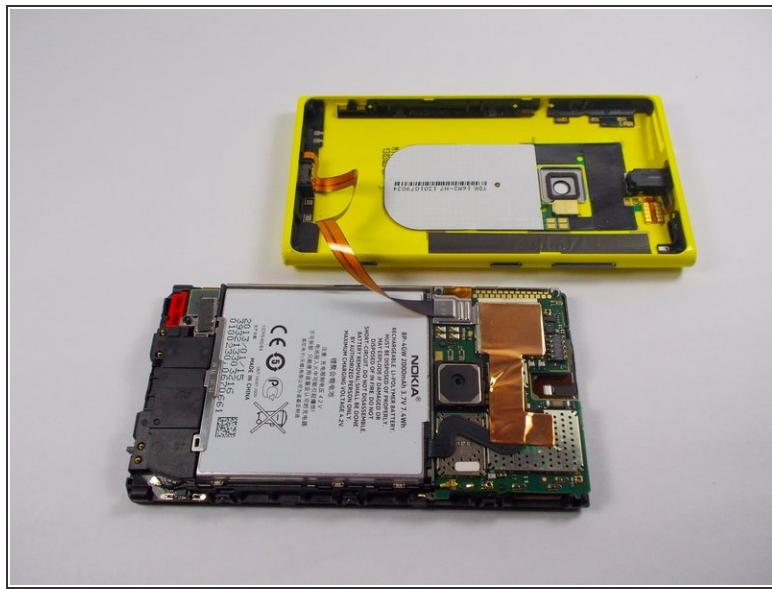
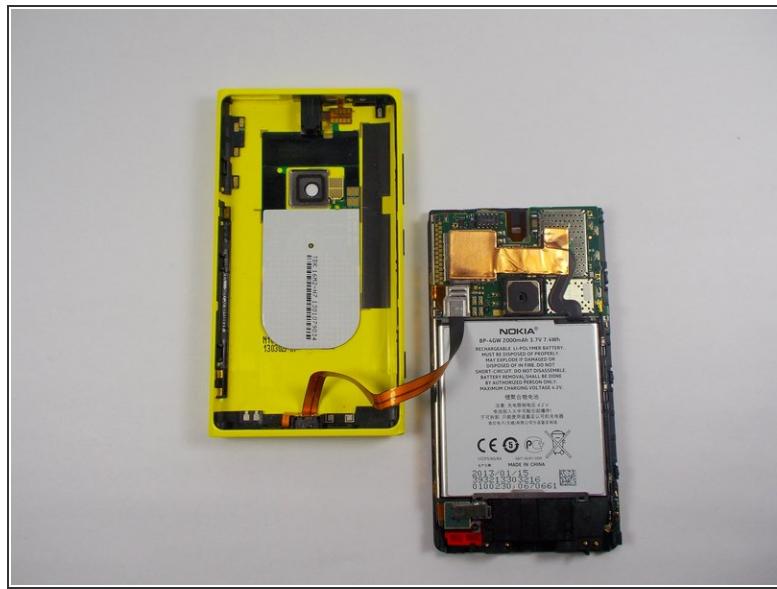
## Step 3

- Once both screws on the bottom are removed, and the plastic SIM protective piece is removed, gently push on the outside of the screen.
- The screen should become separated using little force. And should look like the pictures shown once complete.

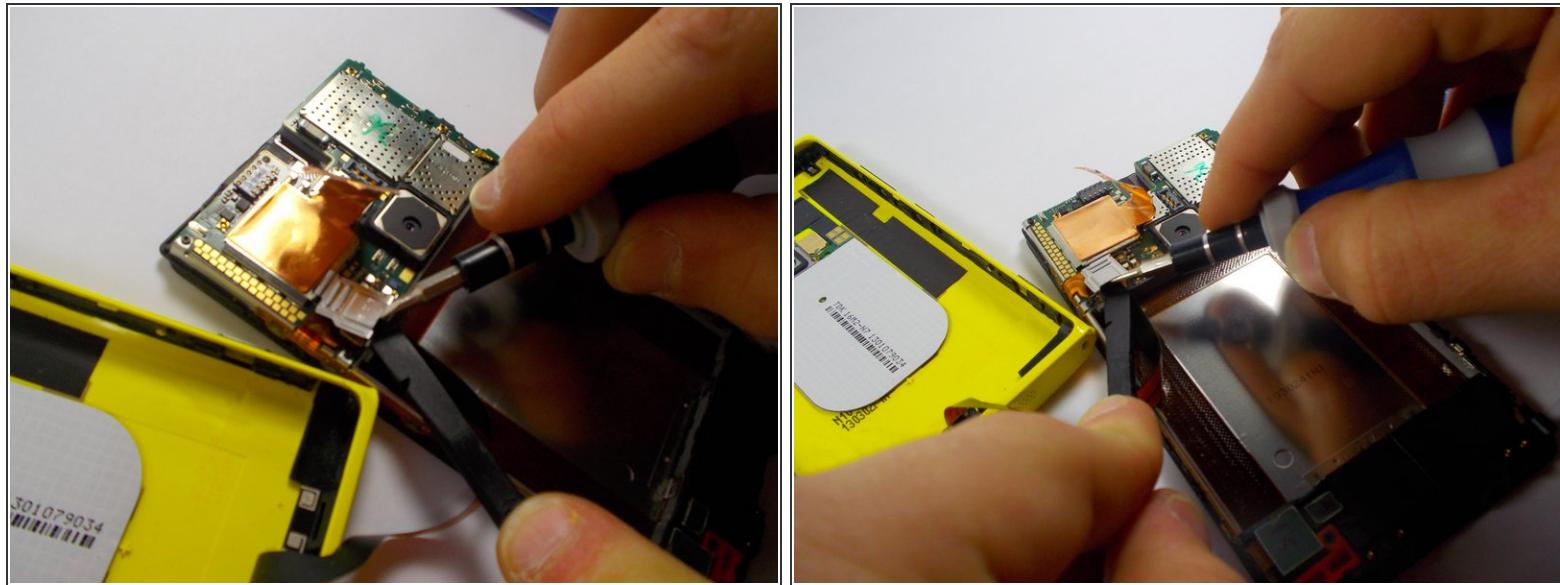
## Step 4

- Place the spudger tool or flat plastic tool on top of the ribbon cable to avoid damaging it when prying up on the metal clip.
- Use a plastic opening tool, or gently use a small metal flat-head screwdriver to pry up the metal clip. (It is recommended to use a plastic tool; However, if the opening tool does not work or fit into the small opening underneath the clip, use the flat-head.)
