Oculus Rift DK1 Control Box Buttons Replacement

This guide will teach you how to remove and replace the Oculus Rift control box buttons that no longer register your touch.

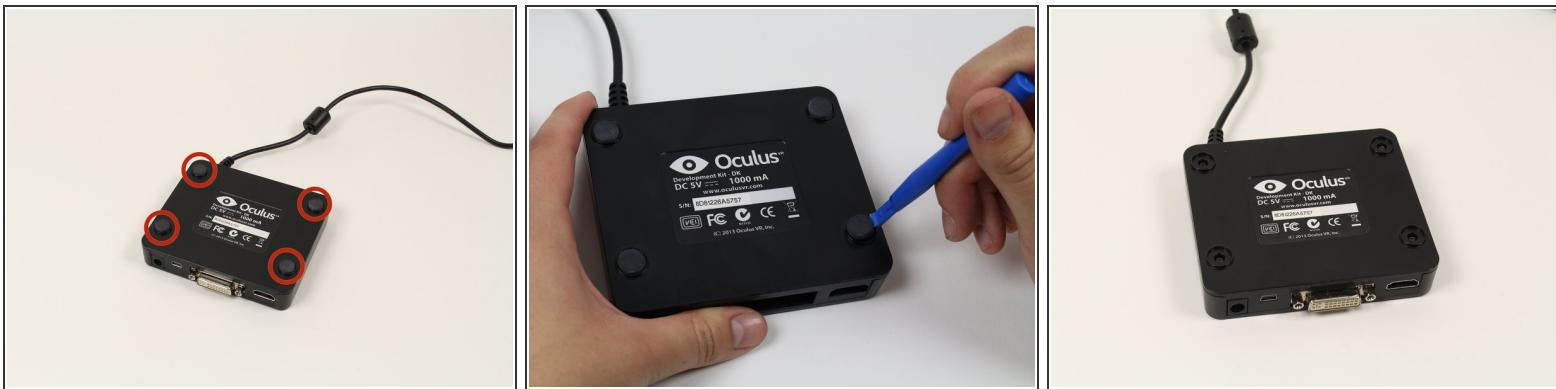
Step 1 — Control Box Bottom Cover

- Use a plastic opening tool to carefully pry off the four rubber feet from the control box.
- You have now revealed the four 9 mm Phillips #1 screws underneath the rubber feet.

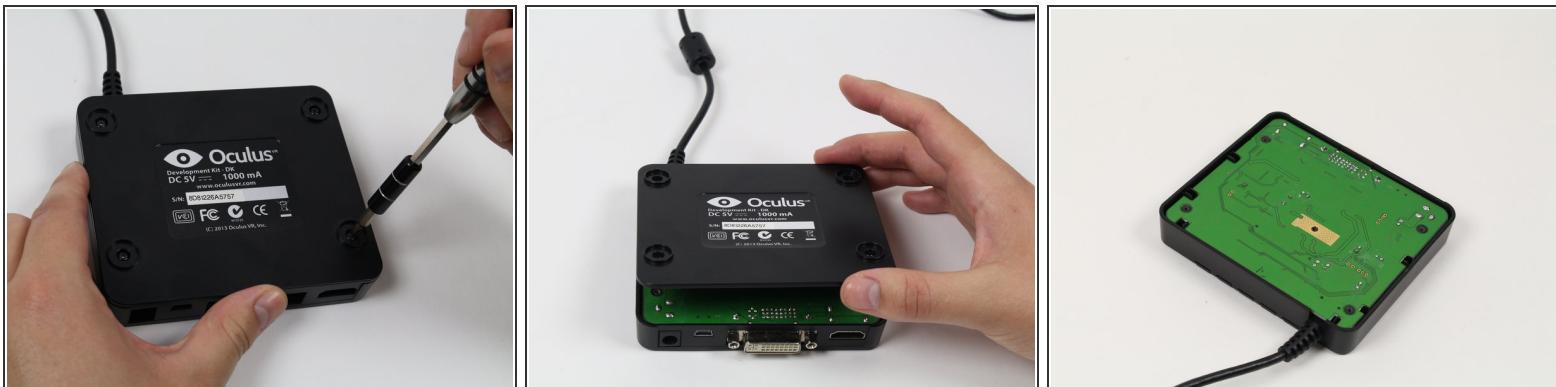
Step 2

- Use a Phillips #1 Screwdriver to unscrew the four 9mm Phillips screws on the bottom of the control box.
- You can now remove the bottom lid of the control box. It should come apart easily.
