# Oculus Rift Development Kit 2 Cable Hub Replacement

This guide leads the user through the replacement steps for the Oculus Rift Development Kit 2 cable hub.

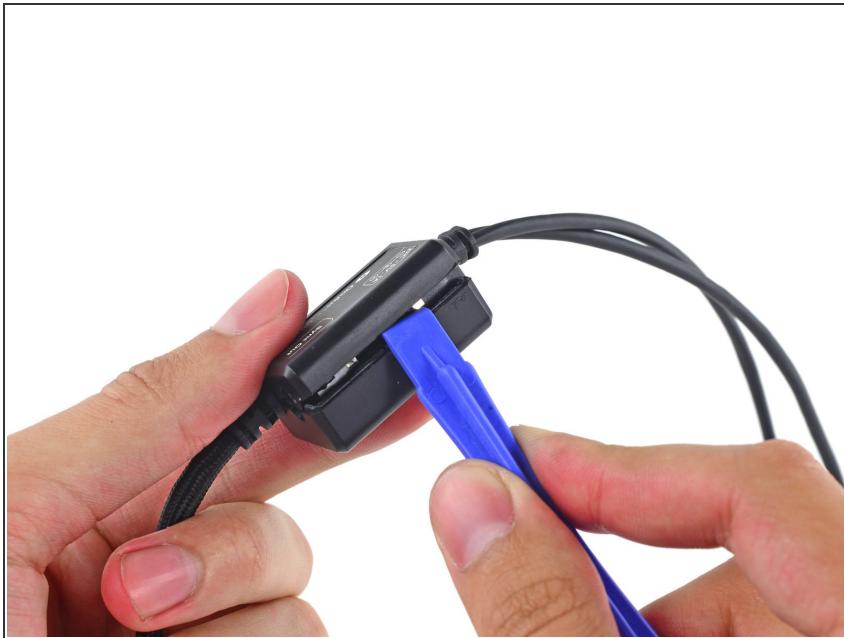
## Step 1 — Cable Hub

- Using the plastic opening tools, pry open the cable hub.

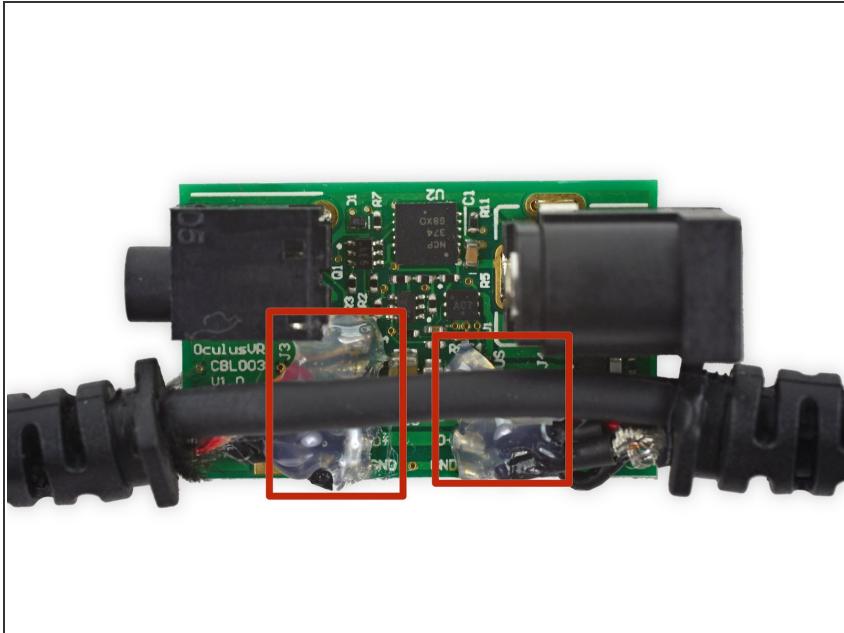
## Step 2

- Carefully pry the cable away from the cable hub motherboard. It is attached with hot glue and should be removed easily.

**⚠** Note that the cable is soldered on to the board. When prying the cable away from the hot glue, pull gently so as not to damage the soldered wire.

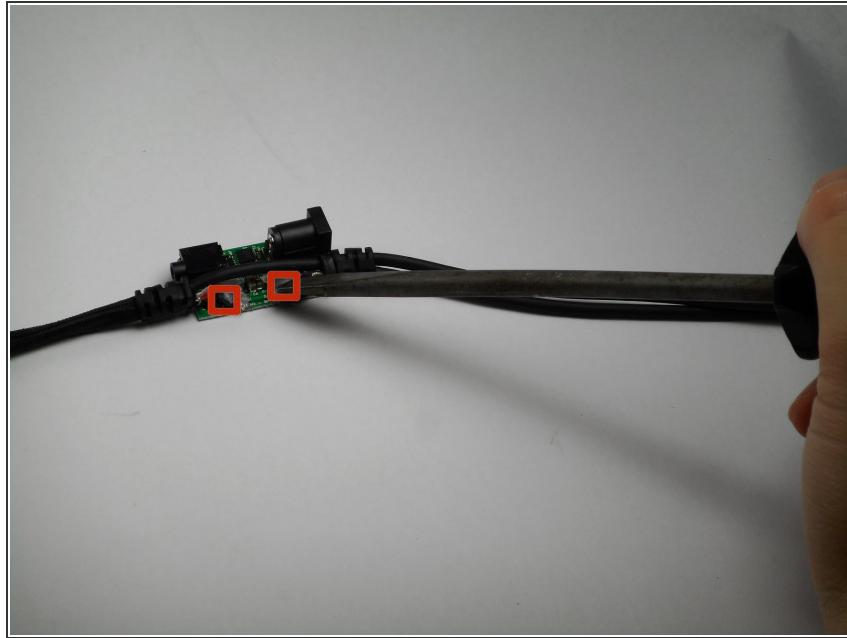
## Step 3

- Desolder the wires as illustrated. This can be done by heating up the solder connecting the board and the wire. When the solder is liquified, pull the wire away from the board.
