# Pebble Steel Buttons Replacement

This is a guide to replace the inner ribbon for the buttons.

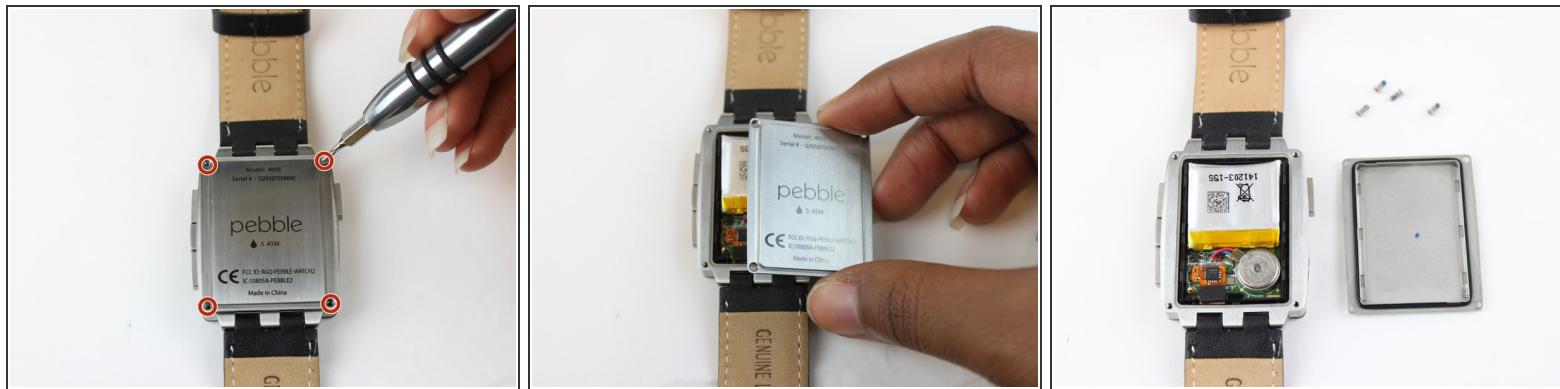
## Step 1 — Internal Hardware

- Use a Torx T3 screwdriver to unscrew the four 3.5 mm Torx T3 screws holding the back plate.
- Make sure the screws are kept in a safe place to insure they are not lost.
- Remove the back plate.

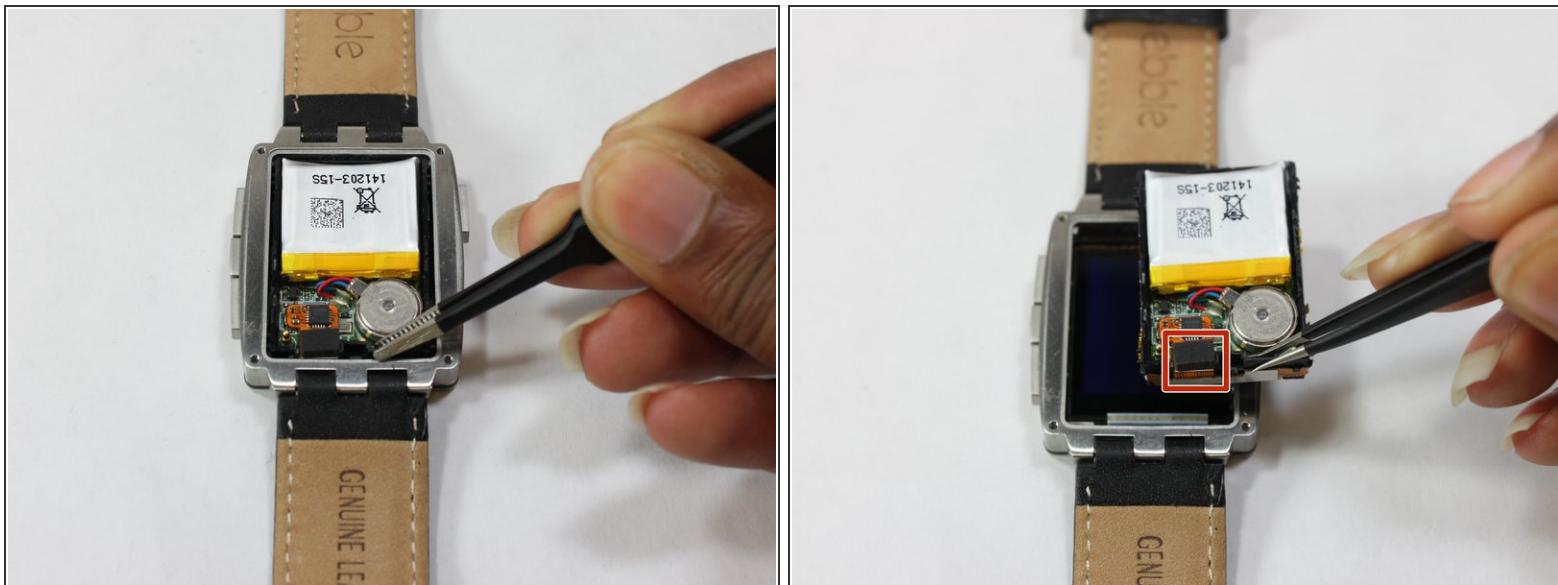
## Step 2

- The plastic frame is clipped inside the steel body with four clips, two each on the left and the right side of the watch, near the corners. You can stick a small screwdriver into the cutouts right above the clips and gently lever the plastic frame up, corner by corner.
- Once the clips are released, use a pair of tweezers to grab onto the black plastic frame and remove the internal hardware.

**i** Adhesive on the back side of the battery holds the internal components to the front case.

- Use tweezers or a plastic opening tool to disconnect the ribbon cable from the motherboard.

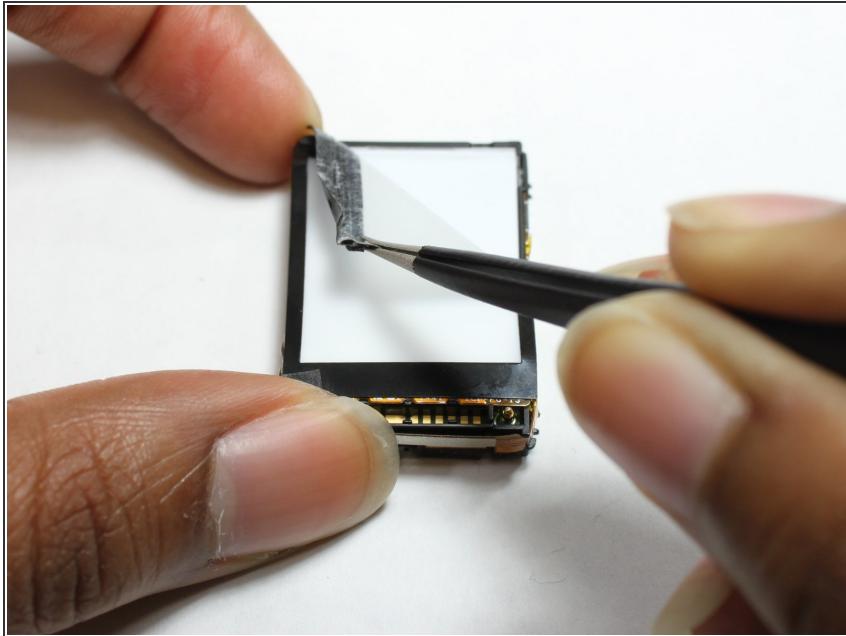
## Step 3 — Buttons

- Starting in the top right corner, use a pair of tweezers to remove the white film.

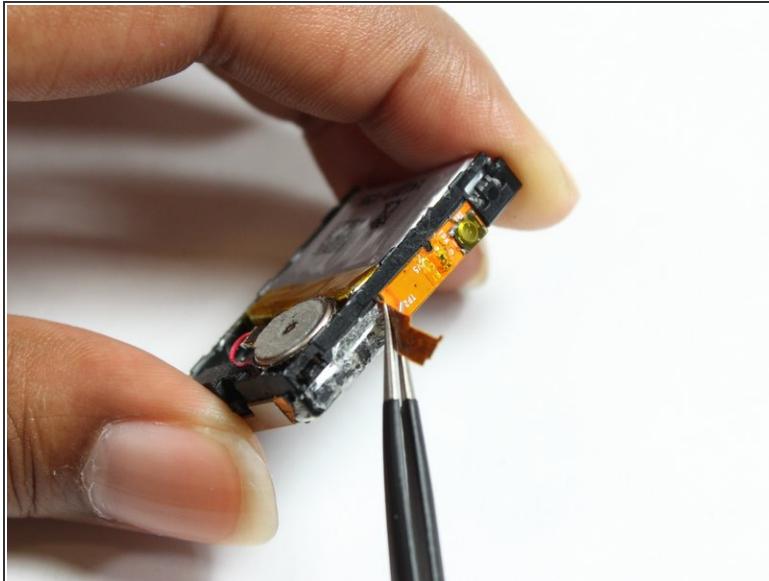
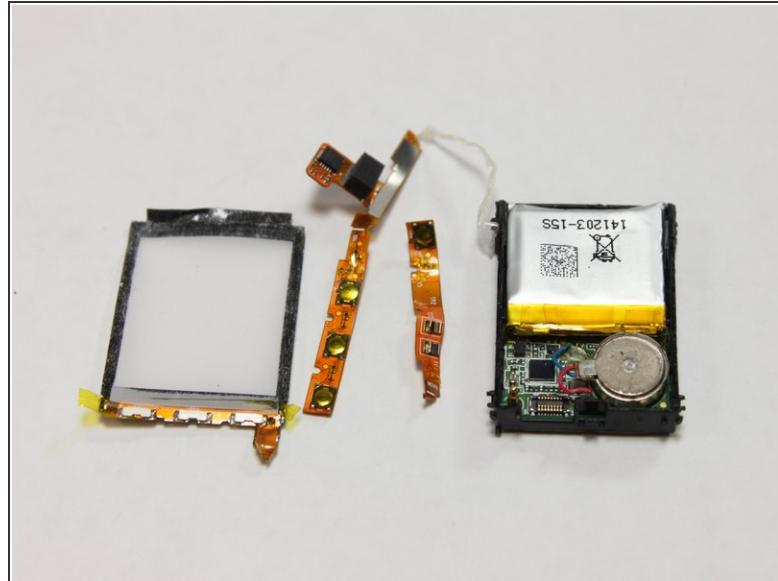
## Step 4

- Continue pulling off the attached orange Zebra ribbon and the inner sensors attached to the ribbon.

*(i)* If pieces of the orange Zebra ribbon remain on the frame, remove them.
