Pebble Steel Vibration Motor Replacement

This is a guide to replace the vibration motor in a Pebble Steel Smartwatch.

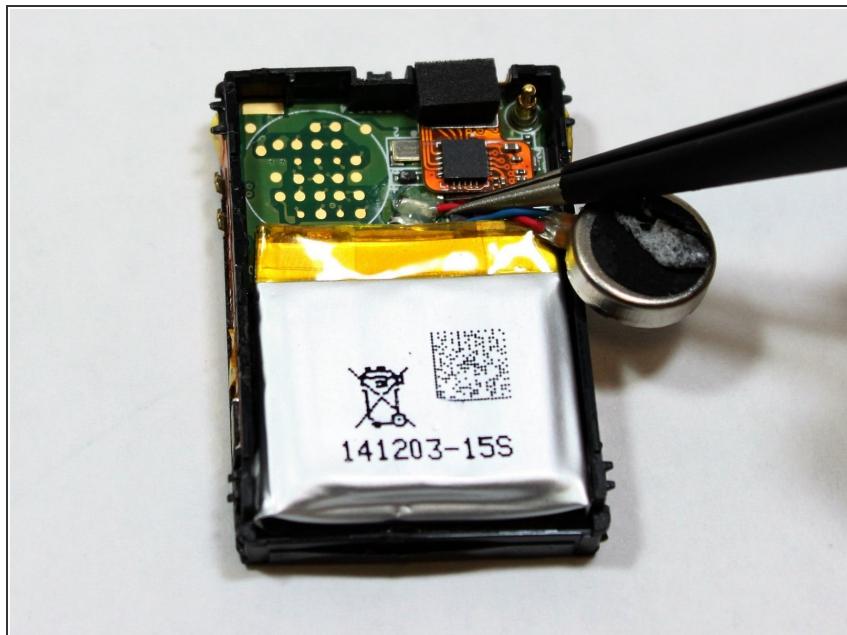
Step 4

- Use a pair of tweezers to detach both the blue and red wires from the motherboard.
