Philips Norelco 5801XL Front and Back Housing Replacement

This guide outlines how to remove and replace the device housing of a Philips Norelco 5801XL.

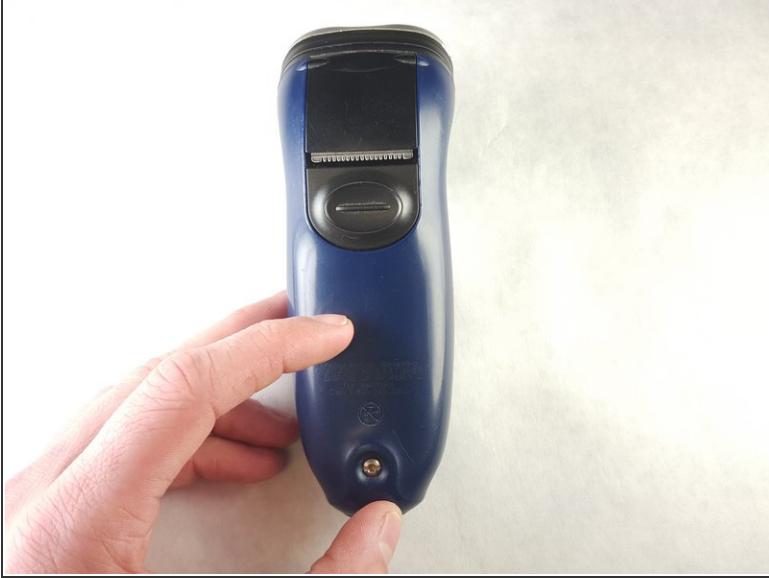
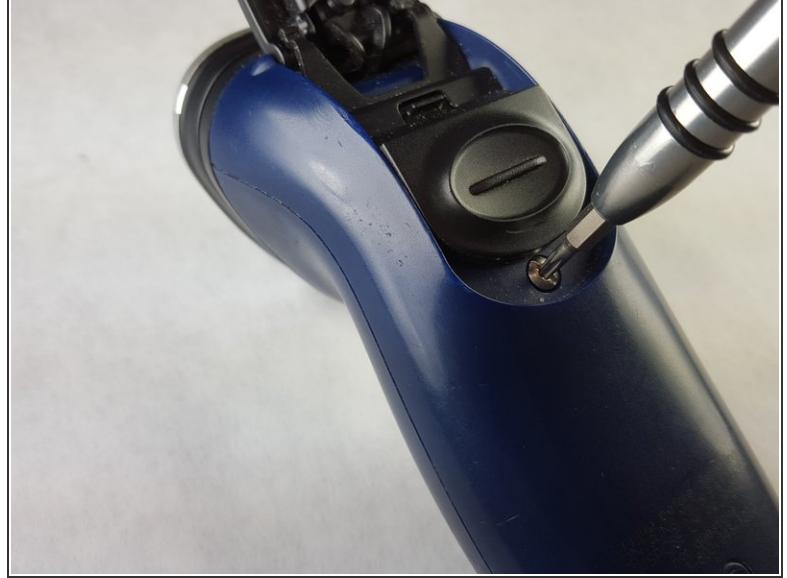
Step 1 — Front and/or back housing

- Remove the two T8 2 mm Phillips screws on the back housing.

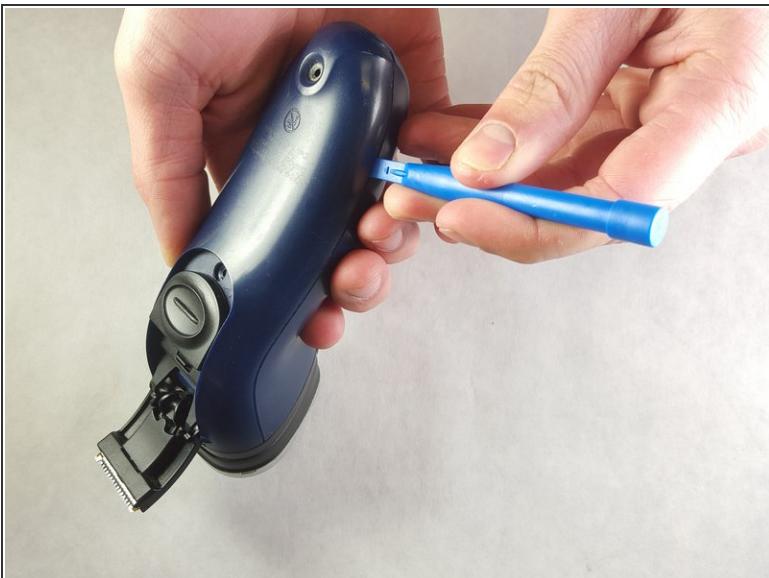
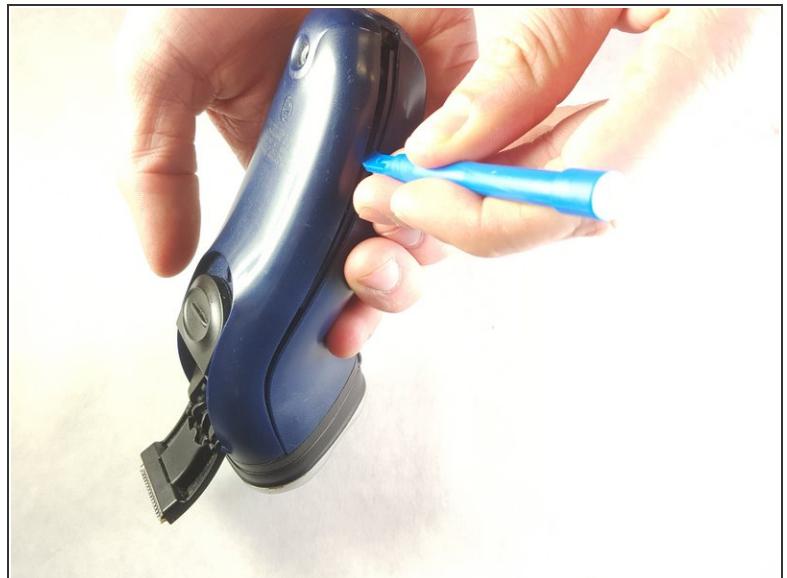
Step 2

- Separate the back housing and the front housing using the plastic opening tool.

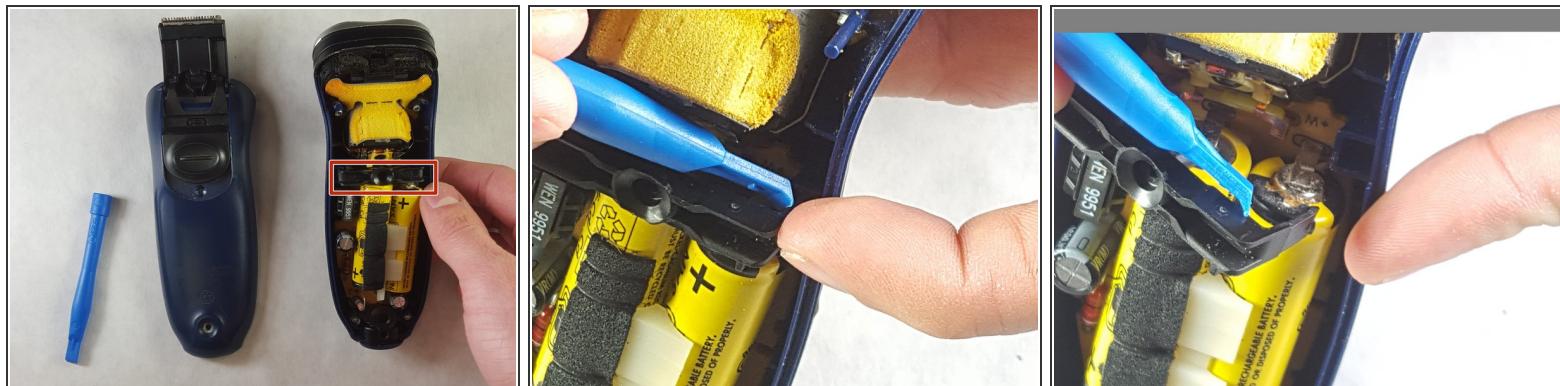
Step 3

- Using the plastic opening tool, carefully pry the inside of the middle bracket towards the outside of the housing in order to remove it.

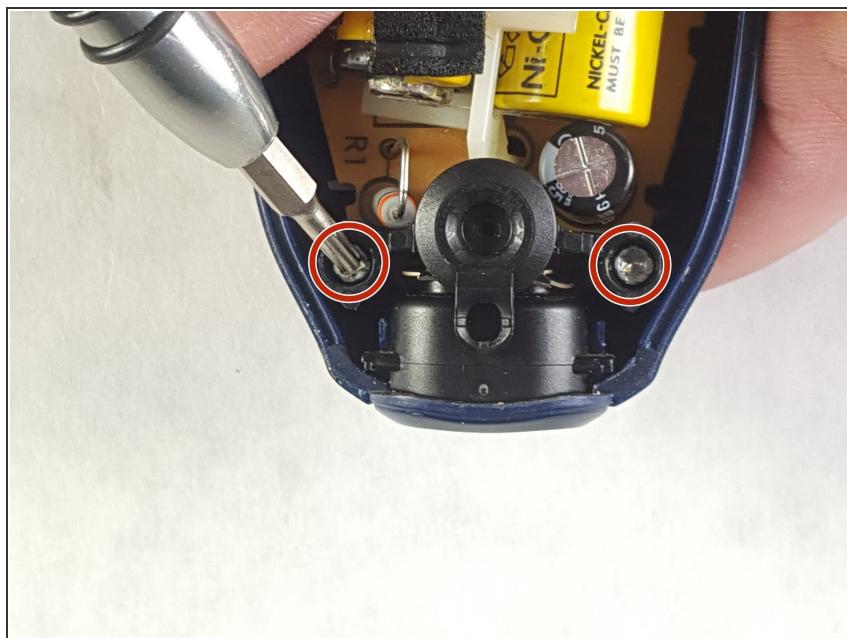
Step 4

- Remove the two T8 2 mm screws near the bottom of the device.
- Remove the bracket the screws were holding in place.

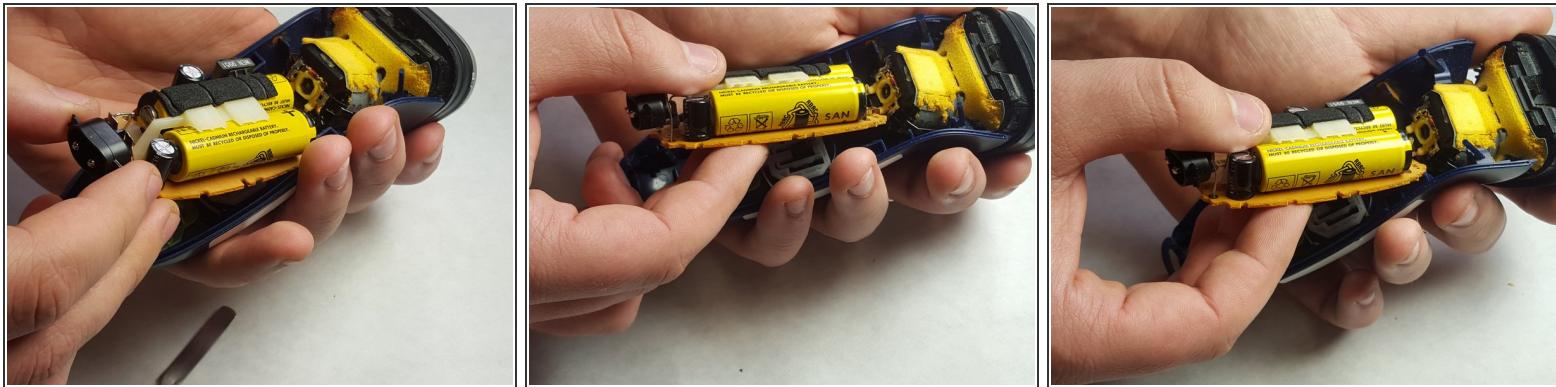
Step 7

⚠ Cautiously lift and twist the circuit board, then begin sliding the inside assembly forward.

- After sliding it forward, the whole assembly will separate from the rear housing.

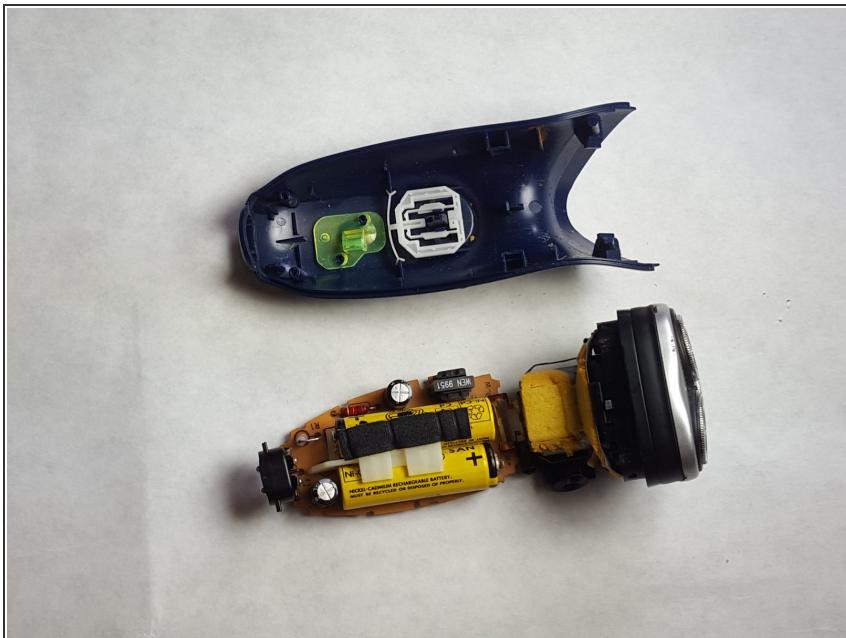
Step 8

- The housing and the inside assembly should be completely separated.

Now, you can put the new housing on. To reassemble your device, follow these instructions in reverse order.
