Philips Norelco BG2040 BodyGroom 7100 Trimmer Head Blades Replacement

Disassemble and replace trimmer head blades in the Philips Norelco Bodygroom series 7100.

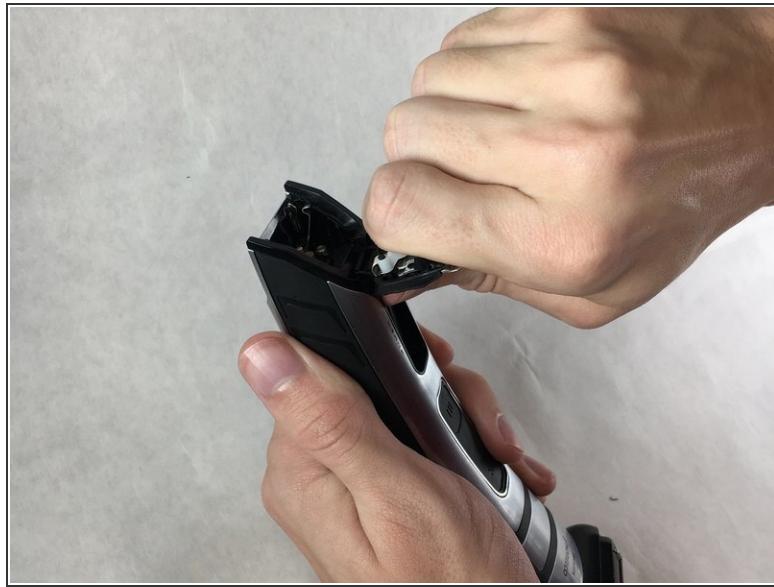
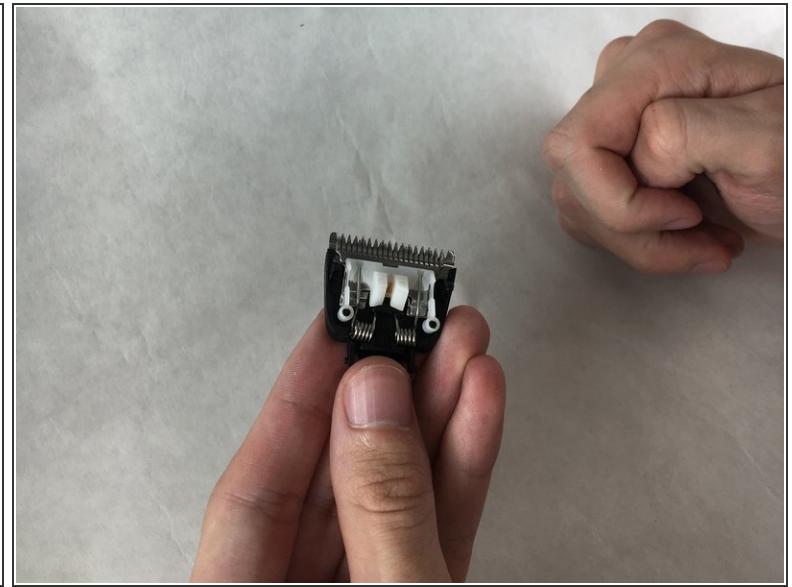
Step 1 — Trimmer Head Blades

- Pop open the trimmer head by pushing against the blades.
- Slide off trimmer guard and open the hatch on the side.
- Remove the trimmer from the base.

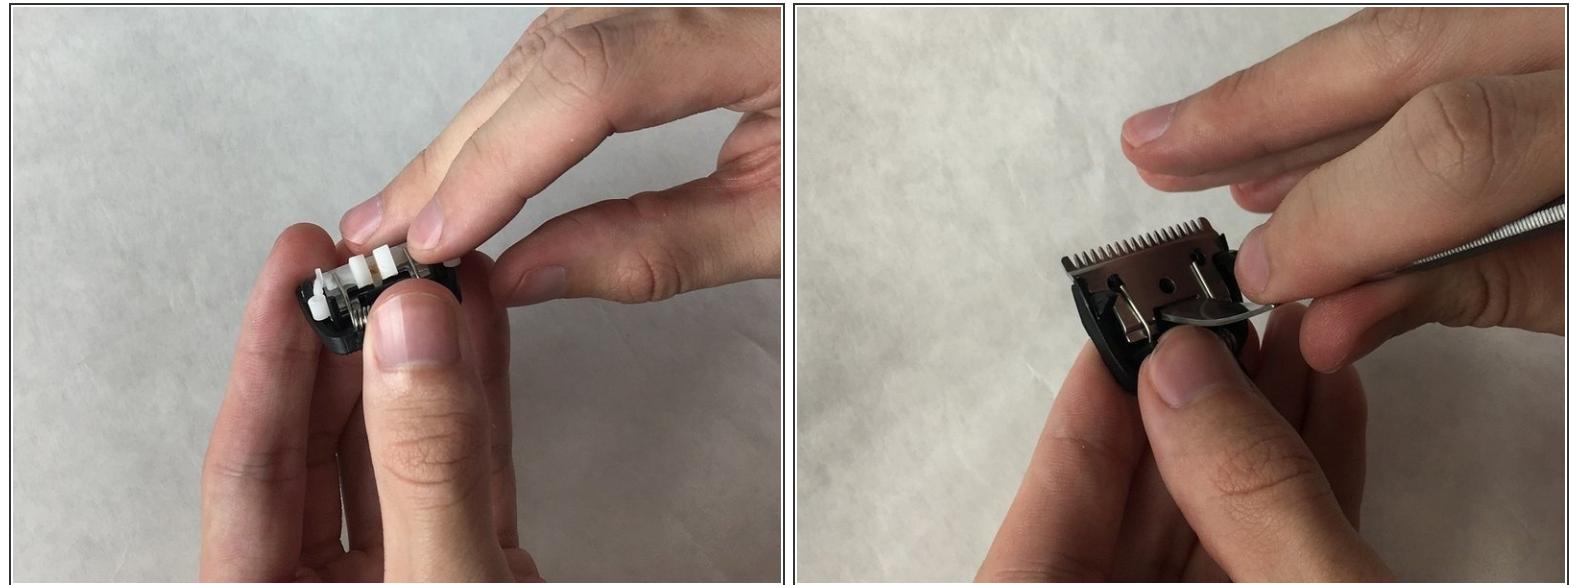
Step 2

- Remove spring first, and then pull off white plastic along with the first, moving blade.
- Use spudger to pry off second, stationary blade.

To reassemble your device, follow these instructions in reverse order.
