# Philips Norelco BeardTrimmer 3100 Blade Replacement

Removing the blades on the Philips Norelco 3100 BeardTrimmer.

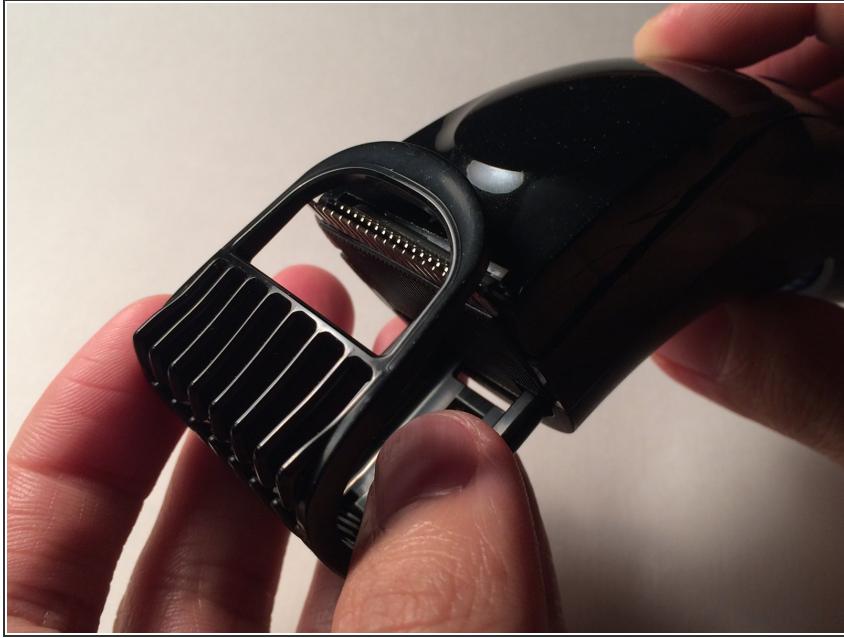
## Step 1 — Blade

- Remove the comb from the head of the trimmer.

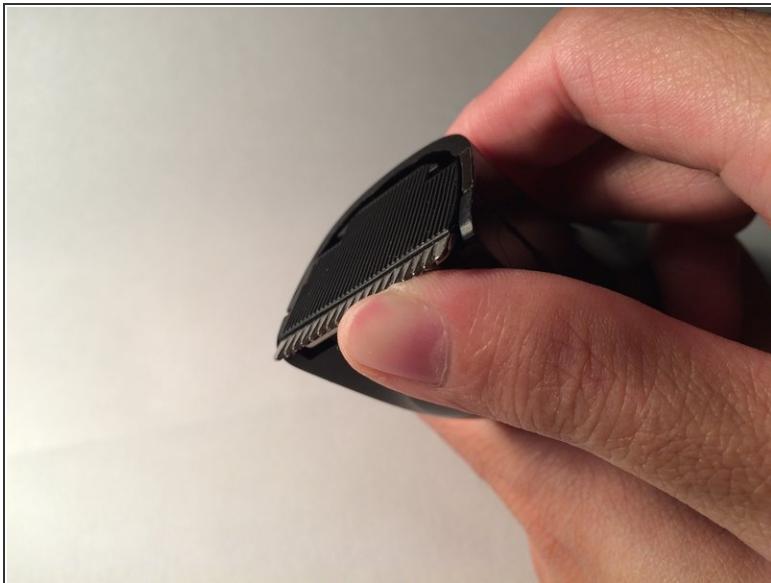
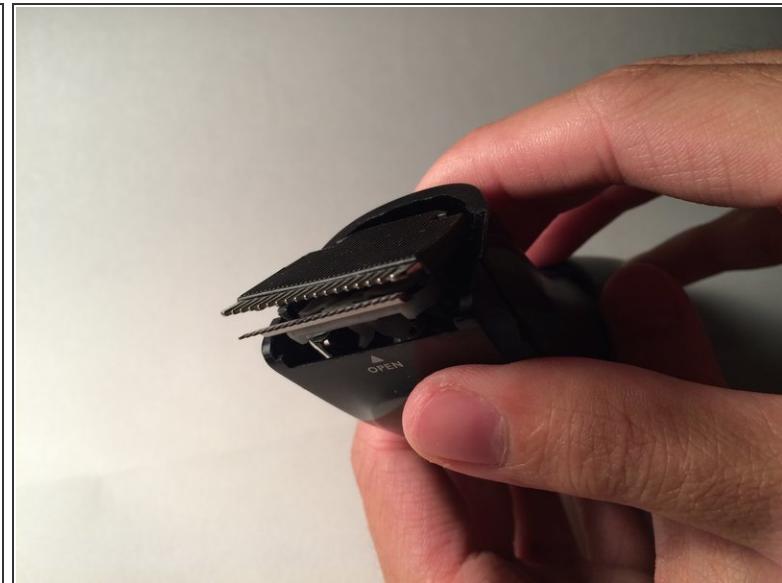
## Step 2

- Place thumb underneath the blade; push upward to pop the blade off.

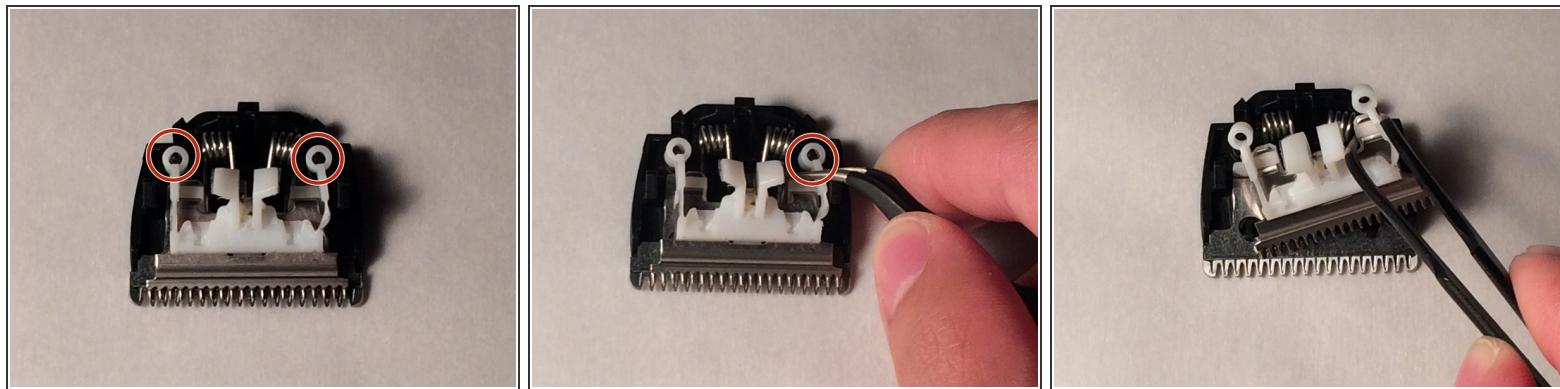
## Step 3

- Grab the plastic arms with the tweezers and pull them apart from the base.

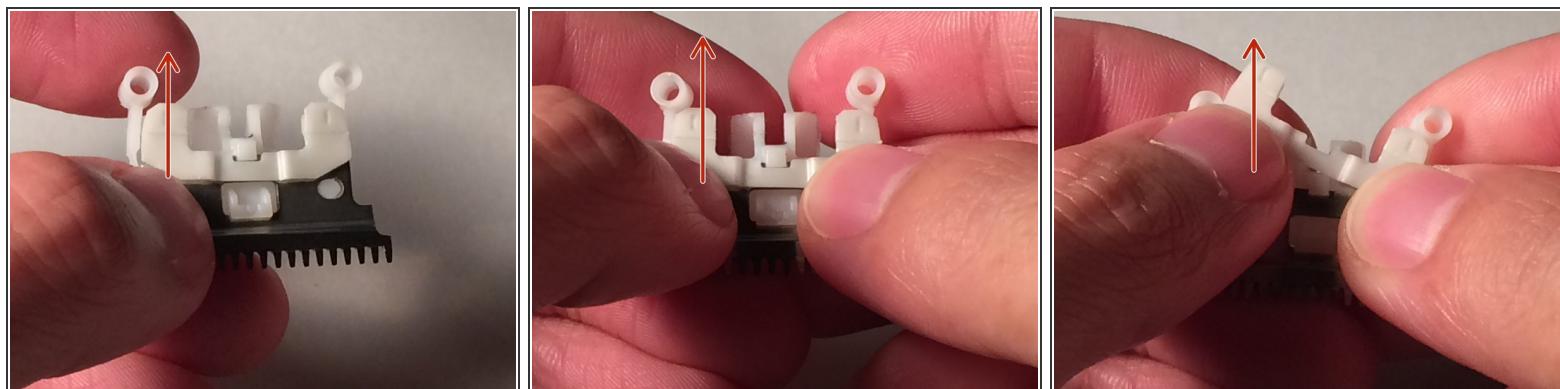
## Step 4

- Remove the plastic casing from the underside of the blade.

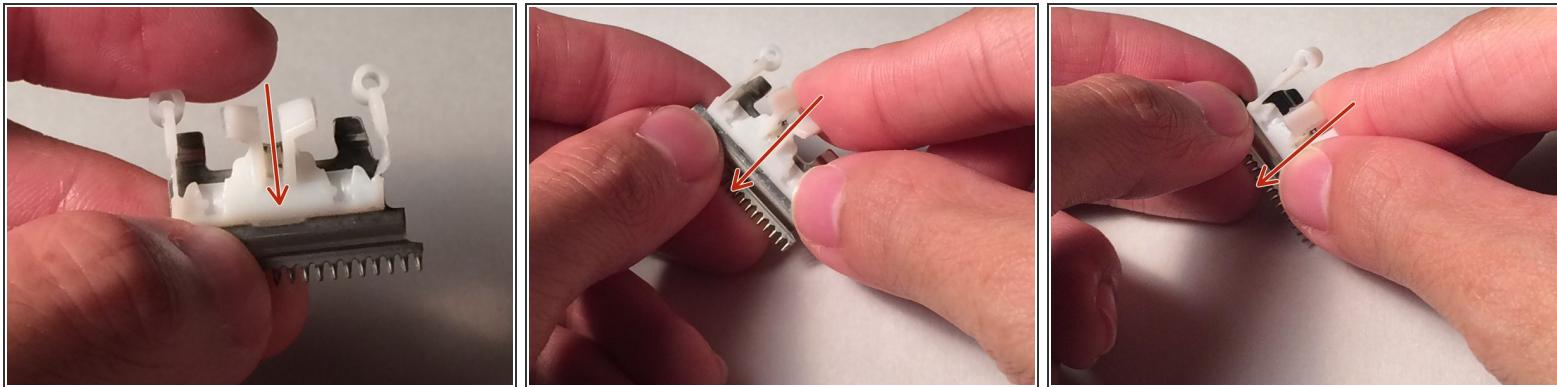
## Step 5

- Remove the last plastic casing from the front side of the blade.

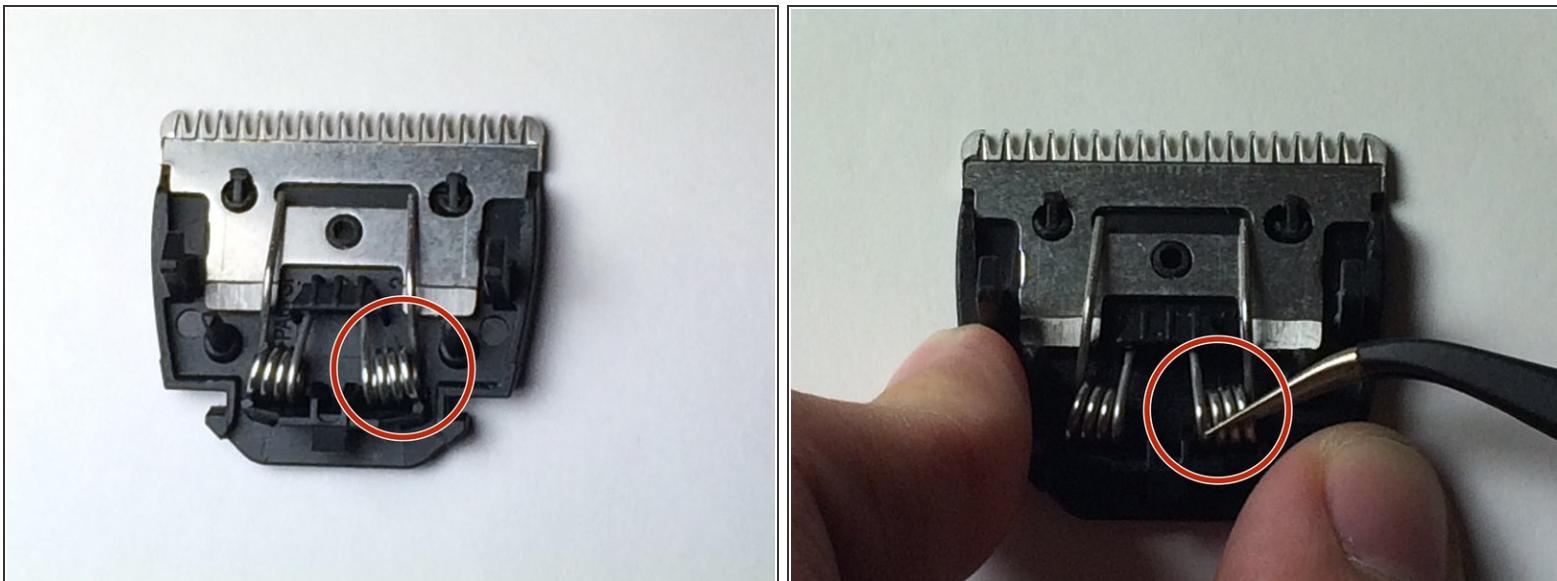
## Step 6

- Pull the spring off from the base with the tweezers.

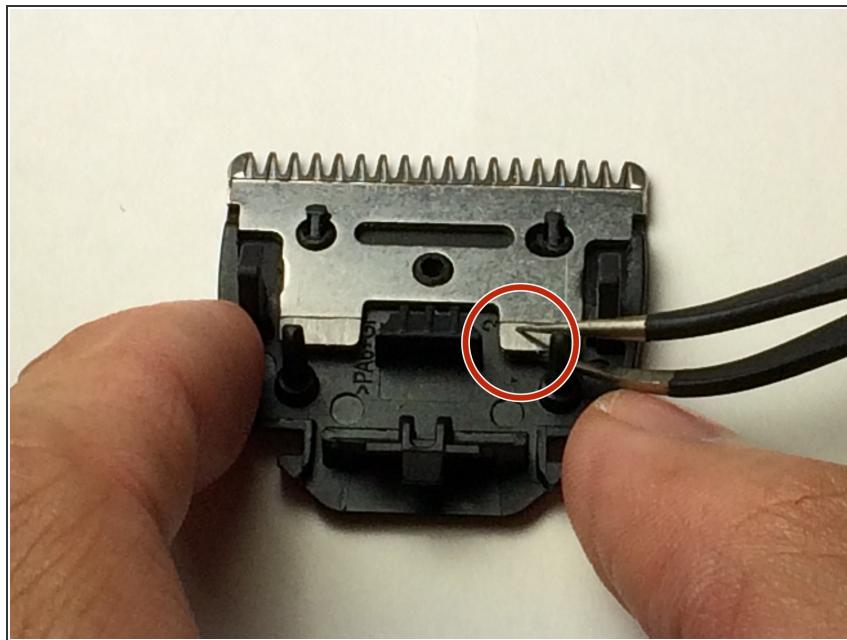
## Step 7

- Pull the blade apart from the base with the tweezers.

To reassemble your device, follow these instructions in reverse order.
