Pioneer MXT-X366BT Knob Replacement

This guide will show the steps involved in removing and replacing the volume knob on the radio.

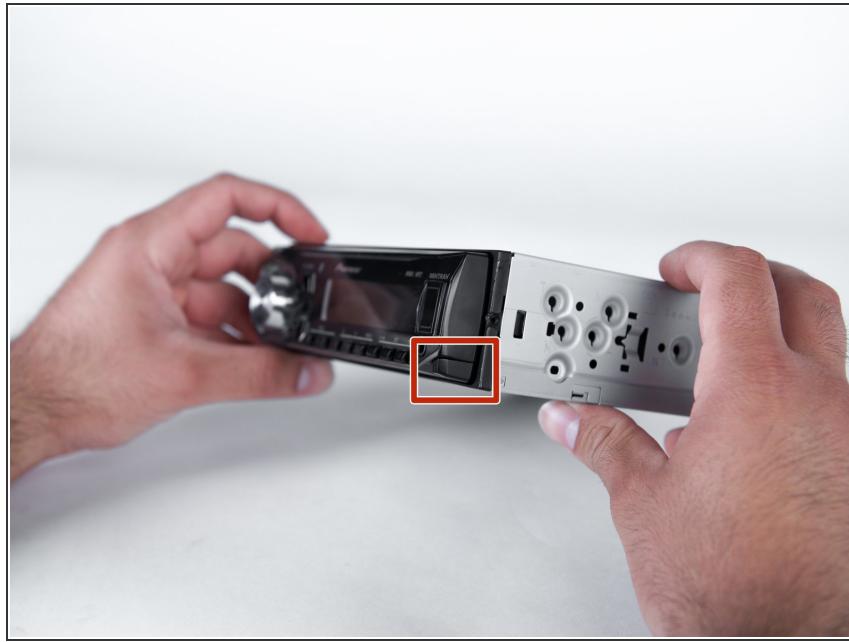
Step 1 — Volume Knob

- Push the eject button to release the faceplate.

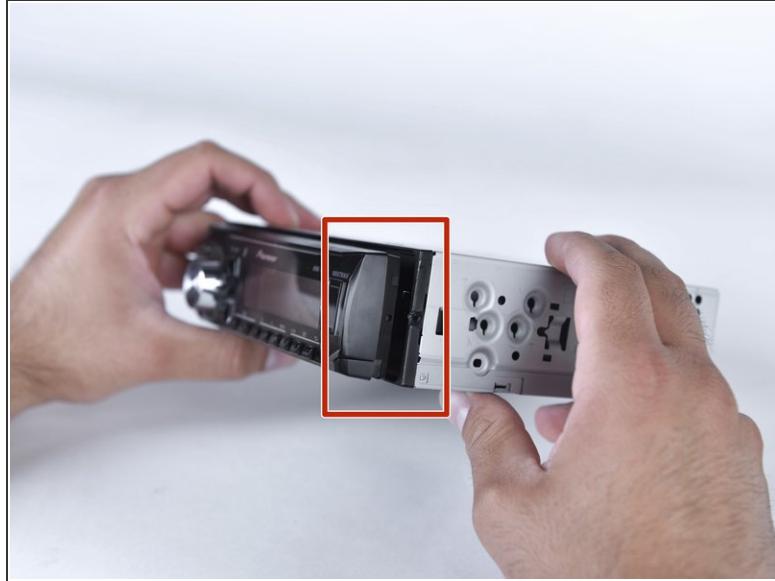
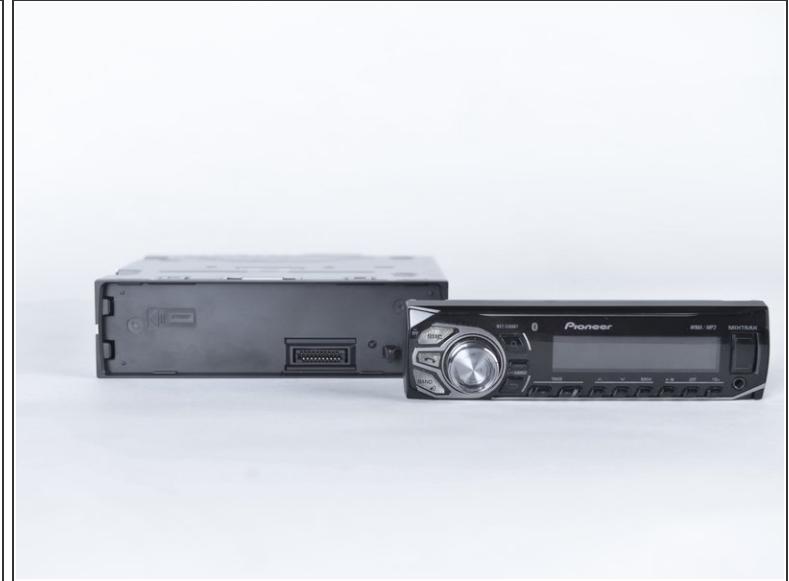
Step 2

- Carefully separate the faceplate from the radio.

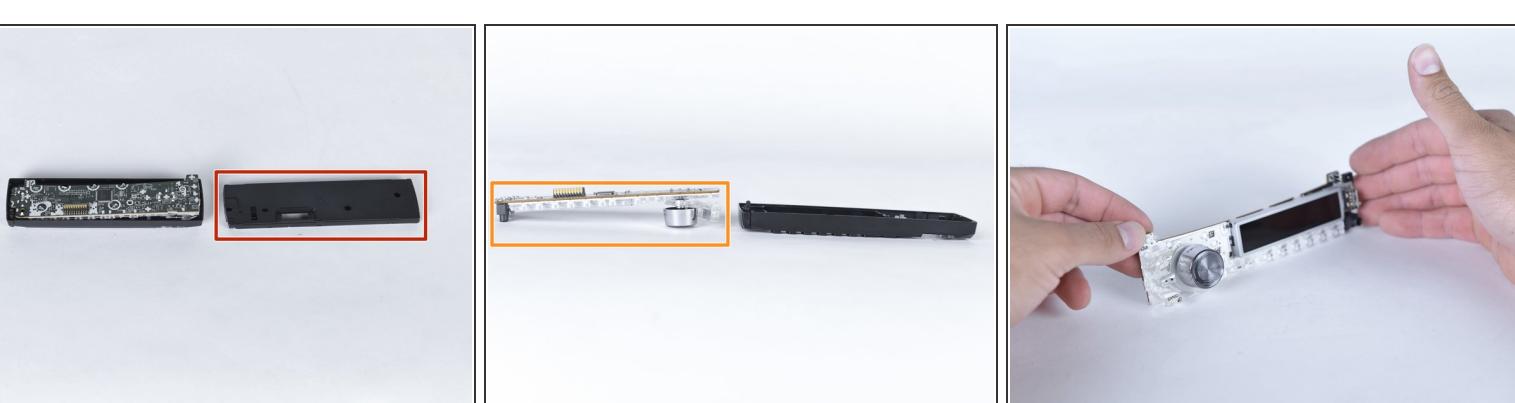
Step 4

- Remove the back of the face plate.
- Separate the motherboard from the casing.

⚠ Handle the motherboard with care.

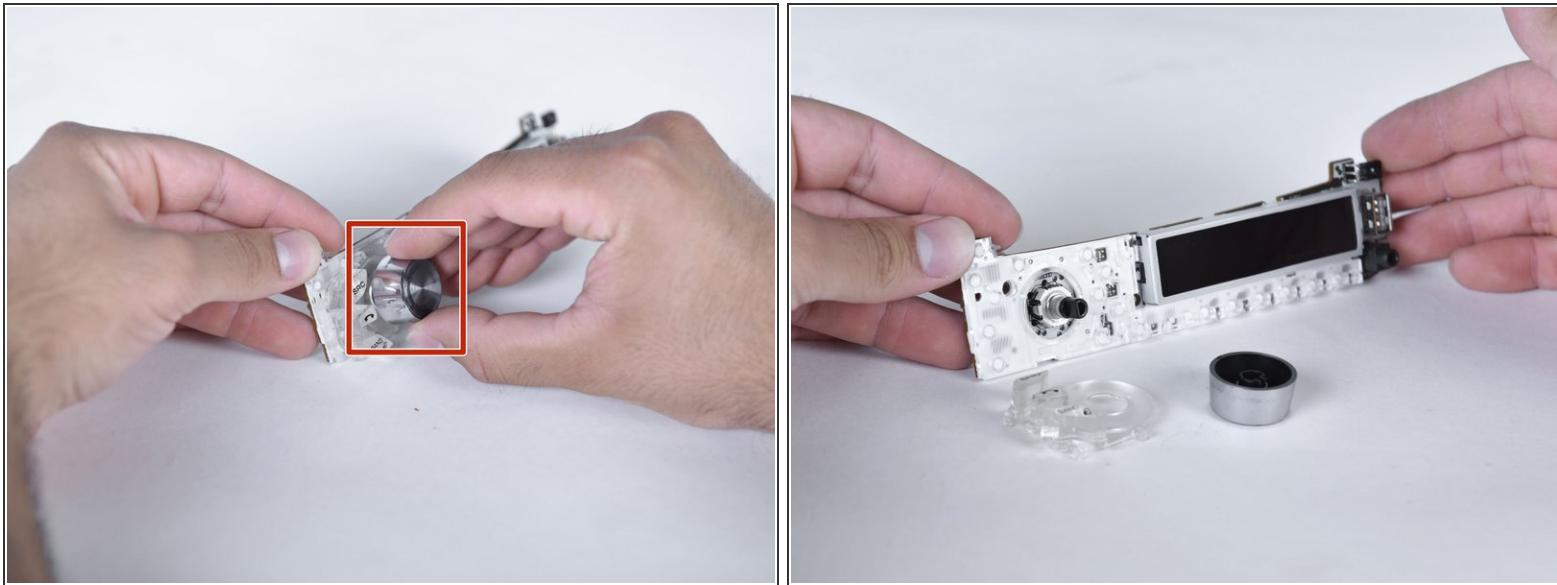
Step 5

- Firmly pull the volume knob.

⚠ Carefully handle the motherboard to not break it.

i Some force may be required to remove the knob.

i Buttons are attached by a ring behind the volume knob.
