Pododent Motor NSK Japan Bearing Replacement

The ball bearings used by NSK are not stainless, although water flows through the handpiece. Therefore, they rust easily. But replacement is cheap and easy.

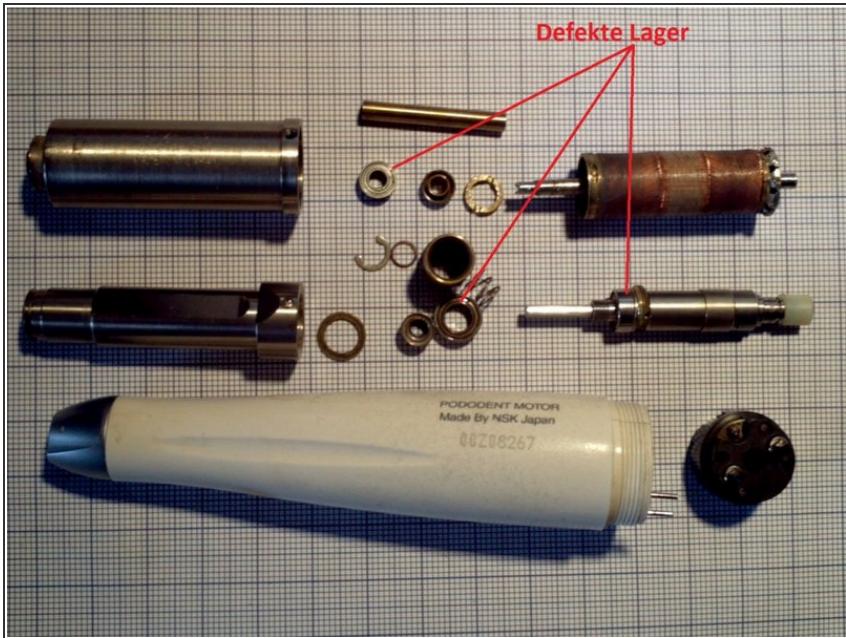
Step 1 — ball-bearing

- The picture shows the items. In the handpiece are the motor housing with the top right anchor. Underneath, on the right, is the clamping body for the tools and to the left thereof the receptacle of the clamping body. The engine is to take after replacement of the ball bearings about 350mA at 24 volts.
