How to repair an iPad 2 that does not recognize the SIM after installation.

## Step 1 — Réparation iPad 2 Ne Pas lire la carte SIM/Fixing a non-reading SIM Card

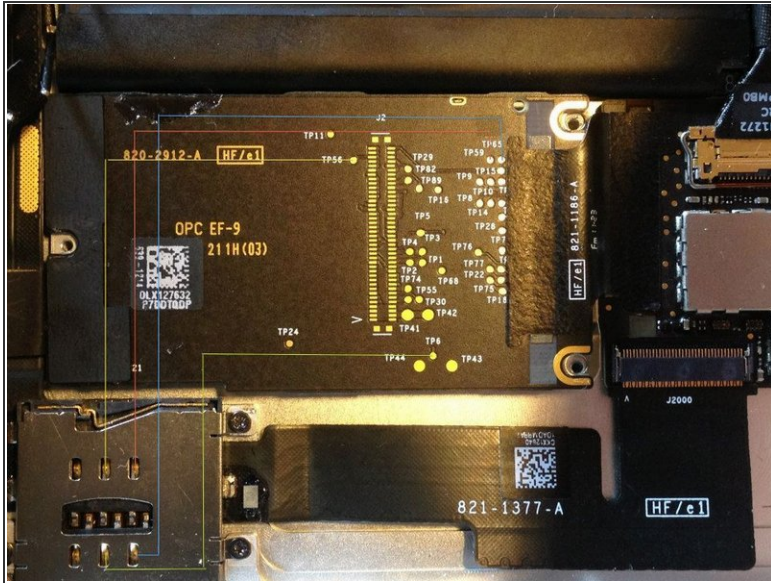
- in this case, check all traces as shown on picture with Volt Ohm Meter
- If some are broken make a shunt, as in the second picture to get the sim reader fully working.
