# RCA RCT6378W2 Volume Button Replacement

This guide will illustrate faulty volume button removal and replacement.

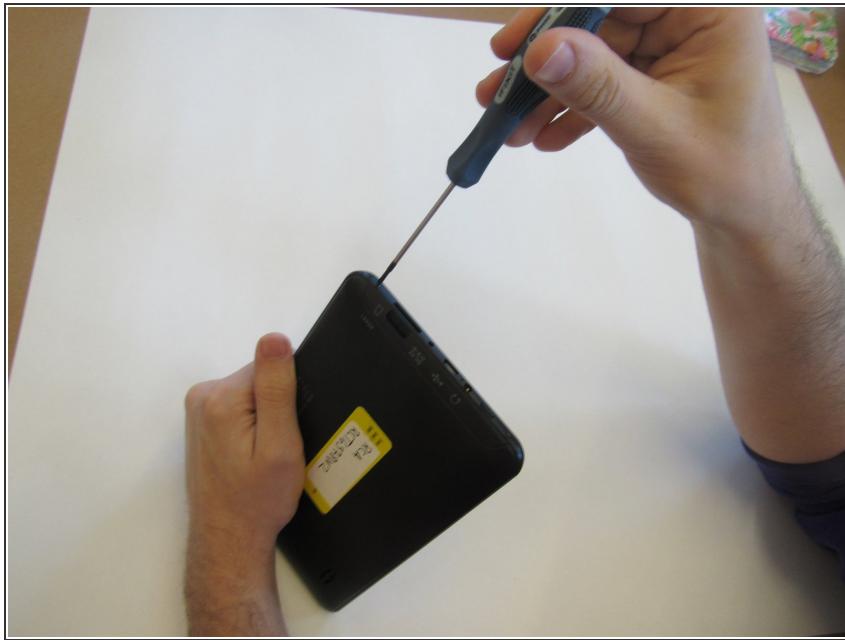
## Step 1 — Removal of Back Cover

- Remove the two 2.4mm x 4mm screws from the bottom of the tablet with a Phillips #00 Screwdriver.

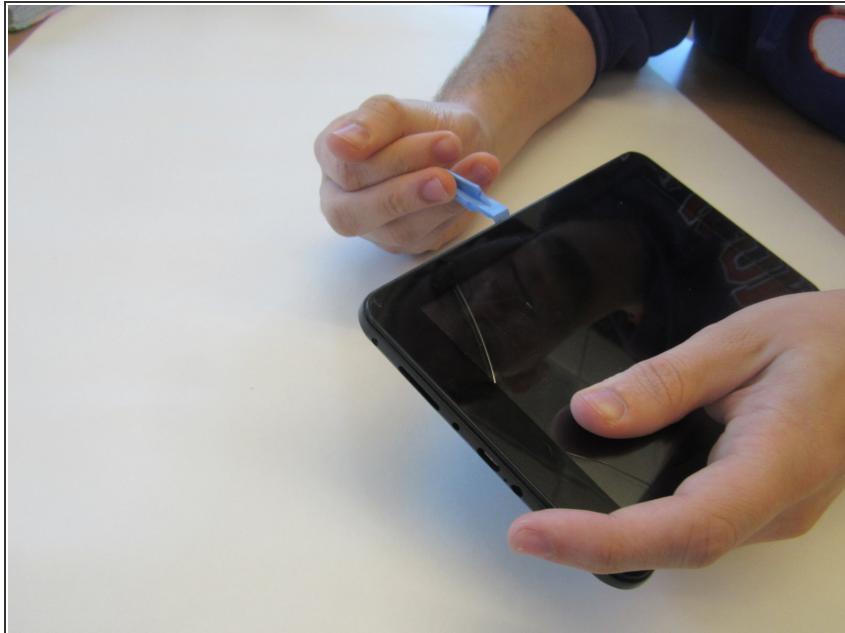
## Step 2 — Cover Separation

- Separate the front and back covers using one of the plastic opening tools.

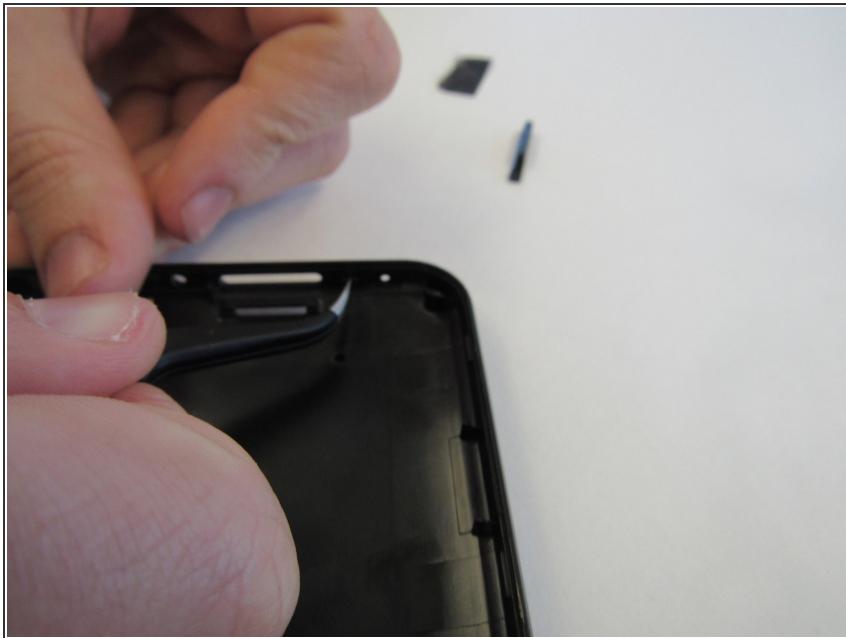
## Step 3 — Button Removal

- Dislodge the power button from the upper right corner of the tablet's back cover using the tweezers

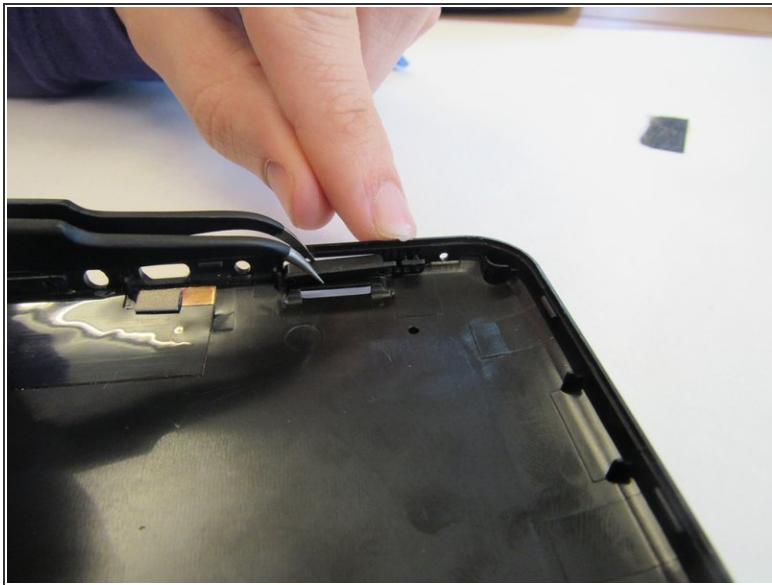
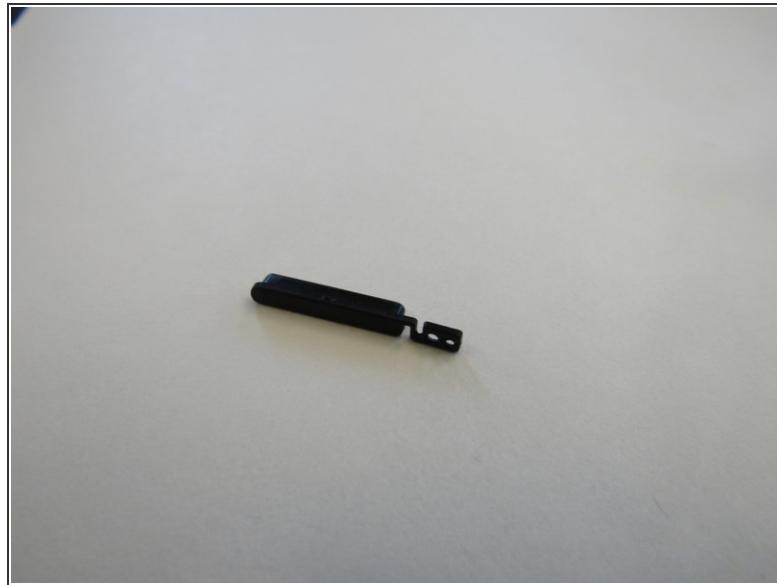
## Step 4 — Insertion of New Button

- Align and place the new replacement button with positive and negative engravings facing outward into the volume space found in the cover.
