RCA RCT6378W2 Volume Button Replacement

This guide will illustrate faulty volume button removal and replacement.

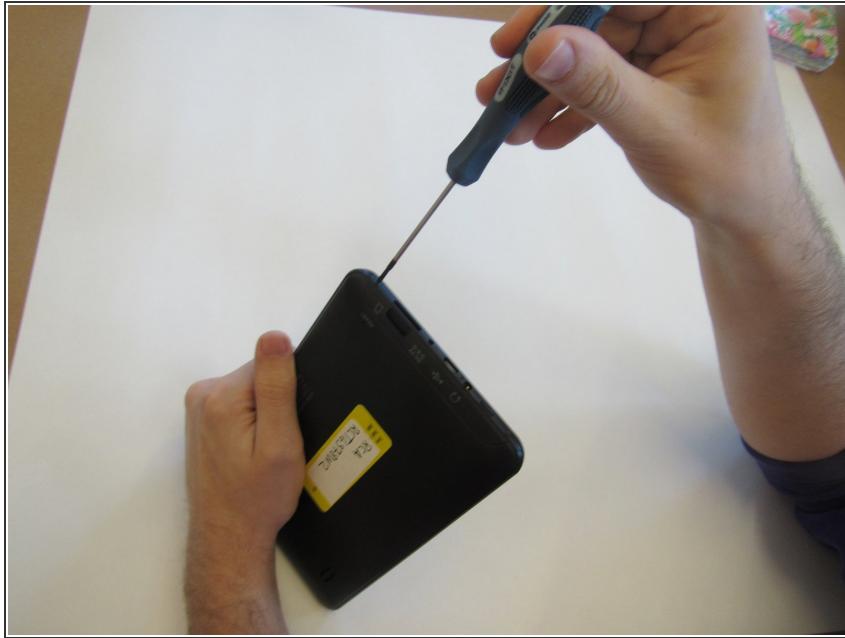
Step 1 — Volume Button

- Remove the two 2.4mm x 4mm screws from the bottom of the tablet with a Phillips #00 Screwdriver.

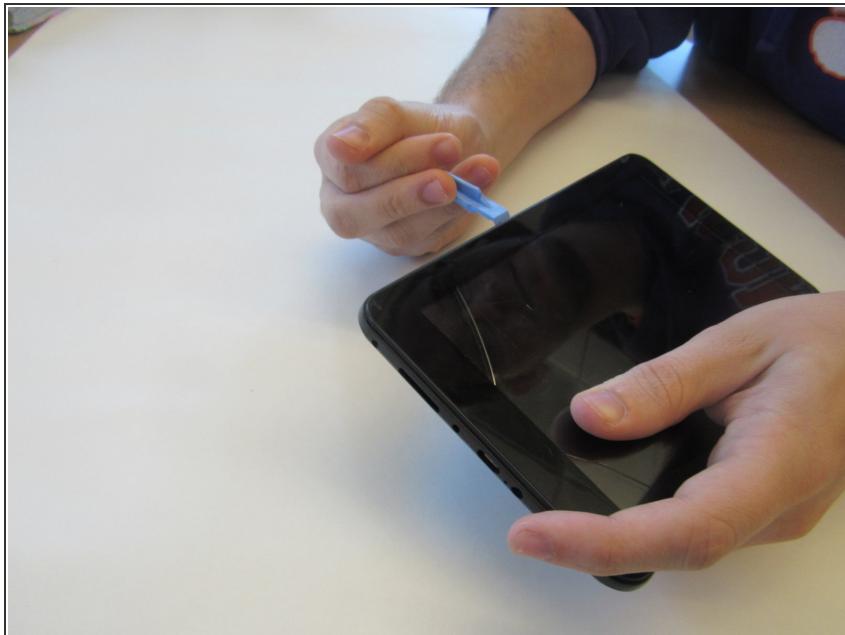
Step 2

- Separate the front and back covers using one of the plastic opening tools.

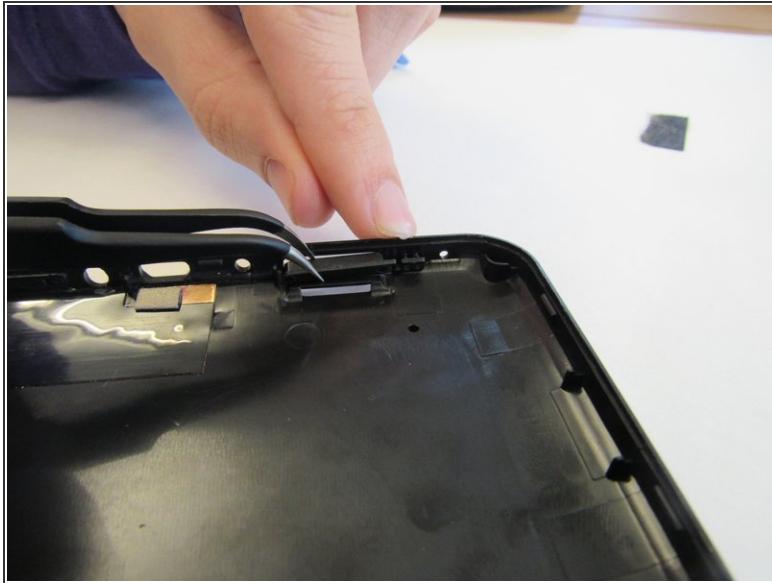
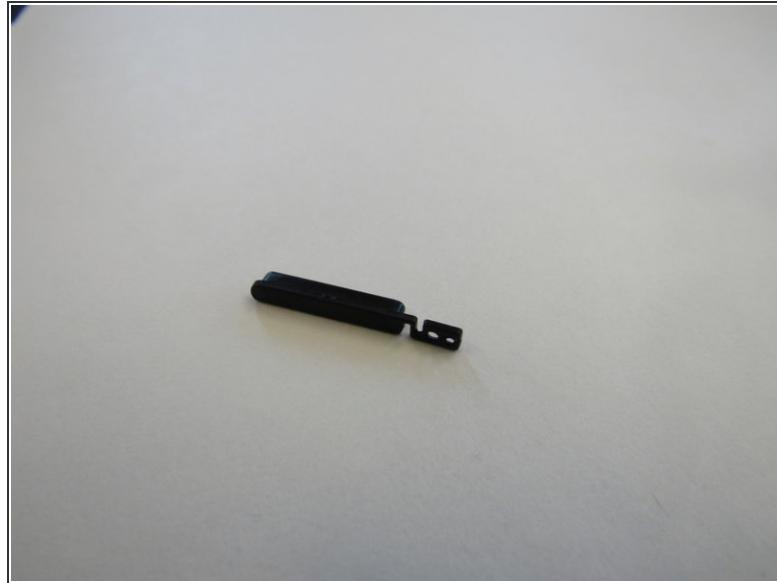
Step 4

- Align and place the new replacement button with positive and negative engravings facing outward into the volume space found in the cover.
