RIDGID R84015 X2 Wiring Repair

Use for a diagnosed wiring problem.

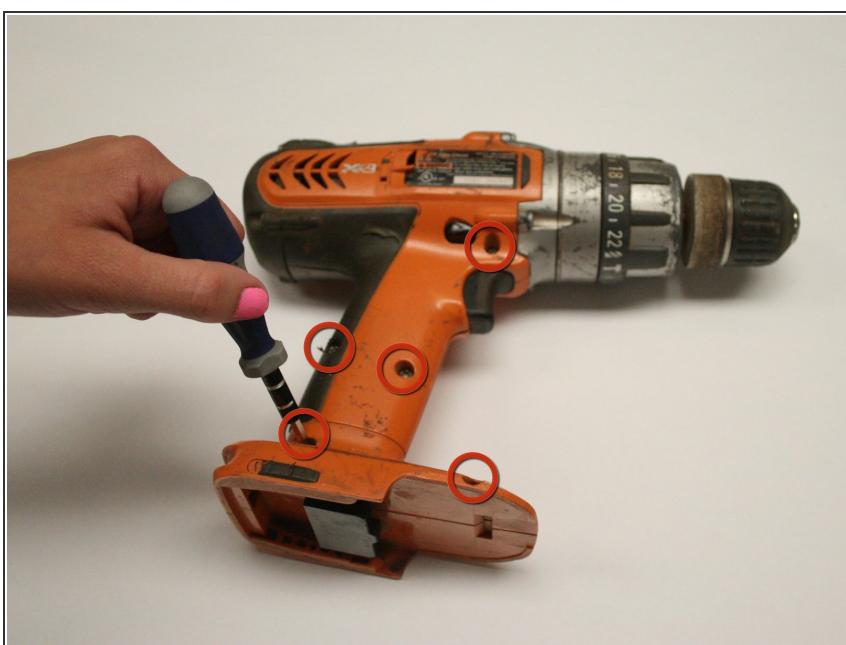
Step 2

- Remove the drill handle.
- Using the Phillips #2 screwdriver, remove the five screws attaching the drill handle to the body.

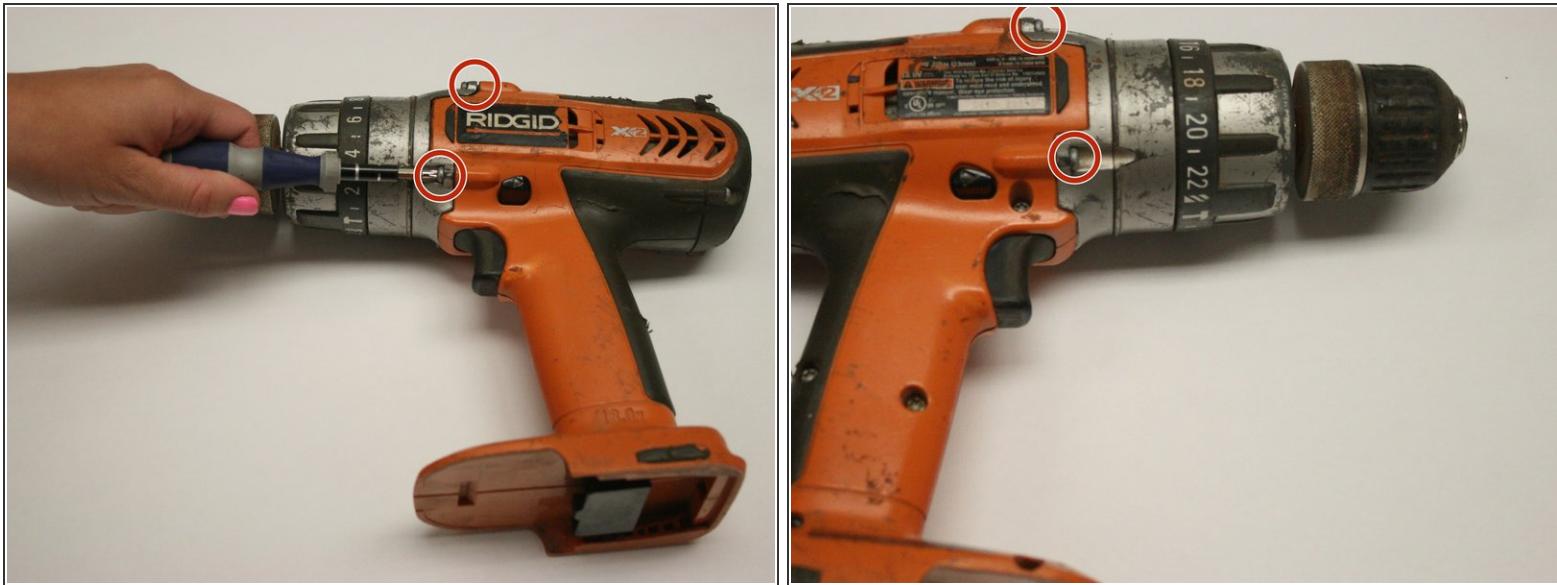
Step 3

- Remove the gear casing from the body.
- Using the Philips #2 screwdriver, remove the four screws attaching the gear casing to the body.

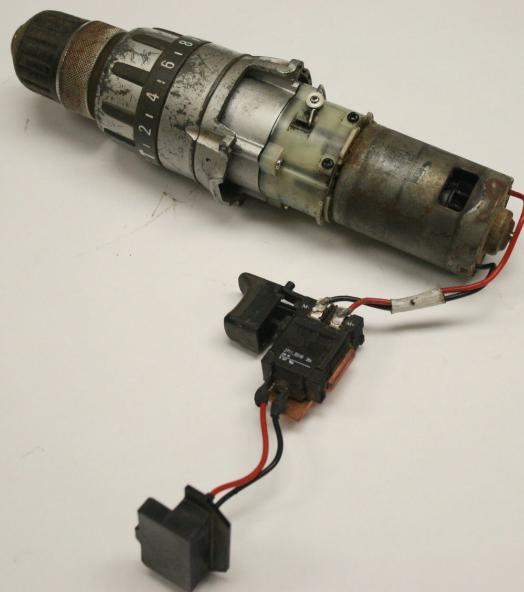
Step 5

- Look for corrosion or burnt wires.
- If there are any bad connections or if there is visible damage, replace damaged wire and solder.

- After soldering sand off jagged solder then wrap with electrical tape
