Repairing Tritton Kunai Speaker Buzzing Noise

This guide is meant to assist in fixing the buzzing noise that occurs in the speakers of the TRITTON headset.

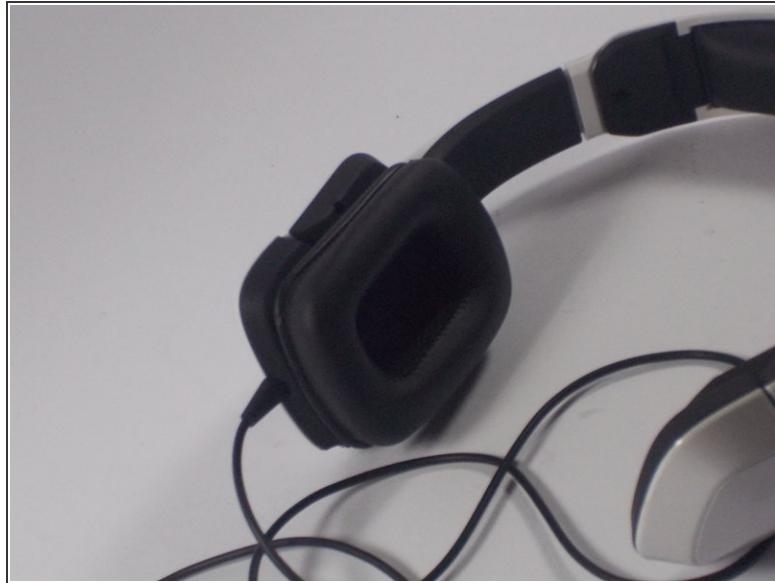
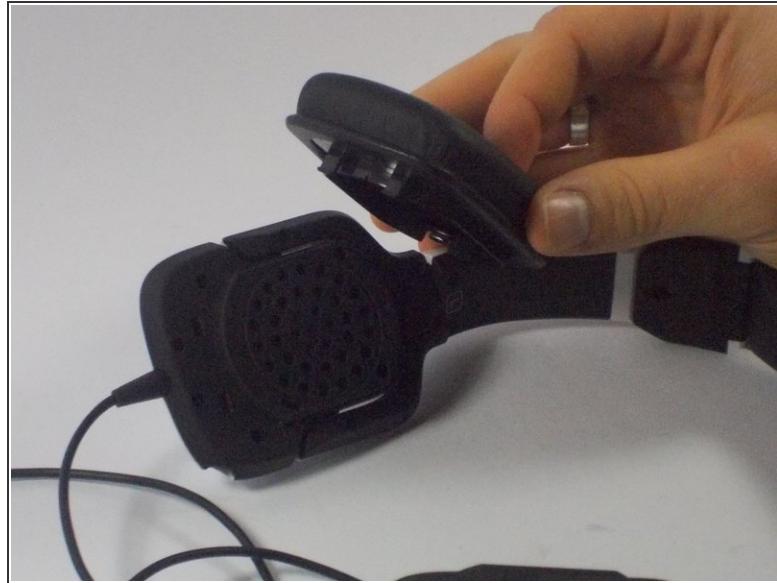
Step 1 — Repairing Tritton Kunai Speaker Buzzing Noise

- Remove the cushion of the speaker that the buzzing noise is occurring.

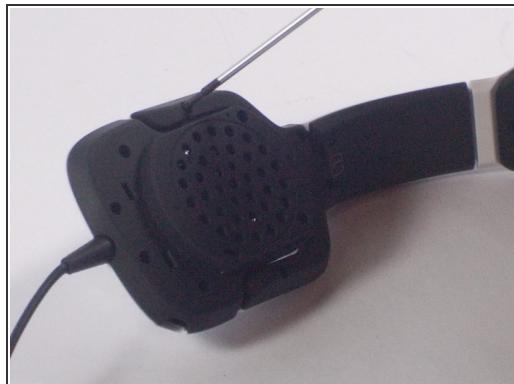
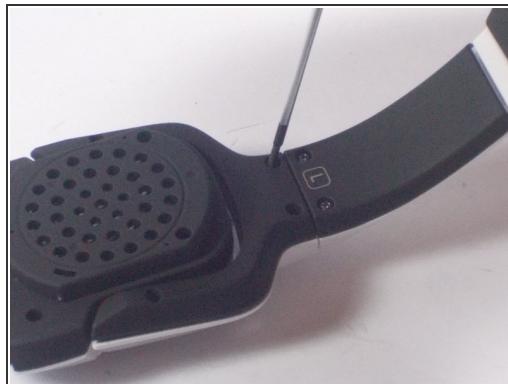
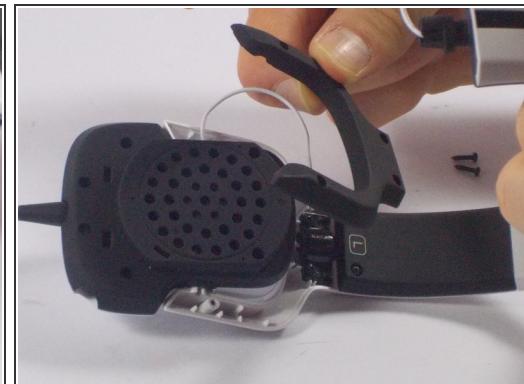
Step 2

- Use the Philips PH00 screwdriver to unscrew the four screws located on the inner part of the rail adjustment.

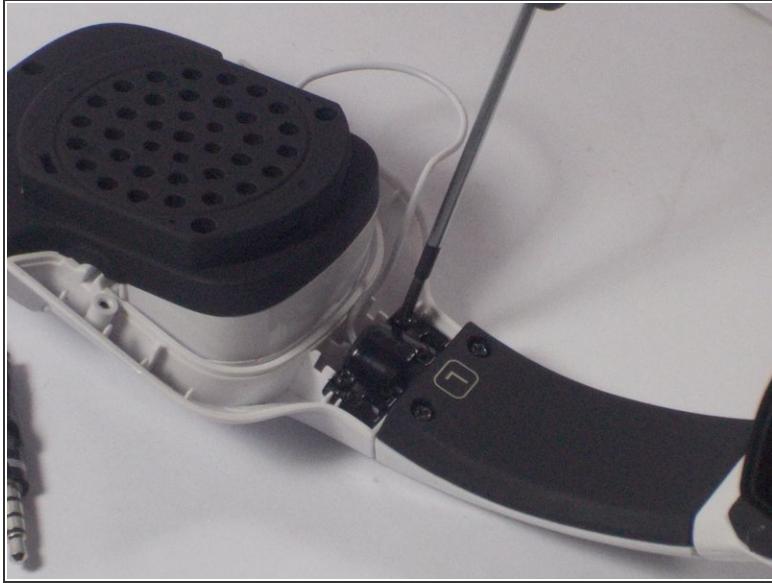
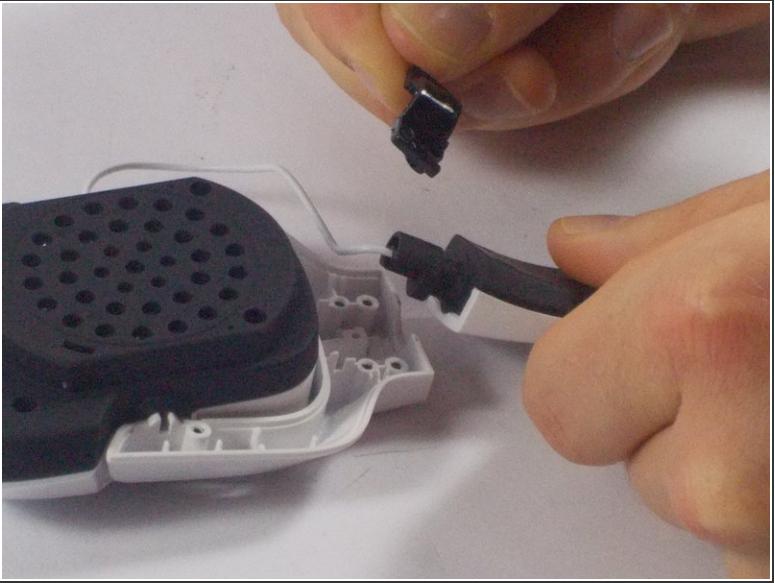
Step 3

- Remove the black metal bracket by unscrewing the two screws connecting it to the railing.

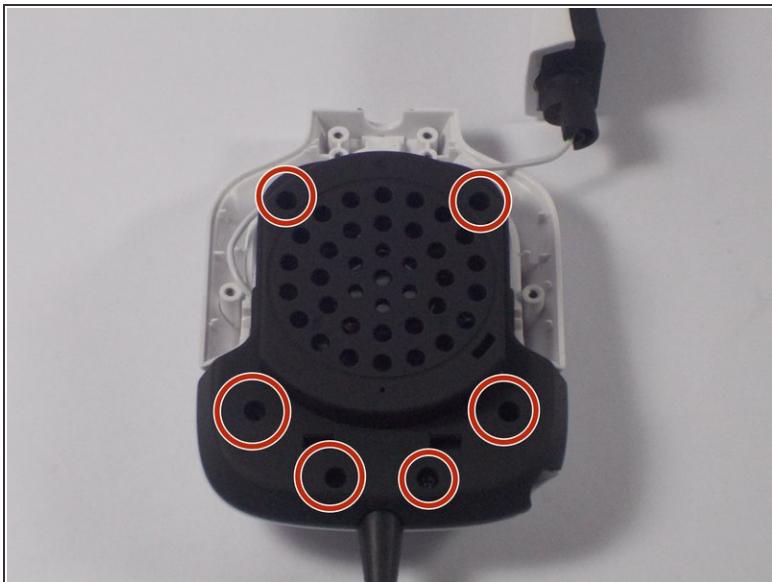
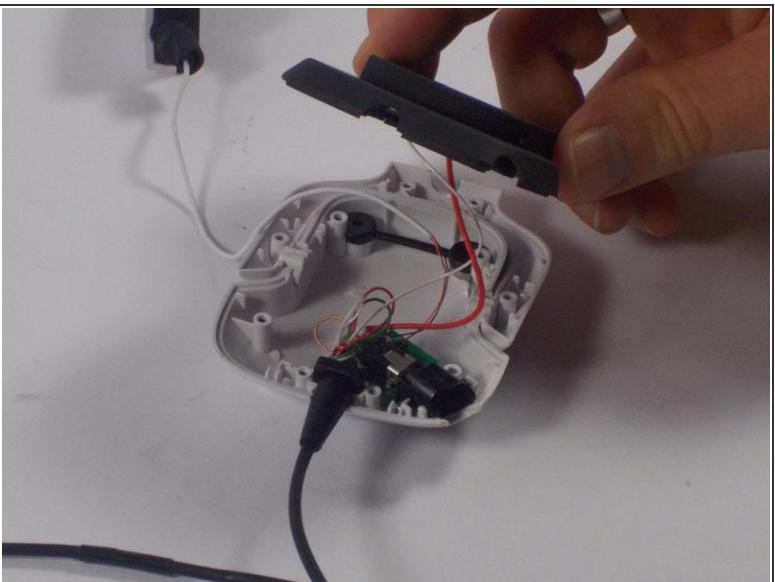
Step 4

- Unscrew the screws in the locations shown to remove the speaker cover.

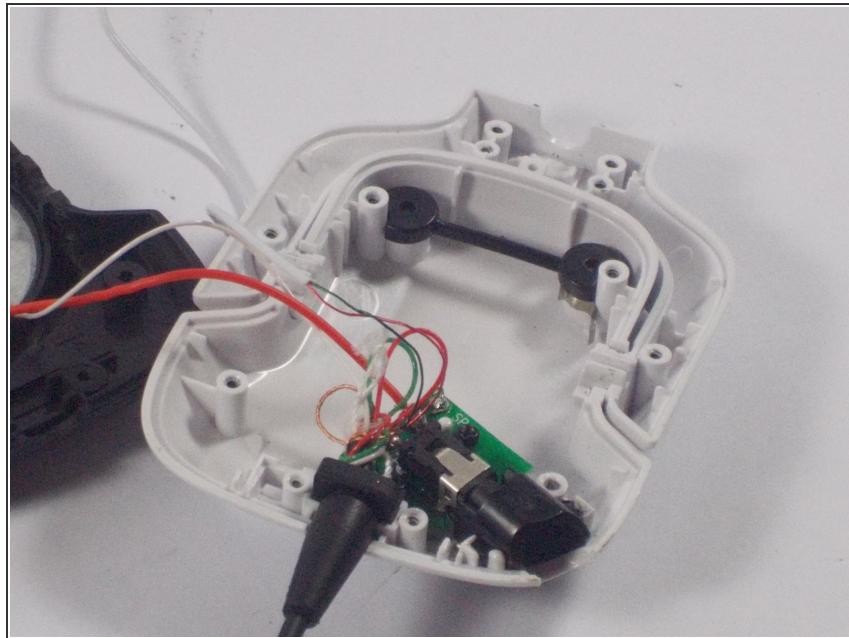
Step 5

- Place the black cover to the side, near the rest of the setup.

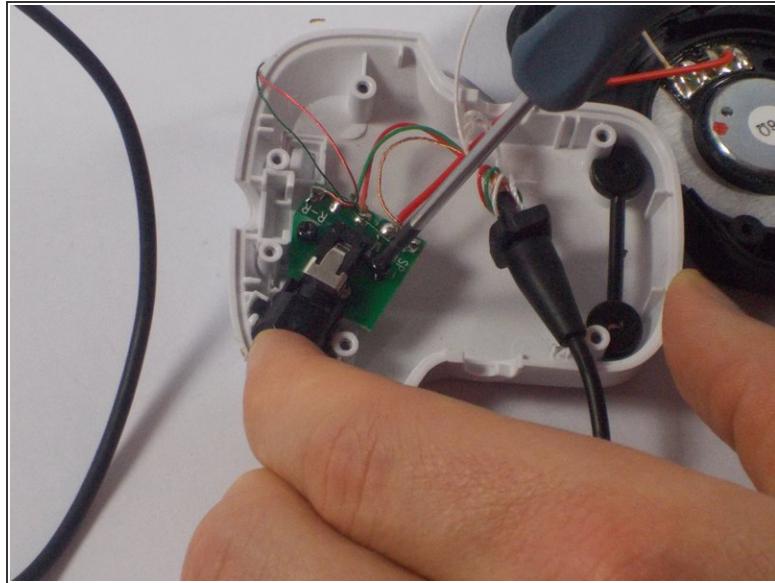
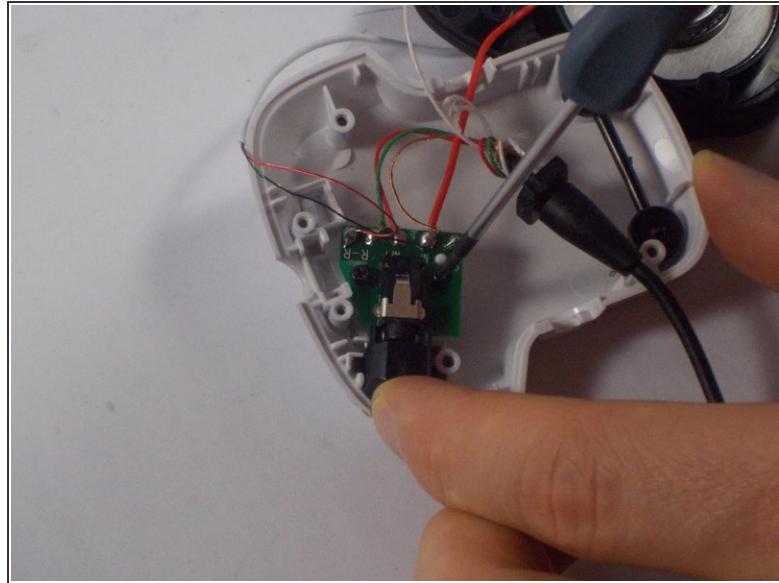
Step 6

- Observe the wire orientation: The red metal wire should be to the far left, while the green metal wire should be next to it, the skinny red rubber wire should be second to the right, and the thick red rubber wire should be to the far right. If any of the wires are out of place fasten them into their proper positions.

To reassemble your device, follow these instructions in reverse order.
