# Repairing a ripped off cable of a Sigma ATS and STS cyclometer mount

The cable of the cyclometer mount can be ripped off quite easily right before it disappears in the case. This guide explains how to fix a ripped off cable.

Written By: Baschtl

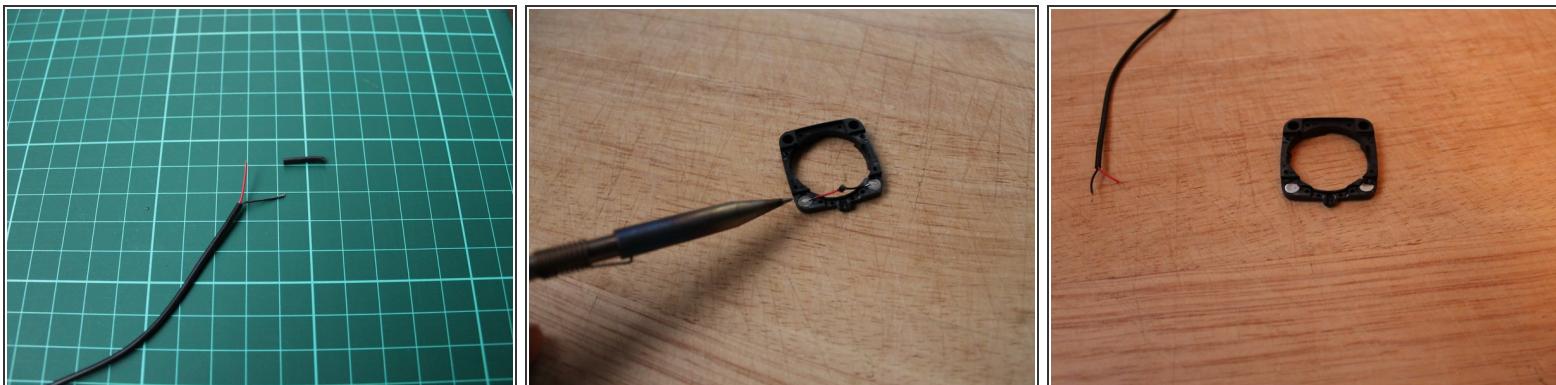
## Step 2 — Prepare the cable

- Take the remaining cable and remove some of the thick black insulation as well as some of the thin insulation as shown in the picture.
- Remove the broken cable by ripping it off carefully or using a soldering iron.

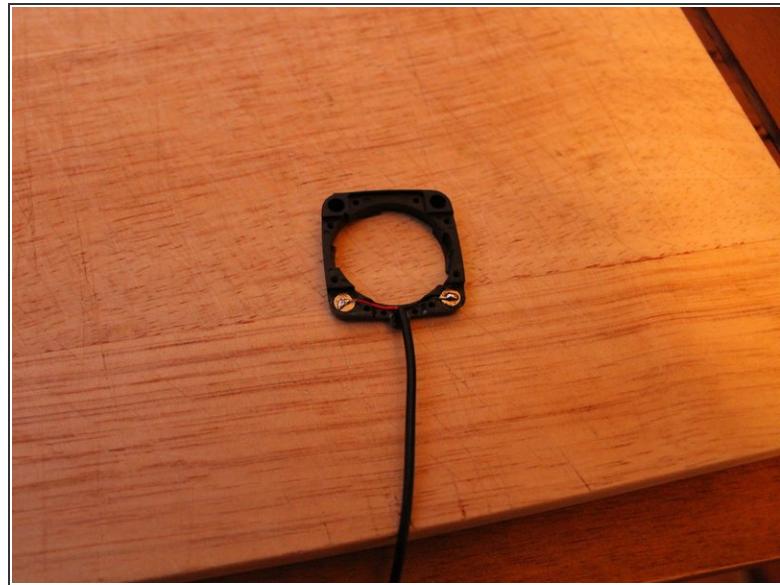
## Step 3 — Solder the cable to the contacts

- Use the paper clip to hold the cable at the right position.
- Solder the prepared cable to the contacts.

Remember: the red cable left, the black cable right.

The contacts take up heat of the soldering iron really fast. This can lead to the contacts melting the surrounding plastic. Hence, you have to be fast.
