Replace Kyocera FS-1010 sponge rubber

If your Kyocera FS-1010 prints / places the text too far up or down while printing, the foam rubber must be replaced.

INTRODUCTION

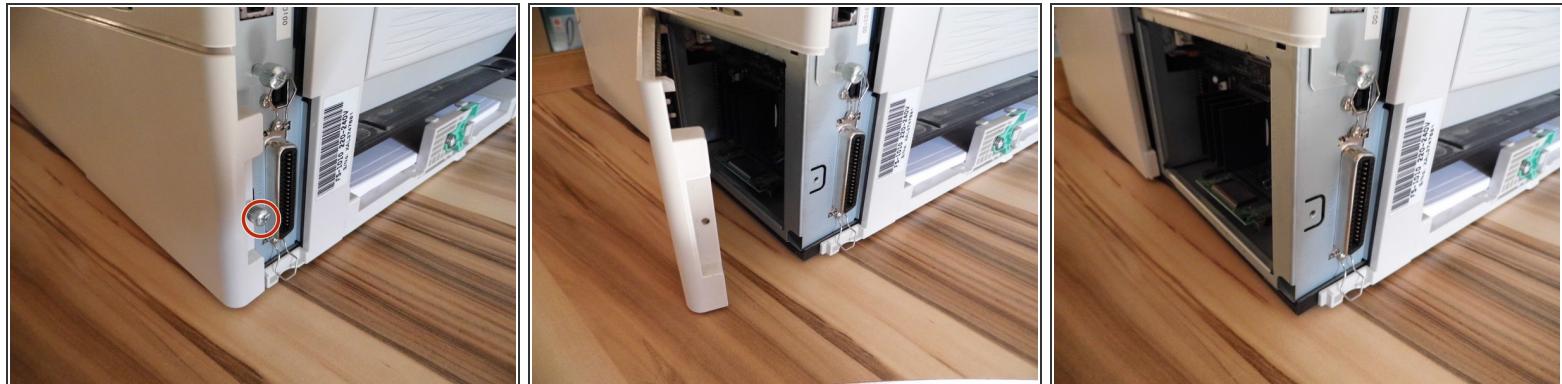
Step 2 — Remove memory cover

- Use a Phillips screwdriver to remove the Phillips screw that holds the memory cover on the right side of the printer in place.
- Remove the memory cover.

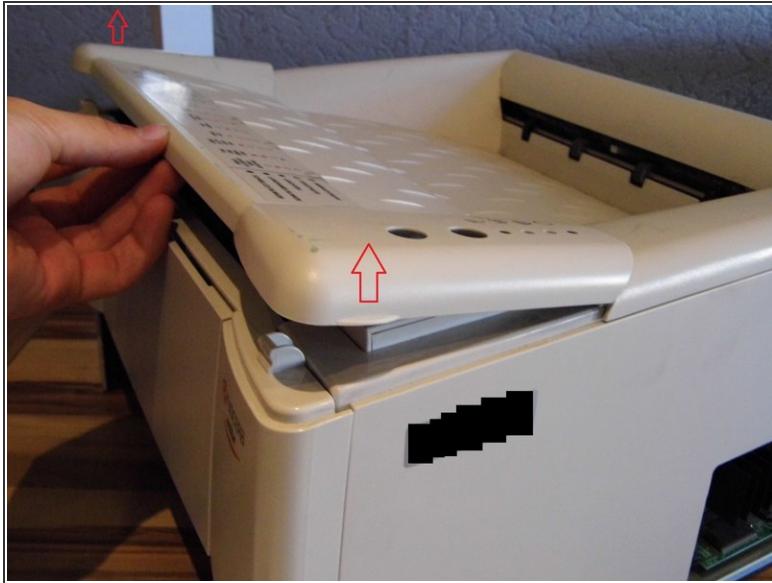
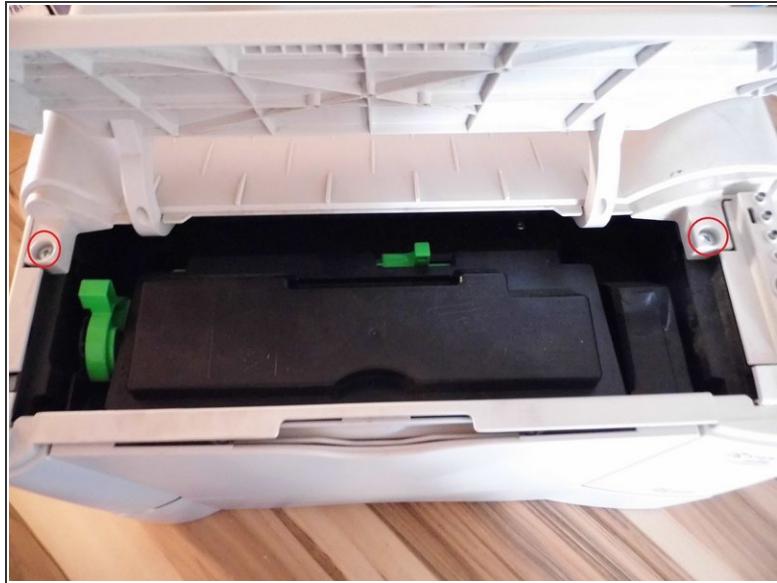
Step 3 — Remove top cover

- Open the cover to change the toner
- Remove the two Phillips screws that connect the top cover to the chassis.

⚠ Since the cover is in the way, you can put the screwdriver only diagonally on the screws. Be careful not to damage them.

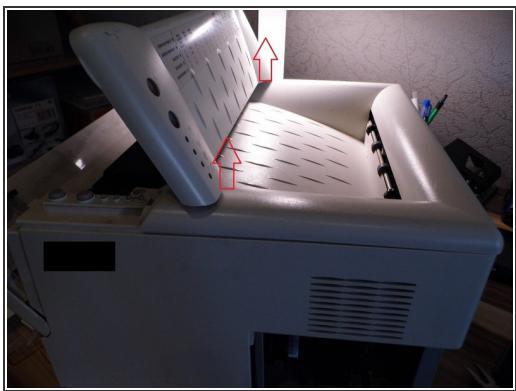
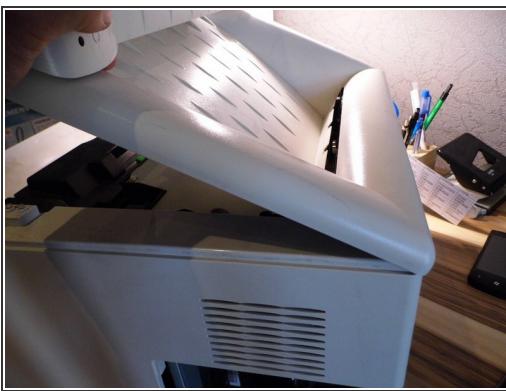
Step 4 — Remove top cover

- Remove the top cover from the printer.
- *i* Lift the cover on the front to easily and easily remove it.

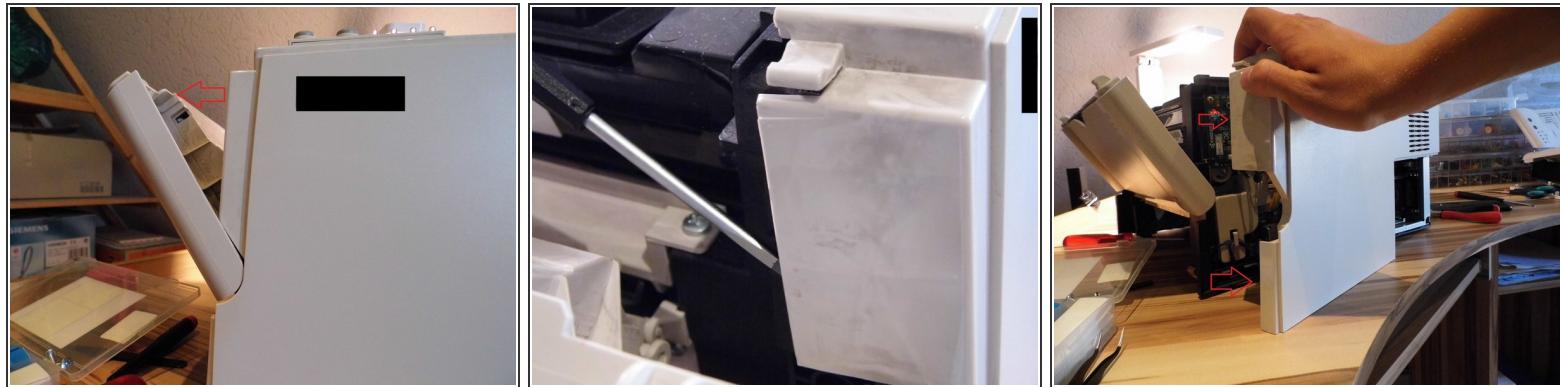
Step 5 — Remove the side cover

- To remove the side cover, the front paper feed must be opened. In addition, the front paper cassette must be removed by pulling out to release one of the clips.
- The cover is held in position by several clips. Removing the side cover is the hardest part of the guide.
- Using a spudger or a flat-head screwdriver you can easily loosen the clips (see picture 2). There are several clips around the cover. Only when all are solved, the side cover can be removed.
- Once all the clips have been released, you can fold the cover out of the front of the paper feeder (see picture 3).

⚠ Make sure you do not damage any clips when removing the cover!

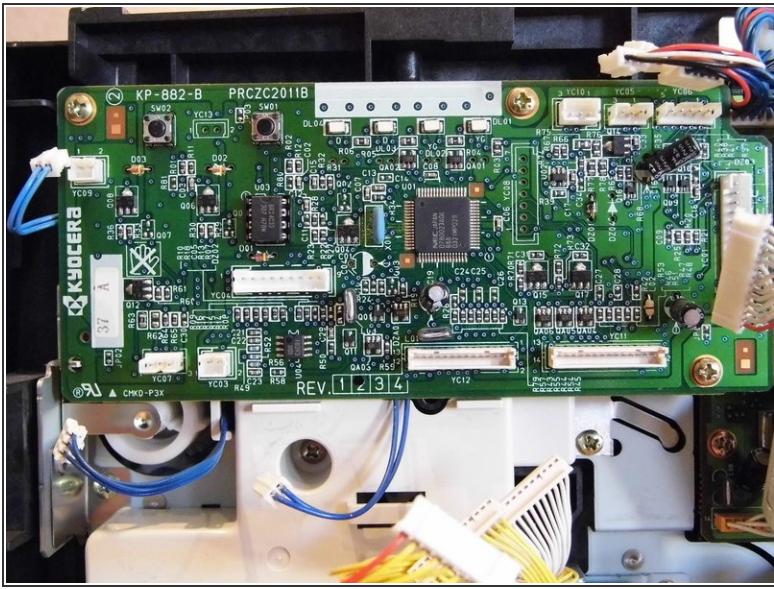
Step 6 — Remove control board

- Remove all cables from the board.
- The green marked cables are very tight and difficult to loosen. Take your time and do not exercise too much violence.

⚠ Do not pull too hard on the cables as they may be damaged. Attempt to loosen the plugs with a spudger or flat-head screwdriver.

ⓘ If it's impossible to remove the green marked cables, you can still complete the guide with attached cables and PCB. But still, it is advisable to remove these cables.

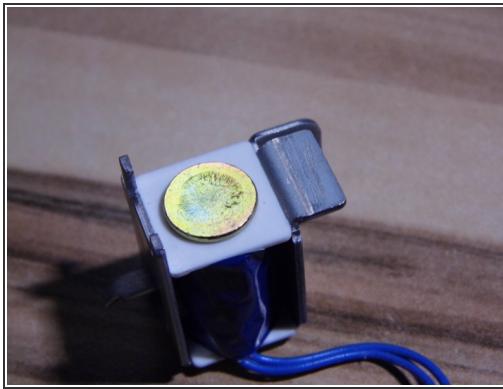
Step 15 — Remove old sponge rubber and replace

- Use a slotted screwdriver, a spudger or something similar to remove the sponge rubber.
- Then clean the place to remove the glue residue. For cleaning, e.g. Brake cleaner or silicone spray can be used.
- After the site has been cleaned, new sponge rubber or something similar (e.g., felt or shrink tubing as shown in Figure 3) can be applied.

⚠ The new material shouldn't be any thicker than the sponge rubber, since the printer might not work if the material is too thick.

ⓘ Before reinstalling, also clean the area where the sponge rubber has come into contact with the metal fork to remove the glue residue.

- After cleaning and replacing the sponge rubber, the metal fork can be re-attached to the retraction breaker. To do this, follow step 14 in reverse order.
- Then the feed breaker can be re-installed in the printer. To do this, follow step 13 in reverse order.
