Ricoh GR-1 LCD display missing segments repair

Detailed guide how to fix your GR1 top status LCD and viewfinder info. This guide describes disassembly, replacement of 3M conductive tape and reassembly.

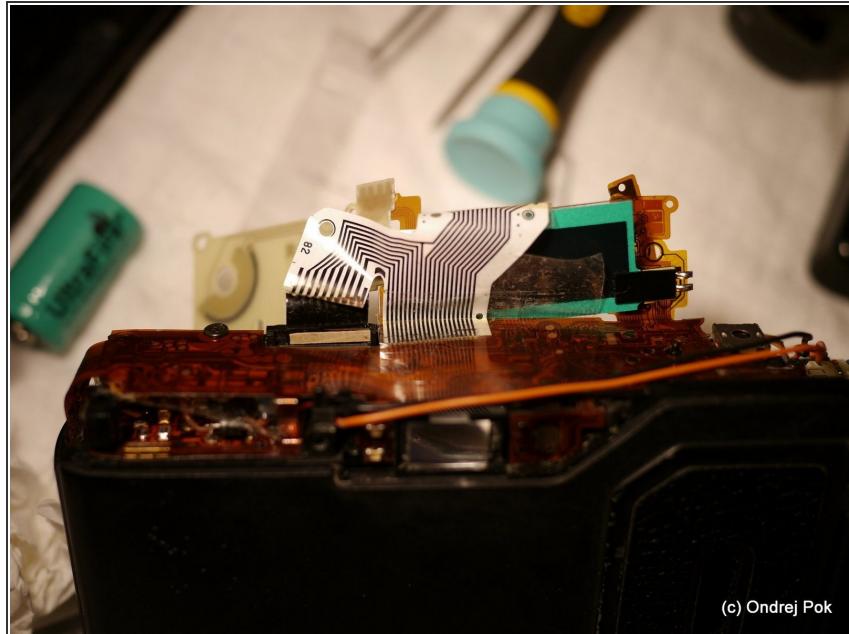
Step 1 — Announcement

- I decided I would try to design and order a small batch of flexible PCB as a replacement of the fragile ribbon - the achiles heel of all GR1's;
- If anyone is willing to donate their dead GR1 for this project, I would try create the input data for the manufacturing of the flexible PCB (Gerber file) and order a small batch of PCBs. I would then make the files available open source.
- So, Is anyone willing to donate the GR1 body? I am paying for the shipping and offer also one of the new ribbon PCBs as a reward.
- Disclaimer: It is still just an idea, and I can't guarantee it will work. However if it turns out the way I hope, this could resurrect hundreds of crippled GR1's with failing LCD or VF lines.

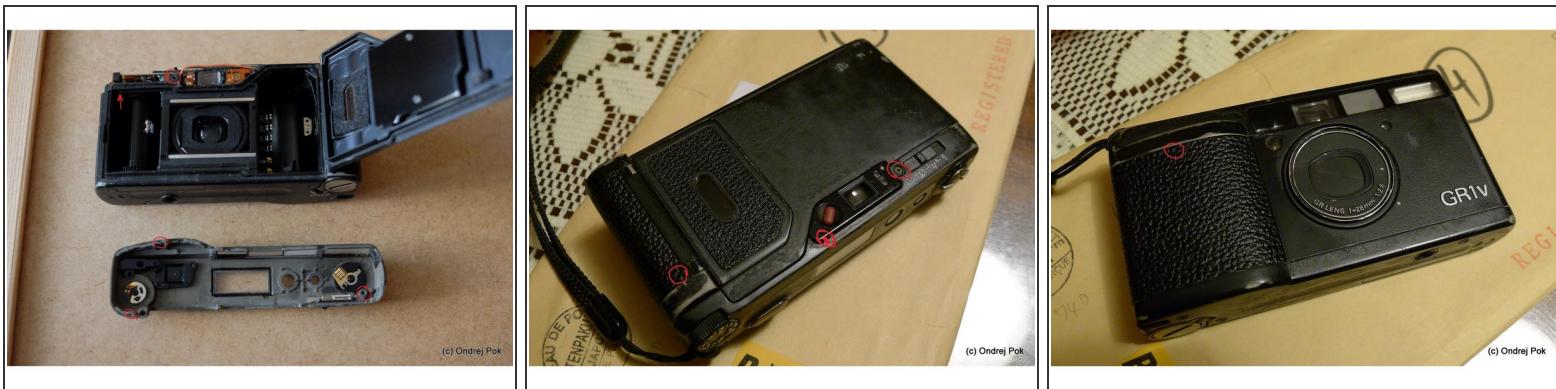
Step 2 — Opening the top cover

- There are 4 Philips head screws that must be removed to open the top of the camera.
- 2 are under the leatherette, one on the front and one on the back
- be careful when removing the plastic piece around the eyepiece, there is a hook holding the right hand side farther from the visible screw.
- There is also one long screw accessible from the inside near the film take up spool.

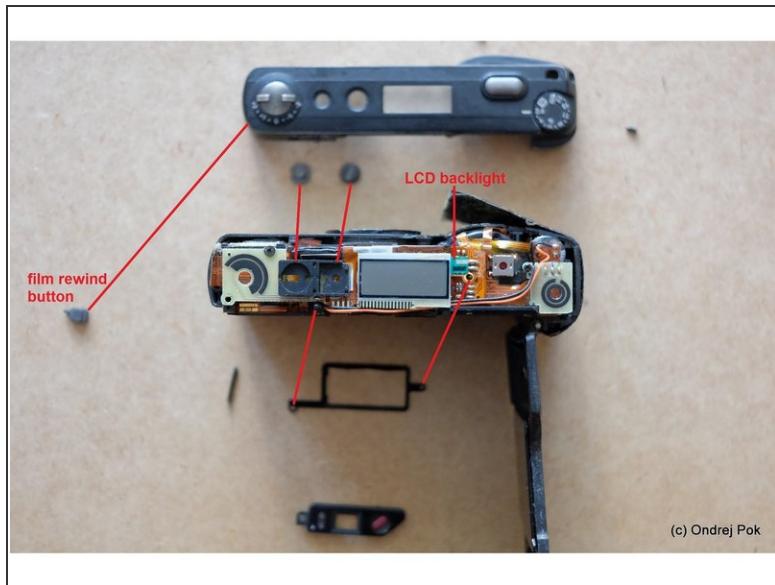
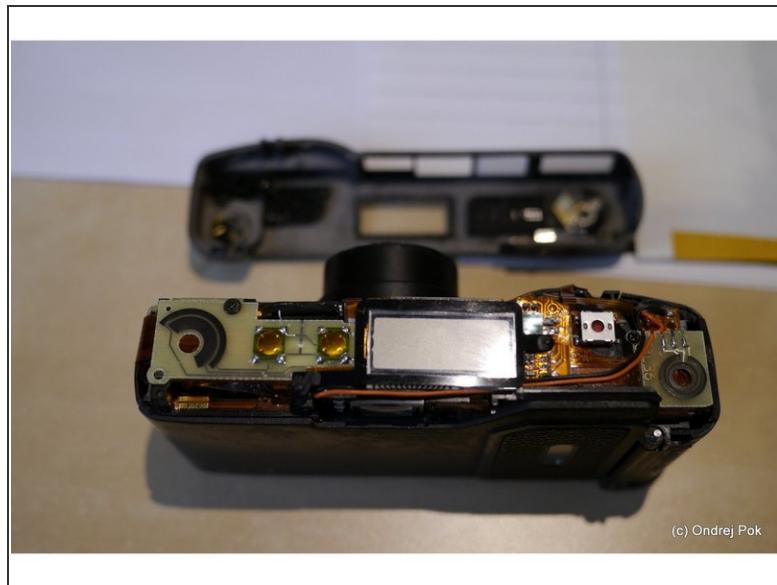
Step 3 — Under the top cover

- You will see the LCD and a bunch of flexible circuit boards soldered on top of each other
- To continue disassembly further you will need about 20-30W "pencil" soldering iron
- If you want to replace the conductive tape and restore lost segments of the top status LCD or viewfinder icons, you will also need a "3M Electrically Conductive Adhesive Transfer Tape 9703" ([product page](#)) Usually can be bought on ebay in smaller quantities.
- Buttons should stay with the top cover as can be seen in the picture without annotations

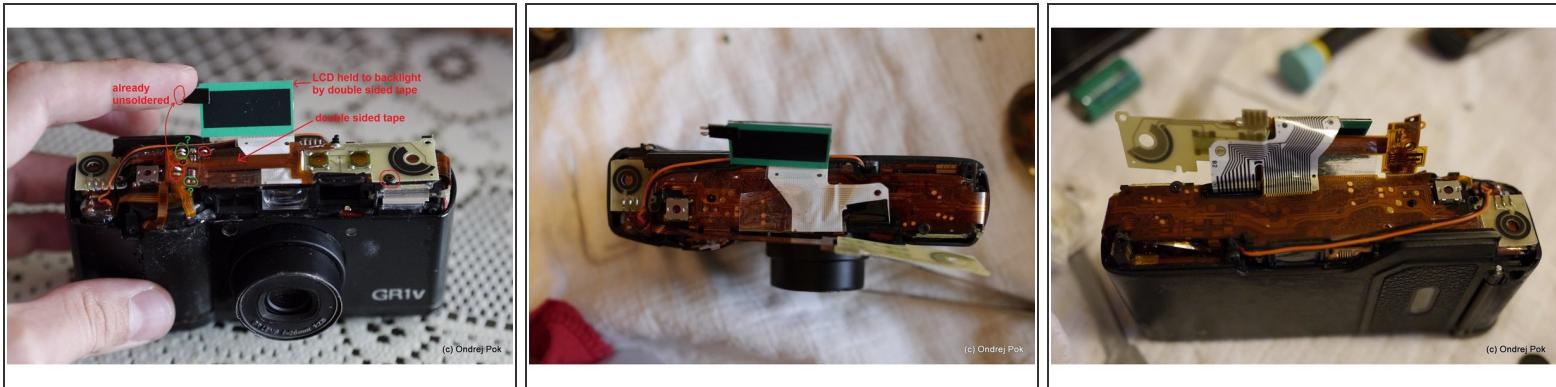
Step 4 — Desoldering

- There are some connections you need to desolder and one screw you need to remove.
- the red circled solder joints may need to be desoldered (see comments below guide), I am not sure about the green circled, but try not to if possible
- the flexible circuit board is held by strong double sided tape and it might appear that you need to desolder more joints, when it's actually just the tape holding it.
- Your goal is to get to state like in the second picture, where I've bent the flex circuit boards open to gain access to the white flexible ribbon cable

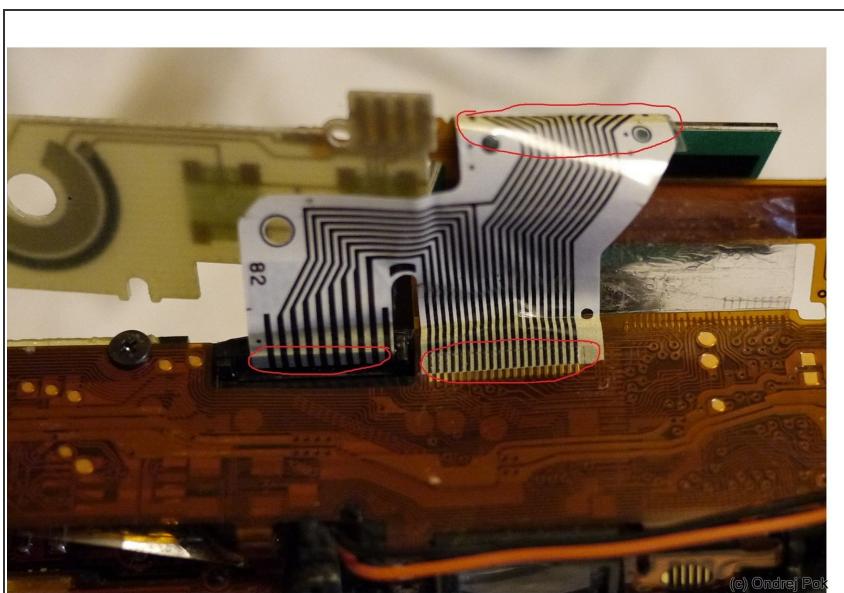
Step 5 — Replacing the 3M 9703 conductive tape

- This is the hardest part, and it's very difficult to take pictures of or describe.
- you need to somehow gently detach the white ribbon cable from the LCD / flexible circuit board / viewfinder LCD (replacing ALL 3 conductive tapes may not be necessary, see comments below guide)

- The ribbon is very fragile, and in all those connections is covered with a transparent tape to add strength to the connection
- Be sure to clean both surfaces with alcohol and remove any residue of previous conductive tape

- Before reattaching simply cut appropriate size of new conductive tape and apply to the ribbon, then press in the right place
- reattaching to the flex circuit board is the easiest, because you actually see the copper paths which need to align with the black stripes of the ribbon

- reattaching to the viewfinder LCD is more difficult, you need to align the right hand side edge of the ribbon
- reattaching to the LCD is by far the hardest. On the LCD itself you can just barely see the conductive paths when you look at an angle. They are made of ITO (Indium Tin Oxide) and nearly transparent. I made marks where the rightmost and leftmost conductive paths are with a sharpie on the other side of the glass, and then glued the ribbon back on

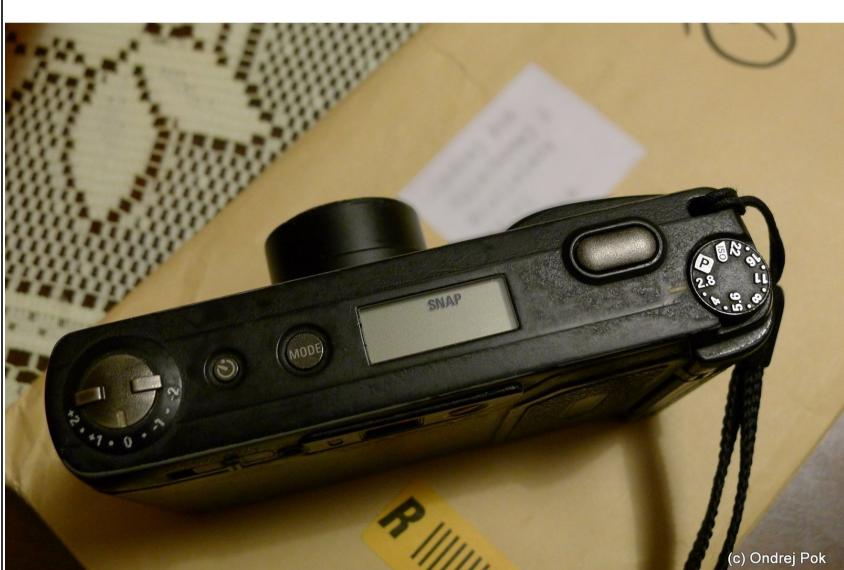
Step 6 — Conclusion

- If you've done everything right, you should see all segments on the the top LCD and in the viewfinder
- it took me several tries to reattach the ribbon to the LCD and viewfinder LCD, patience and steady hands is the key to success.
- Try not to damage the ribbon too much when detaching it. I did and had to shorten it slightly and in the end I had problem to fit the parts back together.
- Reassembly should be just reverse order of disassembly. Don't forget the rewind button.
- When you're at it, do yourself a favor and buy some leather sheets from Aki Asahi and give your GR1 a new covering.
