Ryobi P501G Blade Replacement

This guide goes over how to replace the RYOBI P501G power saw's blade.

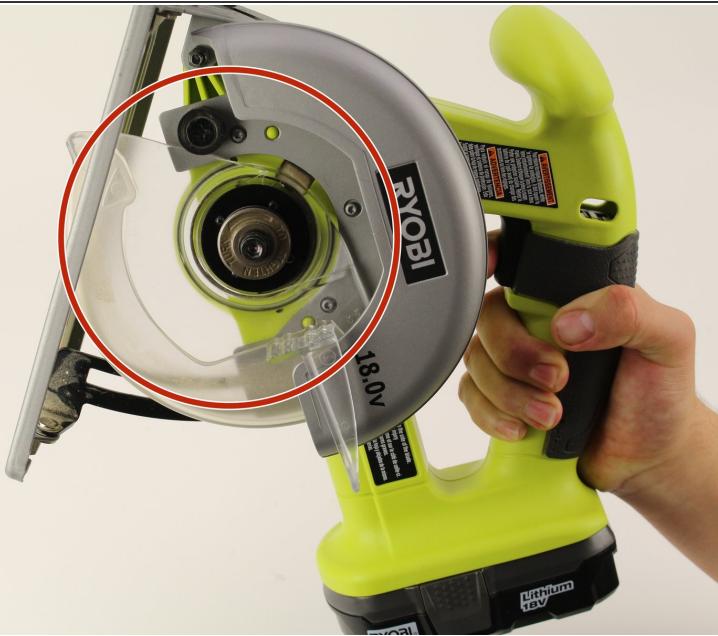
Step 1 — Blade

- Locate the area where the blade is connected to the motor, where the circular covering is on the Ryobi P501G.

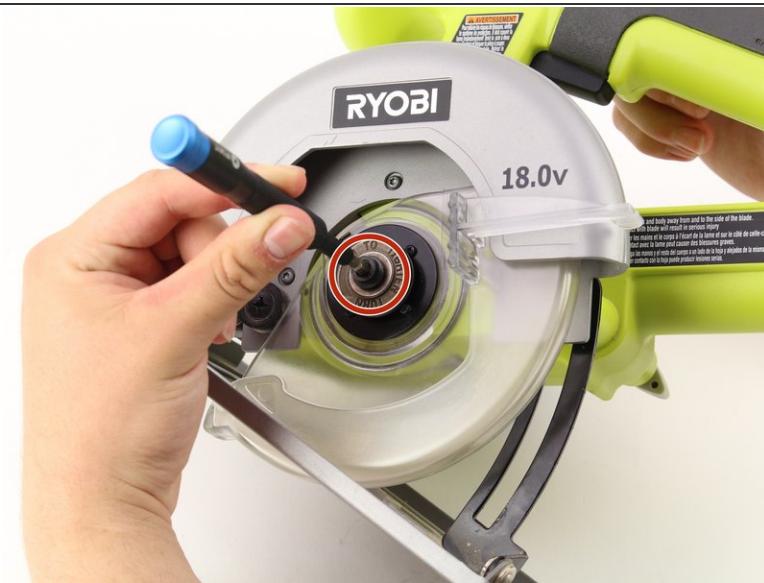
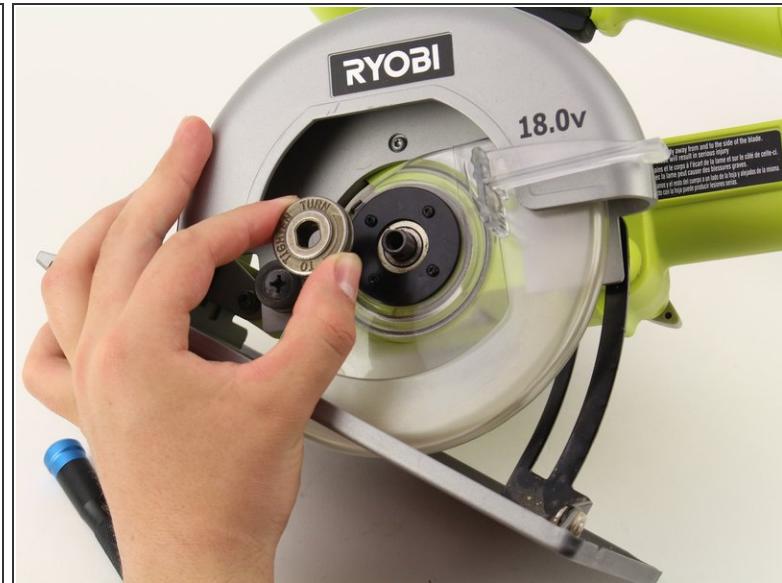
Step 2

- Unscrew and remove the bearing in the middle, connecting the blade to the motor.

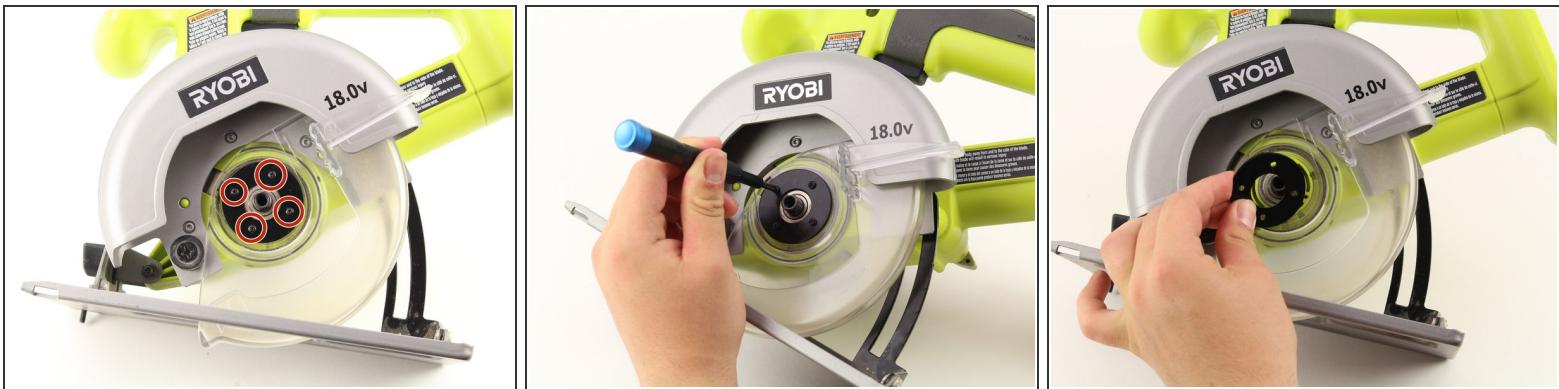
Step 3

- Remove the four black screws holding the black bearing and remove the bearing itself.

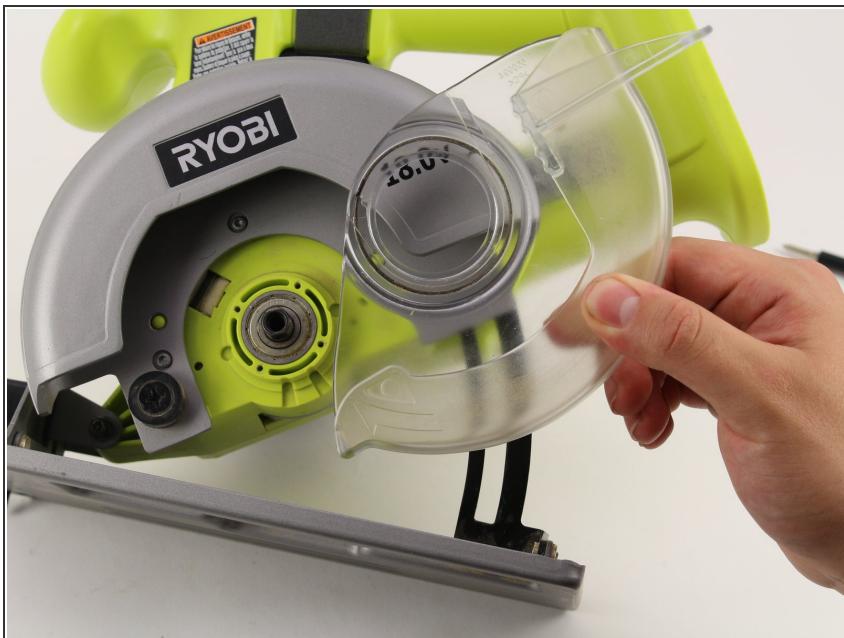
Step 4

- Once the black bearing is off, remove the transparent casing of the blade.
- Once the casing is off, remove the blade.

To reassemble your device, follow these instructions in reverse order.
