Ryobi VC120 Rubber Seal Replacement

This guide will help you replace the seal in the nose of the Ryobi VC120 vacuum cleaner.

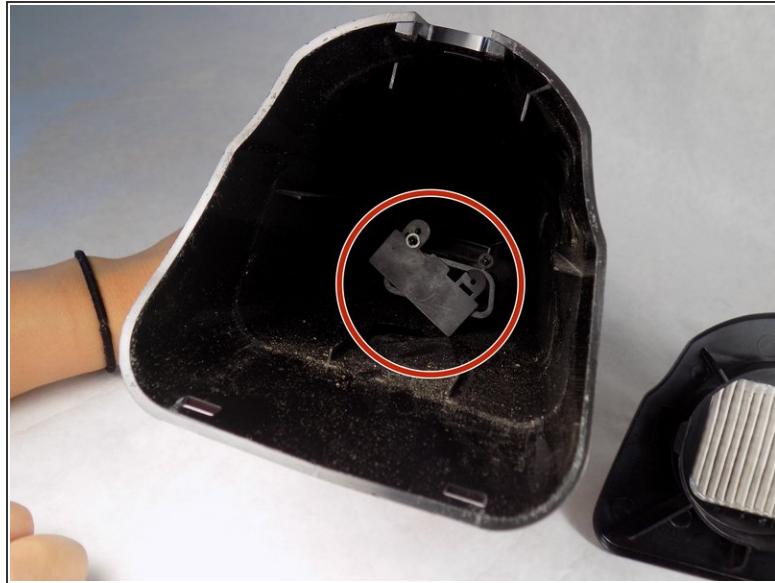
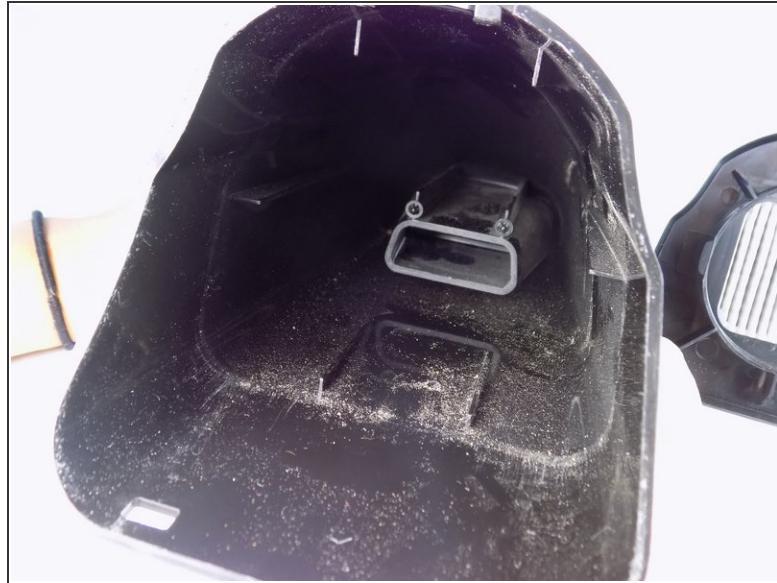
Step 1 — Rubber Seal

- Remove the nose of the vacuum and gently pull off the rubber seal by hand.

Be careful replacing the seal on the posts, if you are too rough it may tear.

To reassemble your device, follow these instructions in reverse order.
