Saeco Vienna Sup 018 water tank seal replacement

Replacement of the water tank seal on a Saeco Vienna Sup 018

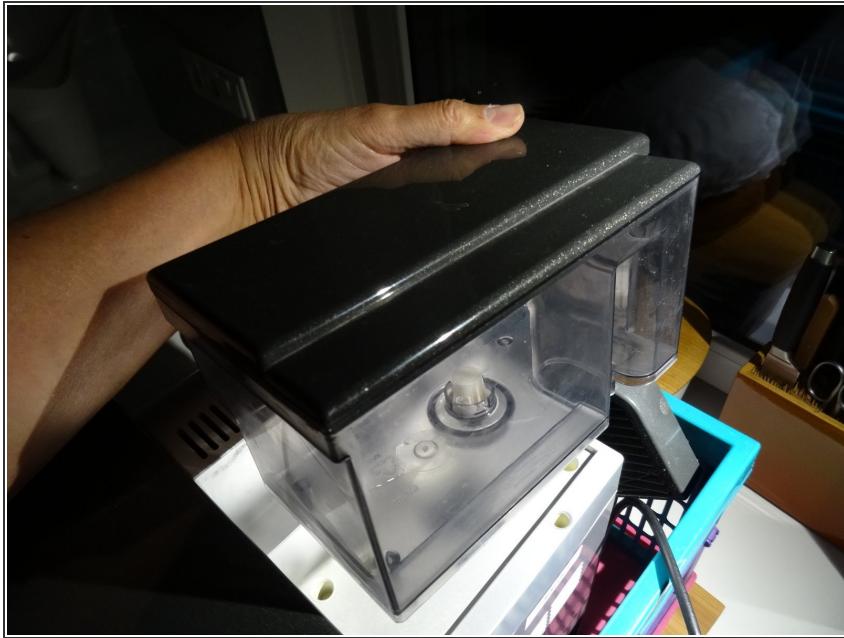
Step 1 — Water tank seal

- Lift the water tank off the machine

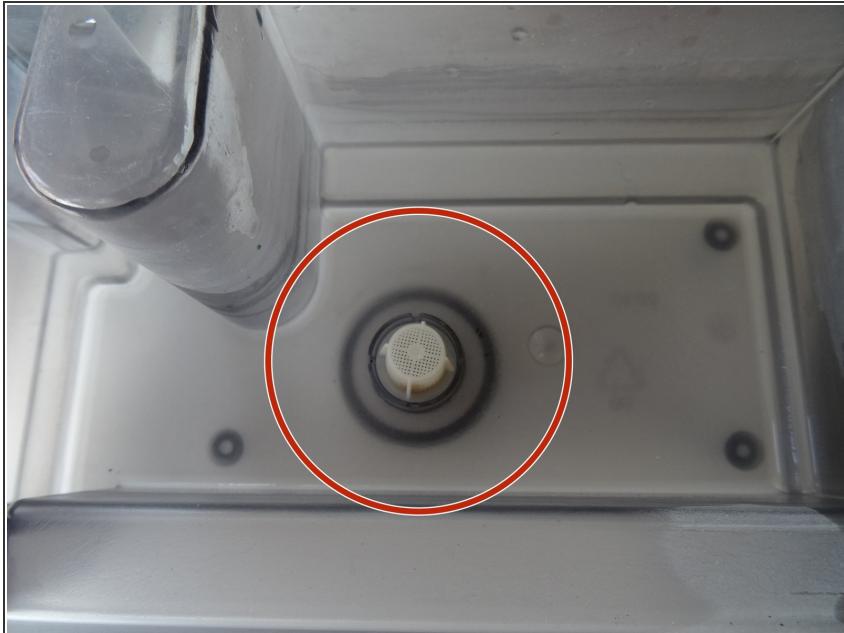
Step 2

- With your fingers pull the filter off the water outlet.

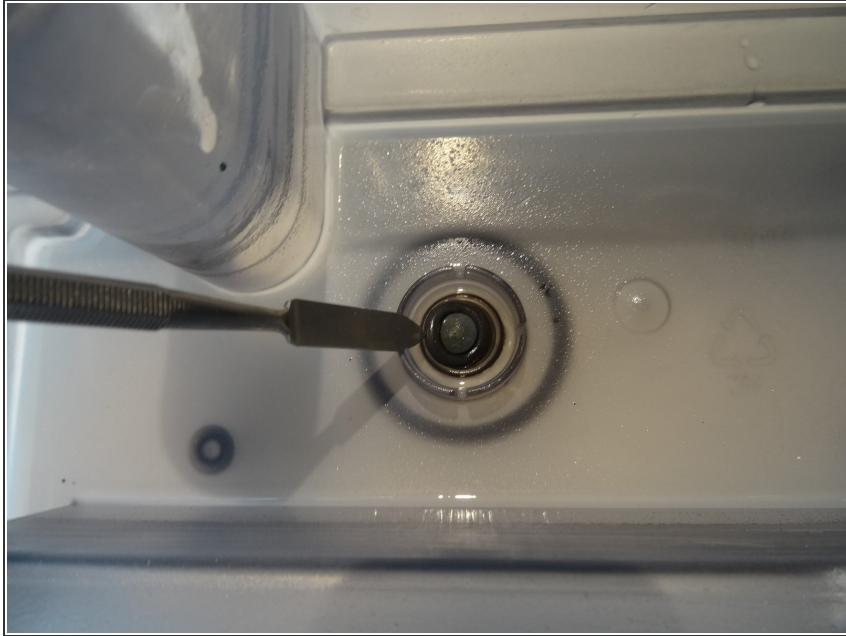
Step 3

- With your fingers press the valve stem from the bottom up. Now you can pry off the seal with a spatula tip.

To reassemble your device, follow these instructions in reverse order.
