Samsung Galaxy S10+ Teardown

An iFixit video teardown of the S10+ released March 5, 2019.

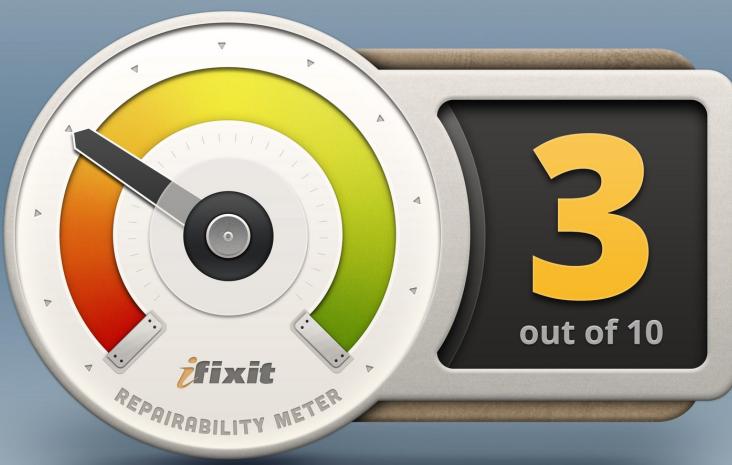
REPAIRABILITY SCORE:

- A single Phillips driver takes care of all the screws.
- Many components are modular and can be replaced independently—but the charging port is now soldered to the main board.
- Battery replacement is possible, but still unnecessarily difficult.
- Glued-down glass both front and back means greater risk of breakage, and makes repairs difficult to start.
- Screen repairs require a lot of disassembly while battling tough adhesive.
