Samsung Galaxy Tab 3 8.0 Charging Port Replacement

If the device will not charge despite a power cable and battery replacement, replacing this component is the likely solution.

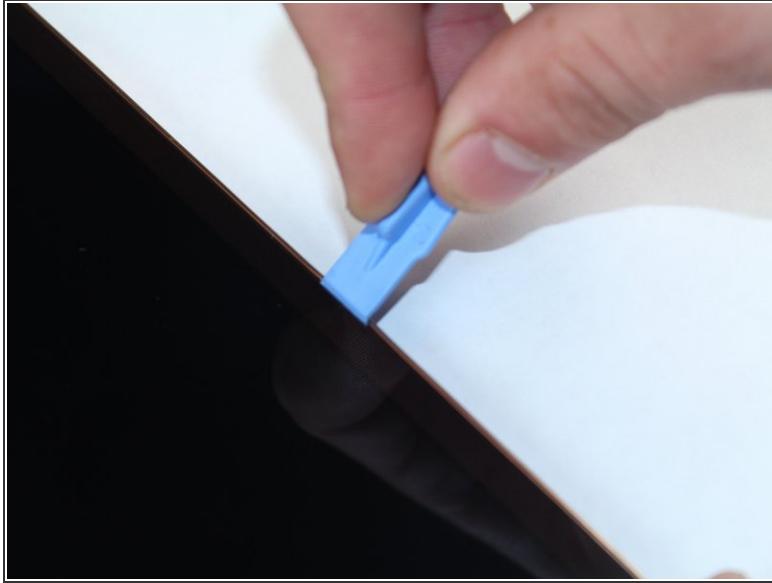
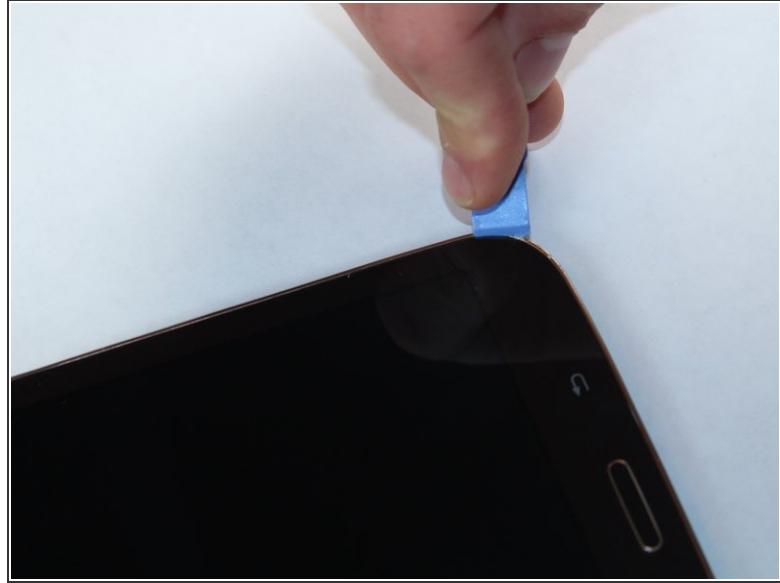
Step 1 — Battery - Open up the tablet

- Start out by separating the screen from the back cover using the larger plastic opening tool to pry them apart.

Be careful when removing the screen as negligence can cause damage.

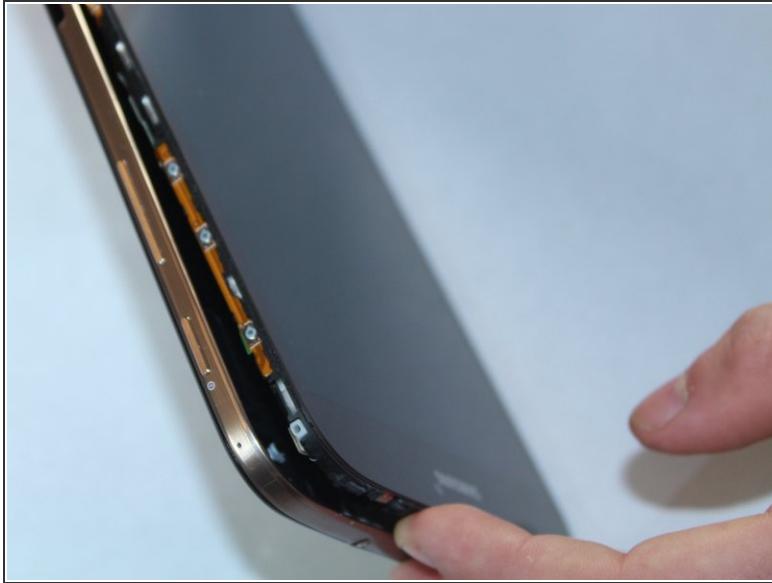
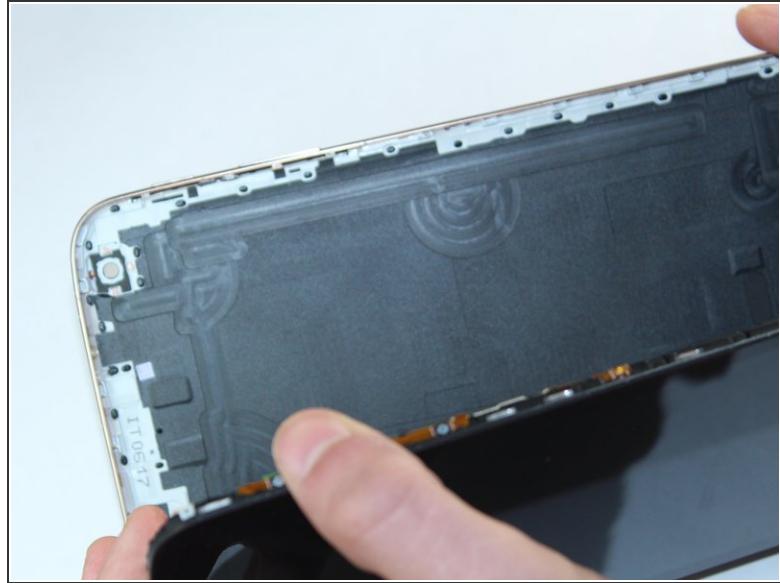
Step 2 — Remove Back Cover

- Once every part of the screen is separated from the back cover, you should be able to fully remove it with your hands.

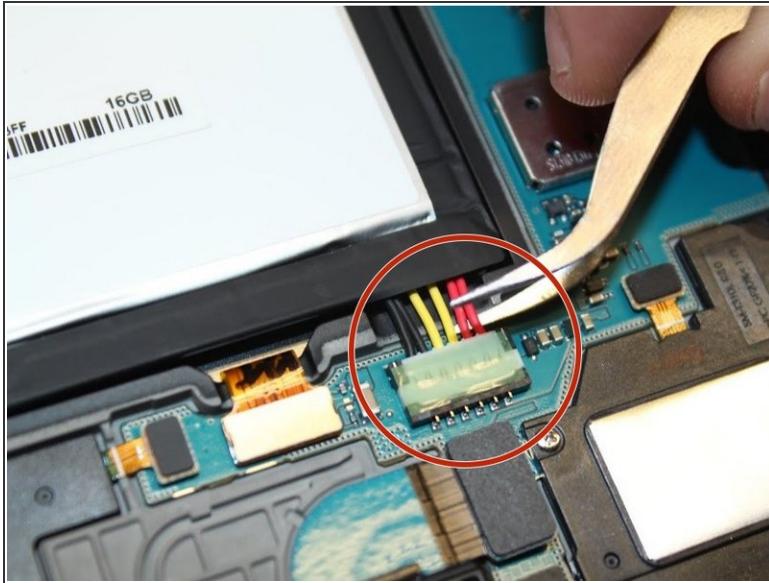
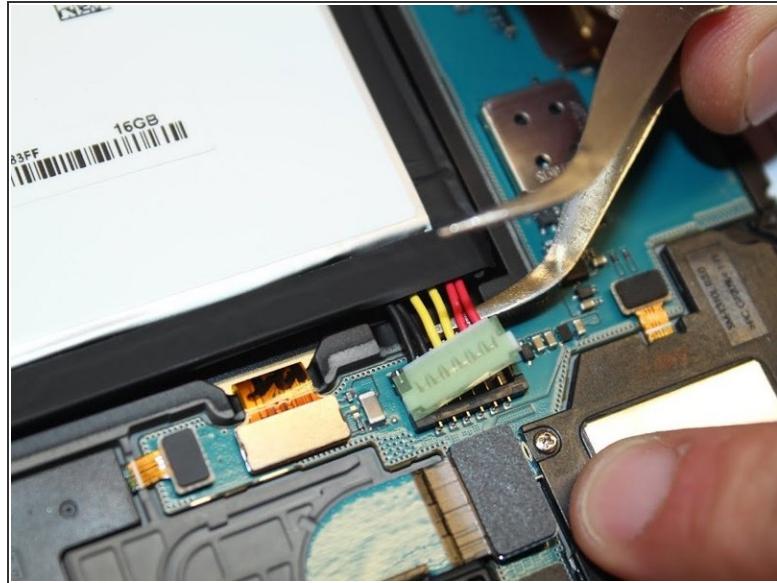
Step 3 — Disconnect Battery

- To remove the battery you must use something small, such as tweezers, to disconnect the battery from its port.

(i) Note: the connection lifts up to remove.

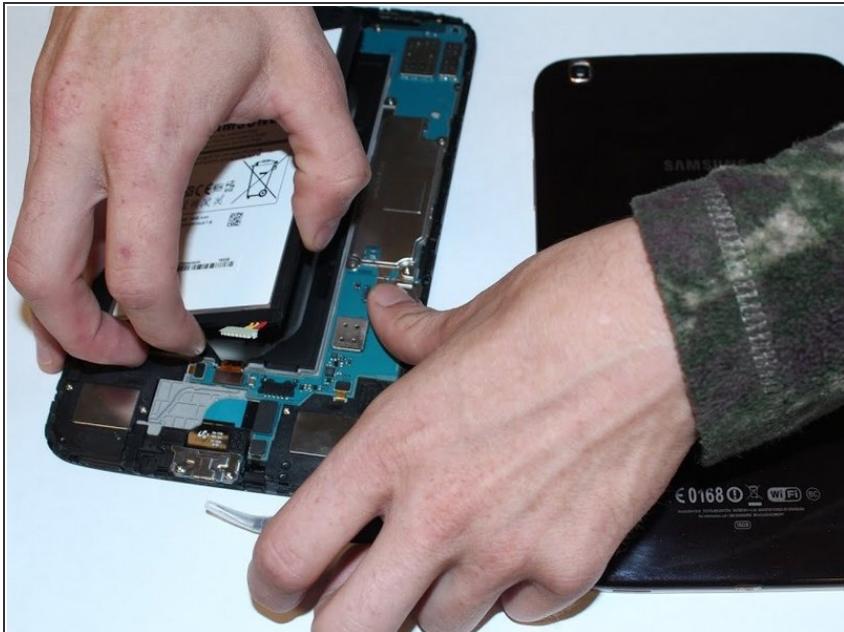
Step 4 — Remove Battery

- After the battery is disconnected, use the pulling tab to safely remove the battery.

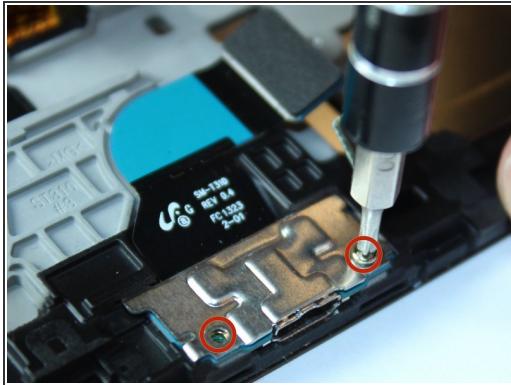
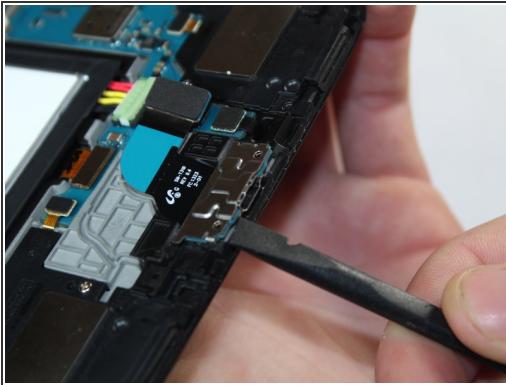
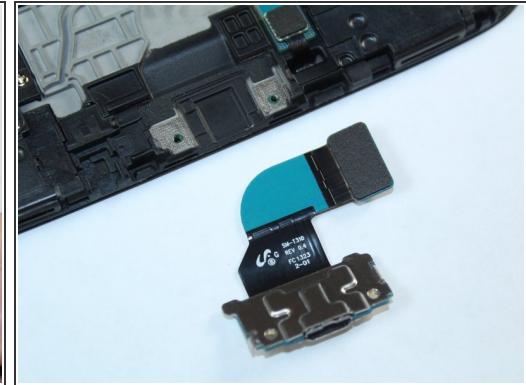
Step 5 — Unscrew Charging Port

- Unscrew the 2.9mm screws from the charging port with Phillips Head #000 and use the spudger to pry it up from under the port to remove component from the device.

To reassemble your device, follow these instructions in reverse order.
