Sony BDP BX350 Disc Tray Replacement

Written By: Kristen Vezina

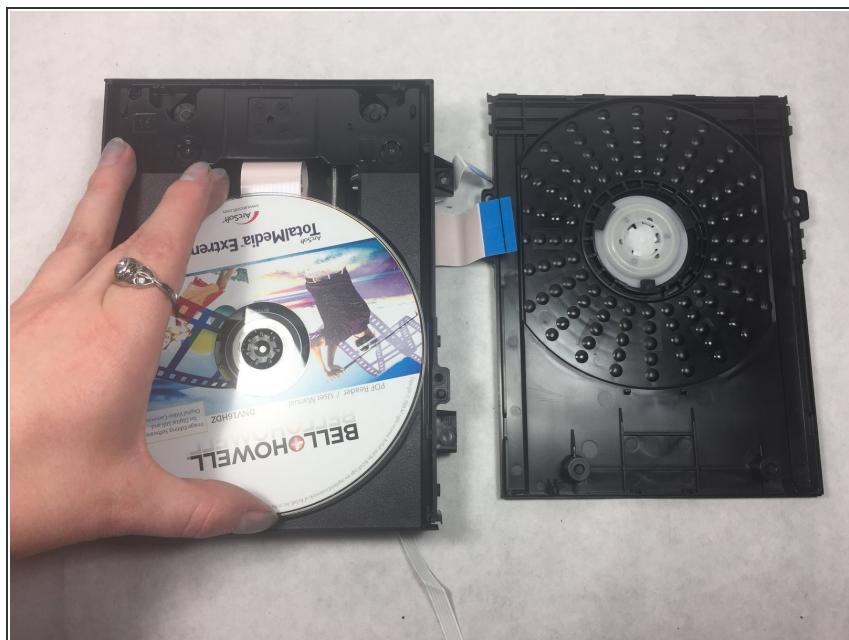
Step 10

- Remove disc from disc tray.
