# Sony Ericsson T68i Vibration Motor Replacement

This guide will assist you in removing the vibration motor from your Sony Ericsson T68i.

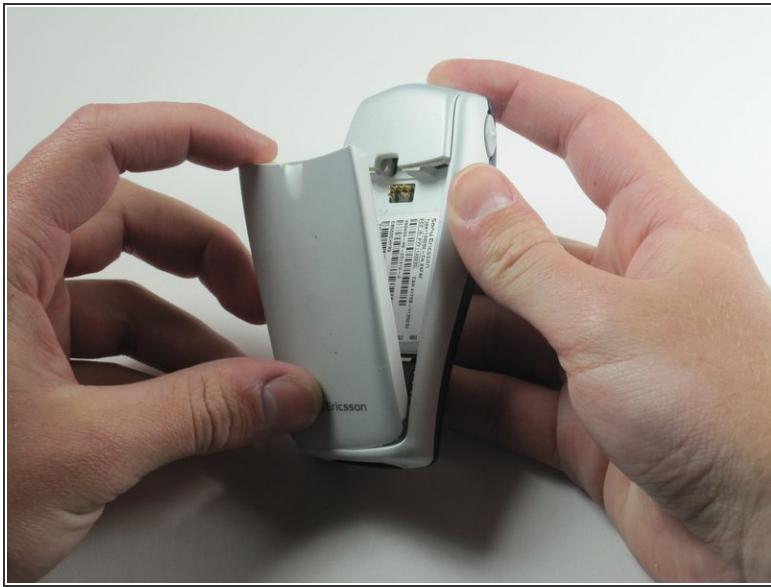
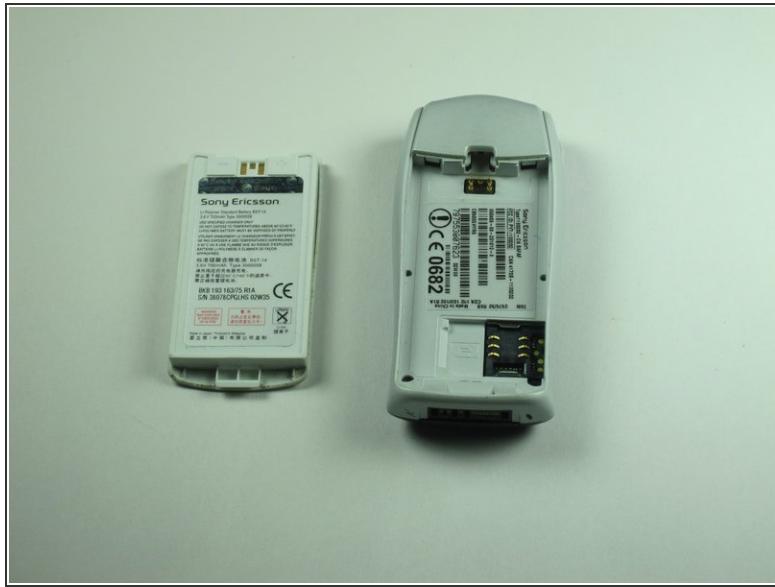
## Step 1 — Keypad

- Remove the battery from the back.

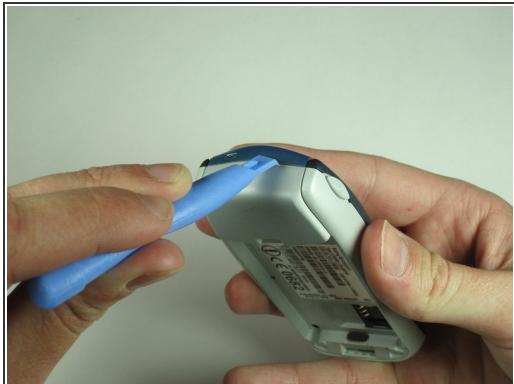
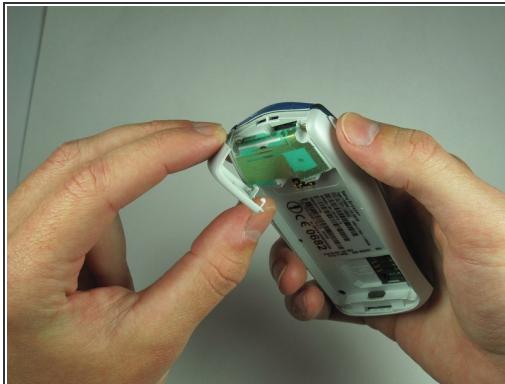
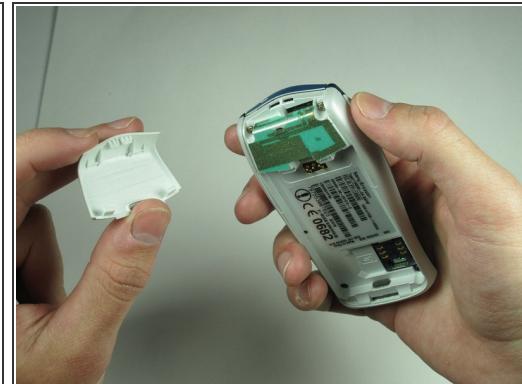
## Step 2

- Pry off the plastic cover from the top with a thin plastic shim, then remove it from the two bottom clips.

Do not bend it too far down, or else you risk breaking the two bottom clips.

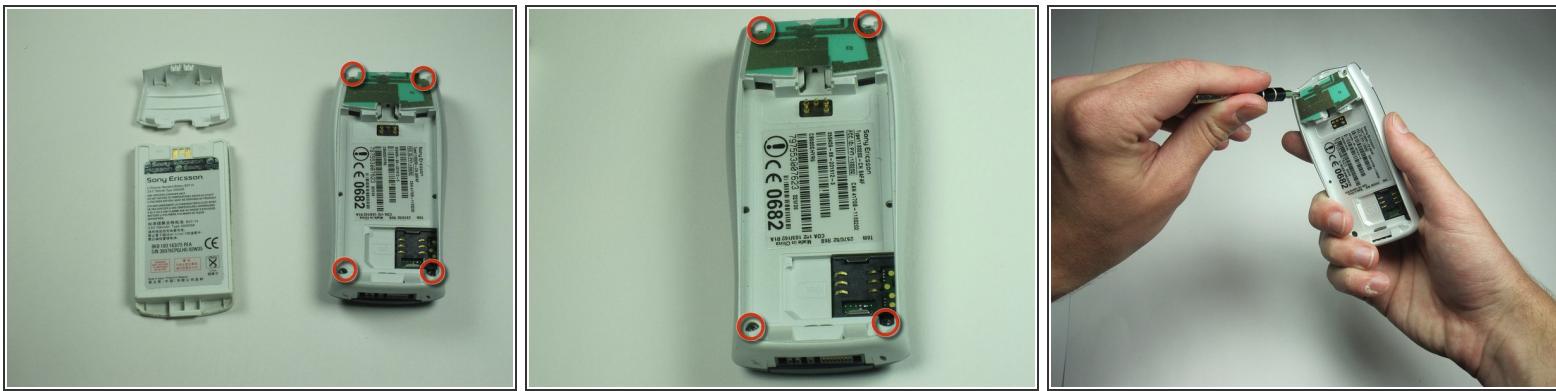
## Step 3

- Unscrew all four Torx T6 screws.

*(i)* Keep in a safe place.

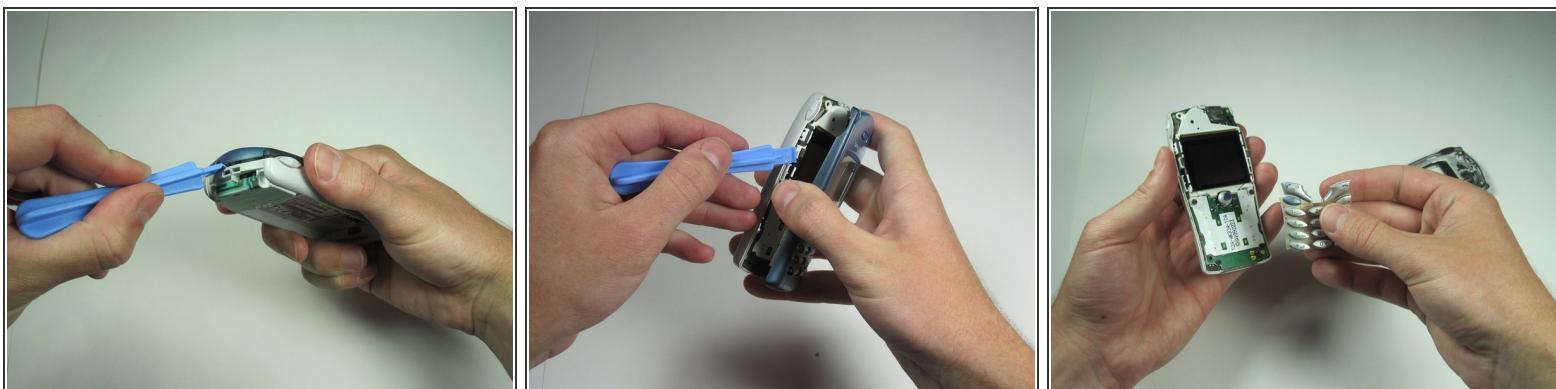
## Step 4

- After removing the screws, the two halves will separate. If not, then pry them gently apart.

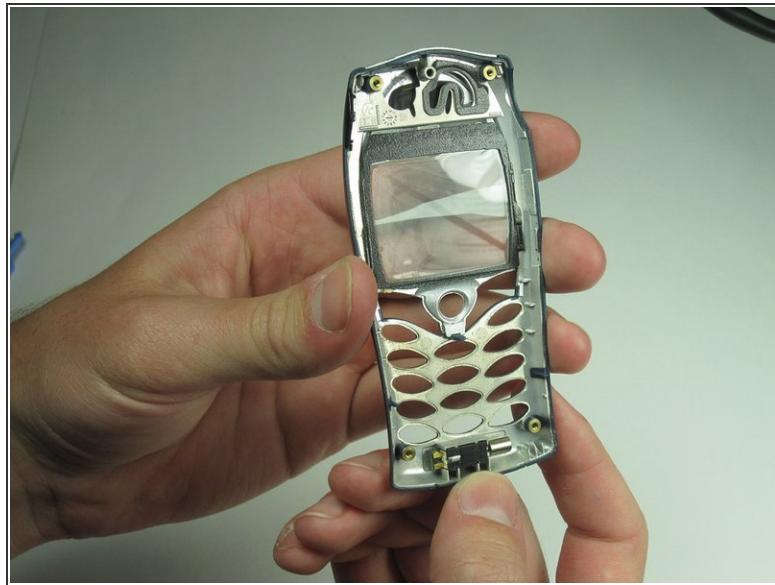
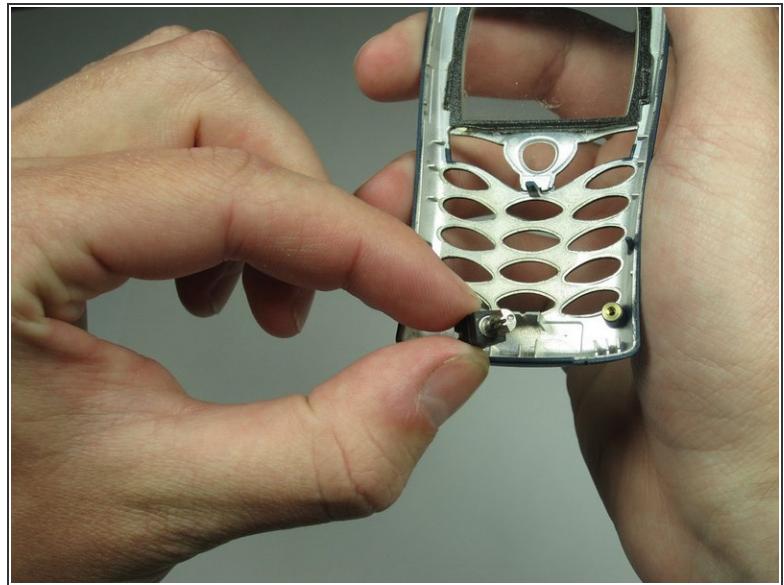
## Step 5 — Vibration Motor

- Remove the vibration motor visible in the front housing.

To reassemble your device, follow these instructions in reverse order.
