Sony PS-LX300USB Drive Belt Replacement

Audio distorted? Turntable platter not turning? Replace your drive belt.

Written By: Michelle Jakab

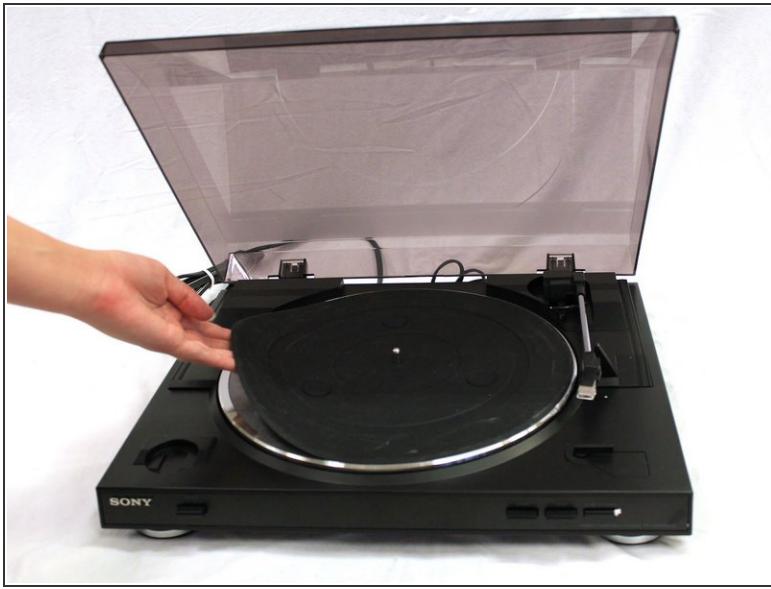
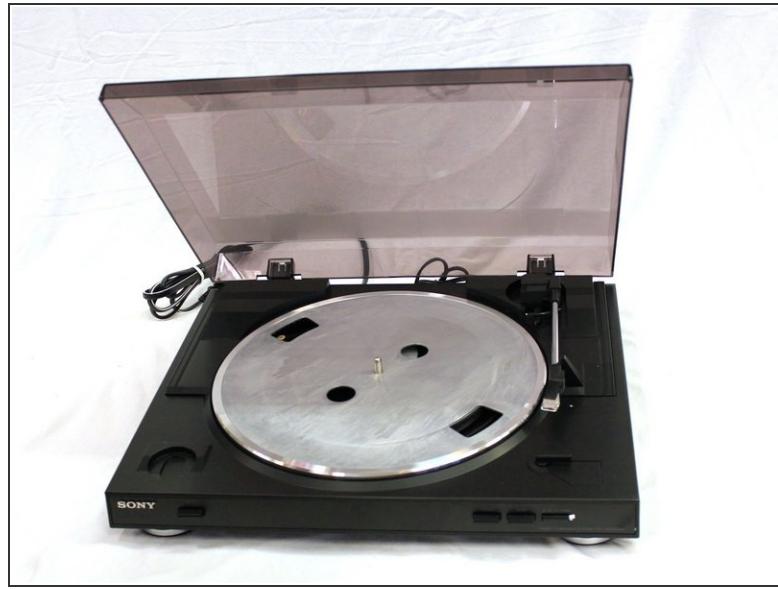
Step 1 — Drive Belt

- Lift the rubber mat, and put it to the side. It should be easy to remove, because it simply rests on a metal platter without anything securing it down.

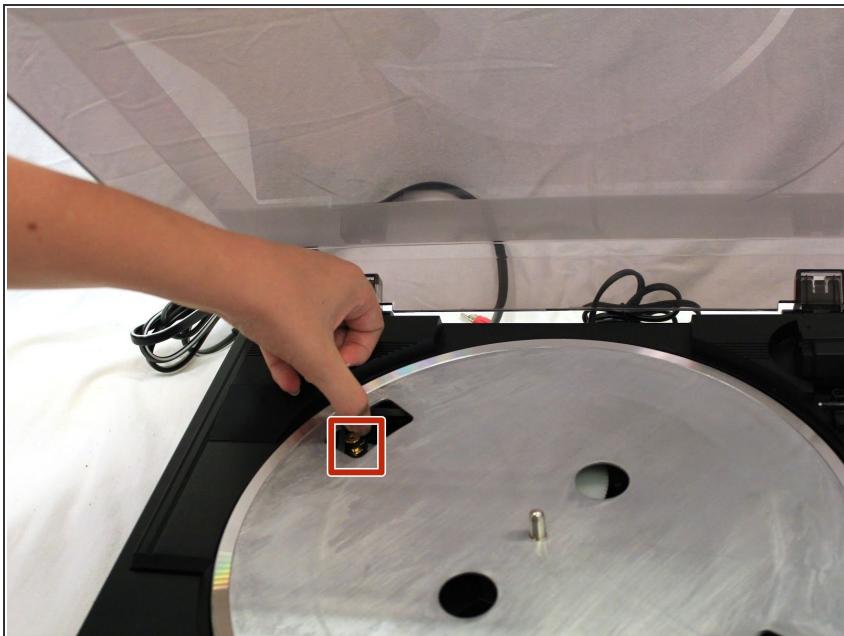
Step 2

- Turn the platter so that the motor pulley can be seen through one of the two outer holes in the platter.
- If the drive belt is hooked around the motor pulley, unhook it.

When reassembling to device, don't forget to hook the new drive belt to the motor pulley.

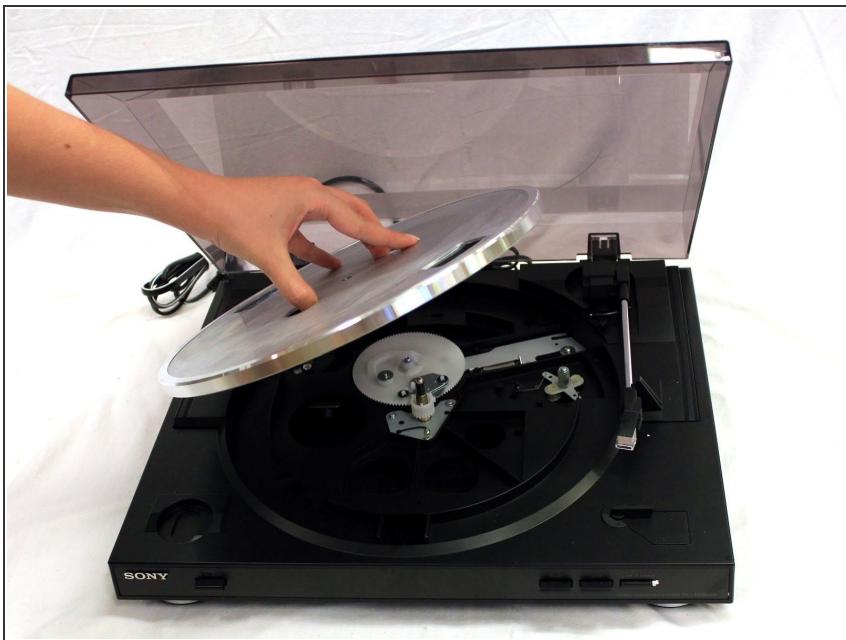
Step 3

- Grasping the platter by its two inner holes, lift it upwards.

i Removing the platter may take a small amount of force. If the pulley is unhooked and the tone arm is safely to the side, don't fear using a small amount of force in lifting the platter.

If you haven't yet unhooked the drive belt, the motor pulley and the belt could sustain damage.

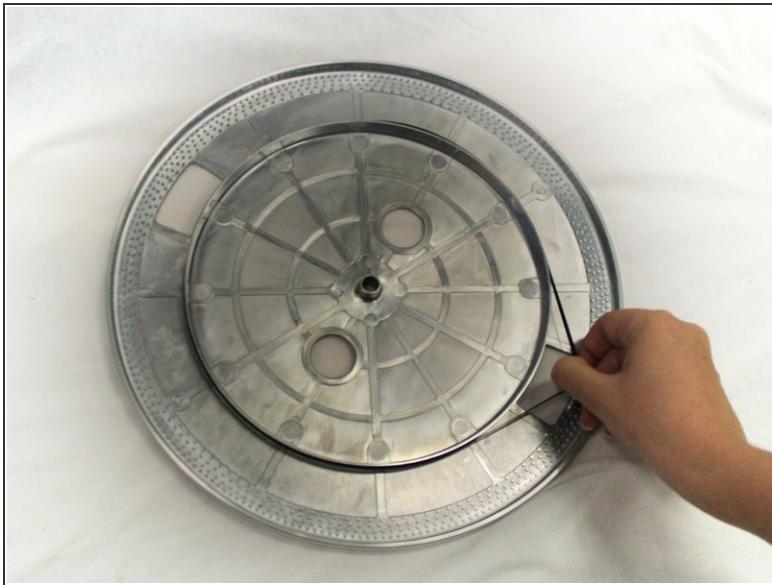
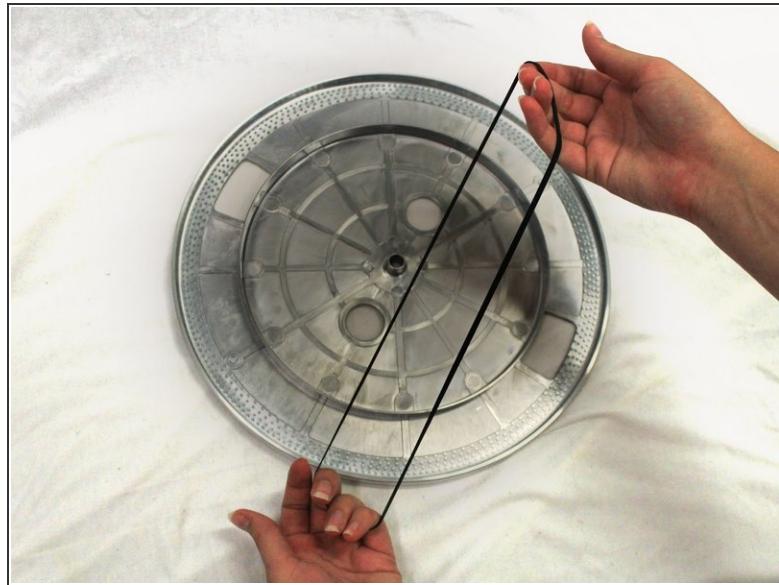
Step 4

- Peel the drive belt from the inner ridge of the metal platter and put it to the side.

i Sometimes, the drive belt can fall off the platter during deconstruction. If this is the case, simply take it out of the device wherever it is.
