# Sony VAIO PCG-3E2L Hard Drive Replacement

The purpose of this guide is to help the reader replace the Hard Drive of the device.

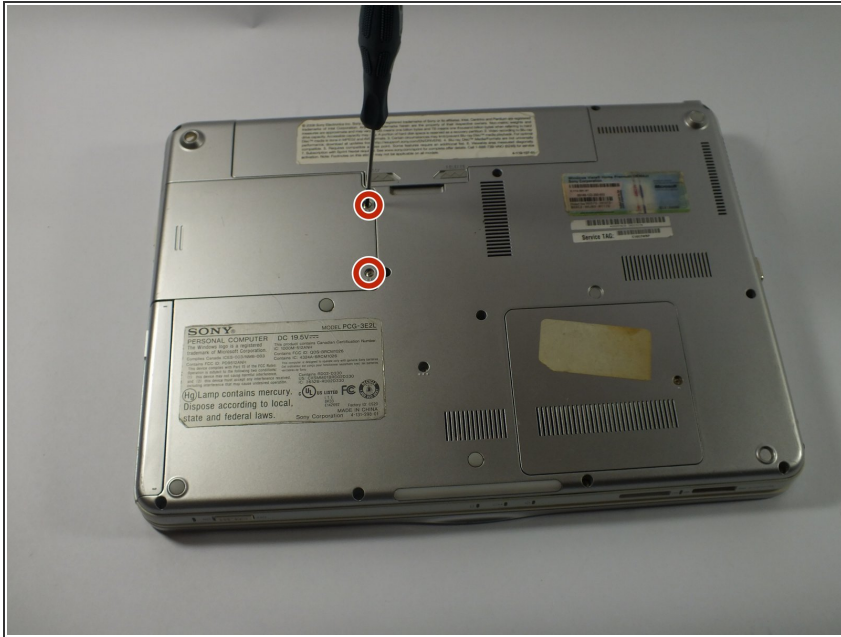
## Step 1 — Hard Drive

- Using a #00 Phillips screwdriver, remove the screw

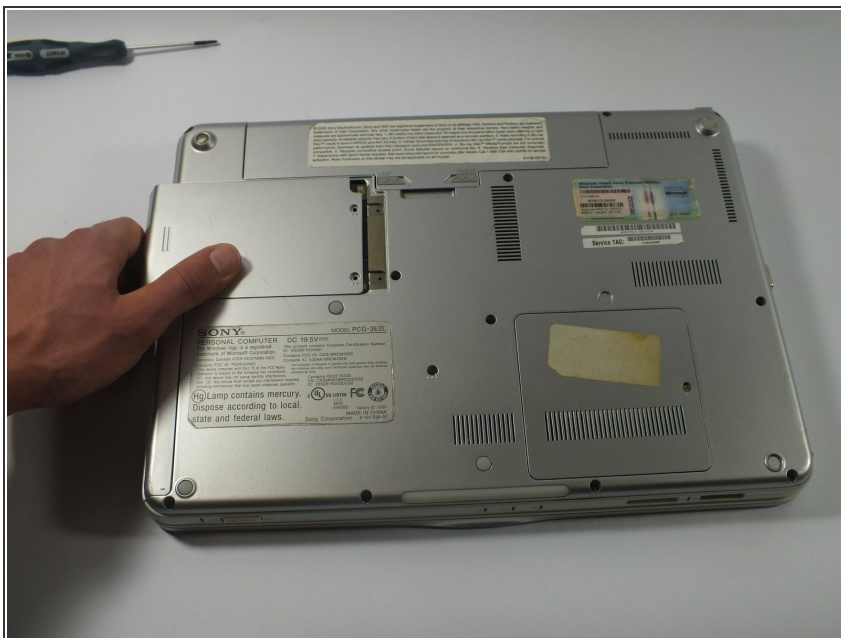
## Step 2

- Remove the cover

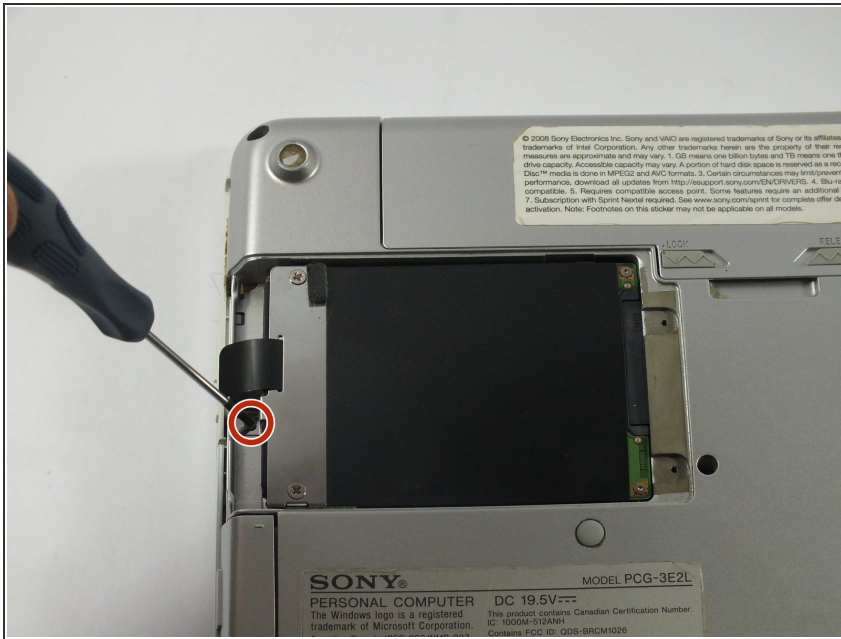
## Step 3

- Using a #00 Phillips screwdriver, remove the screw

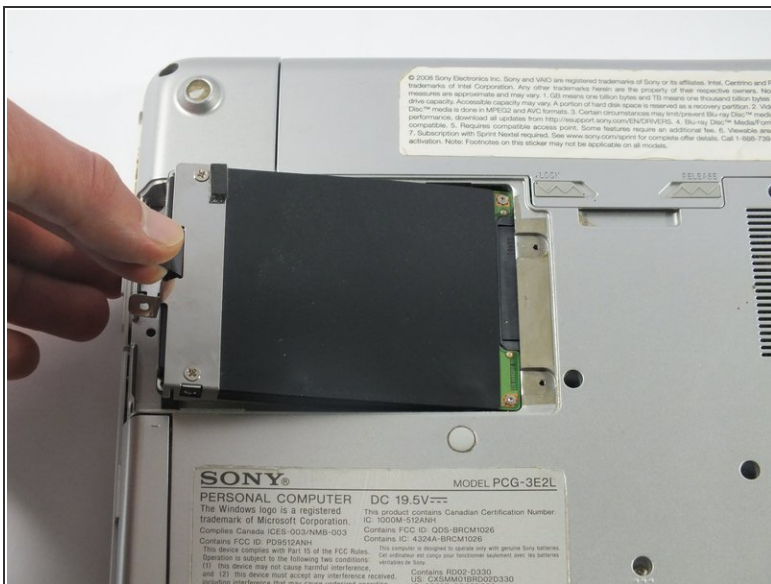
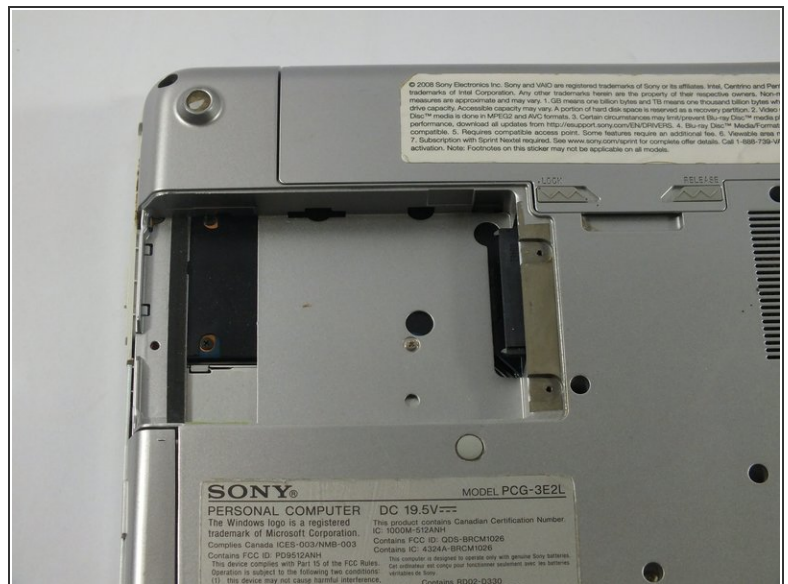
## Step 4

- Grab the black plastic handle and pull the hard drive out slowly.

Only pull the hard drive horizontally. Do not lift the hard drive vertically
