Sony Vaio PCG-71713L Hard Drive Replacement

The hard drive is replaced due to malfunctions and/or defects.

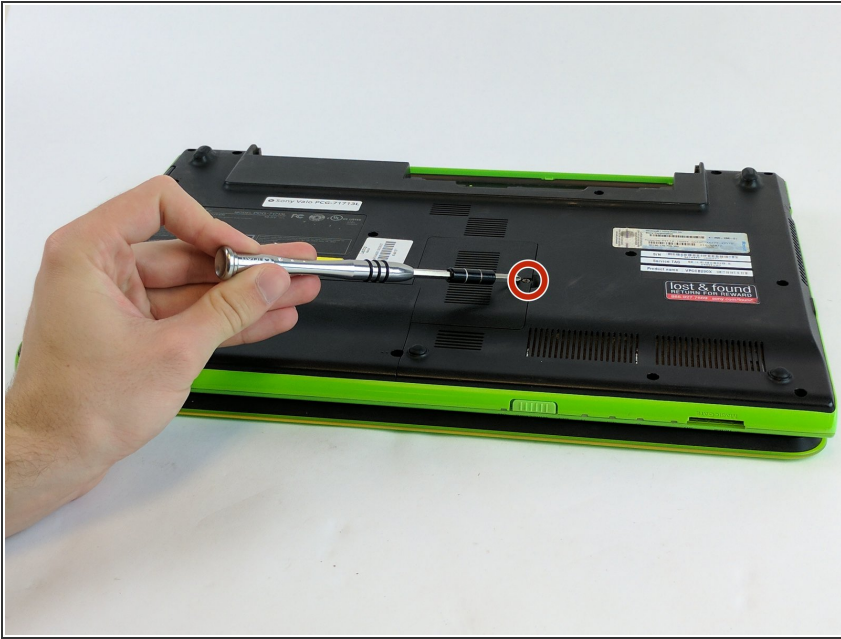
Step 1 — Hard Drive

- First remove screws from the plastic cover on the bottom of the device using a Phillips head #1 screw driver.

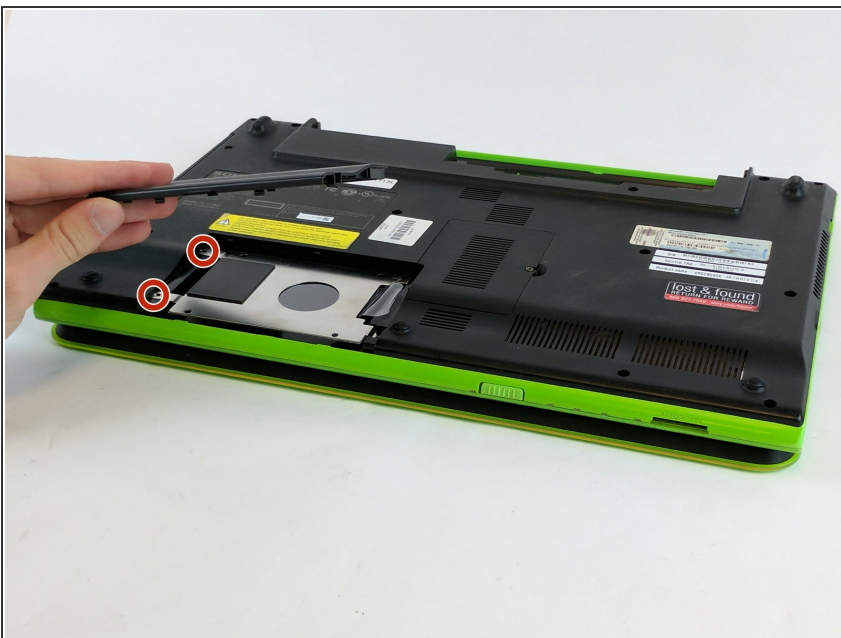
Step 2

- Remove the screws that hold the hard drives metal tray in place. Use a spudger (as seen in the photo) to lift up the hard drive's metal tray.

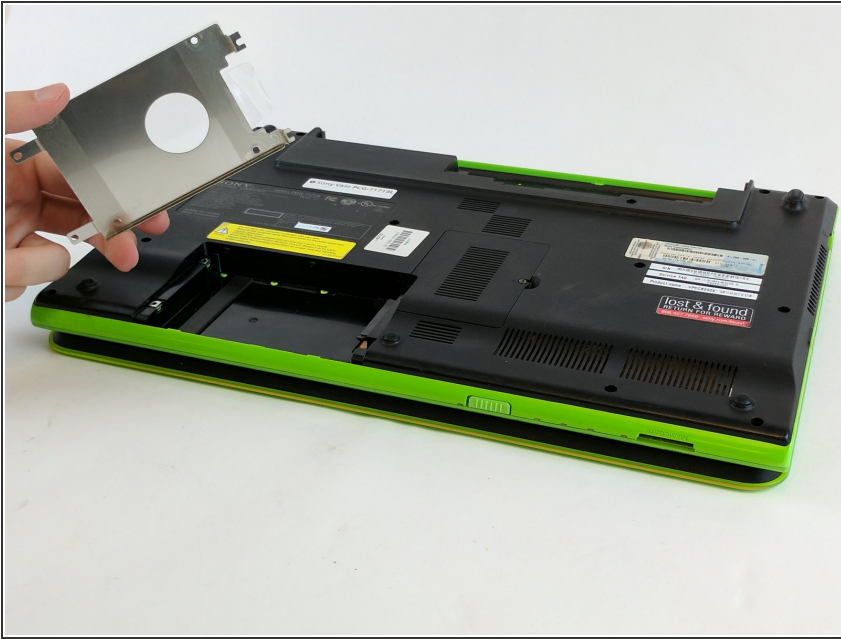
Step 3

- Remove the metal tray and the hard drive which is attached to it.

To reassemble your device, follow these instructions in reverse order.
