Sony XPERIA Tablet Z Volume Button Replacement

Written By: Martin Luna

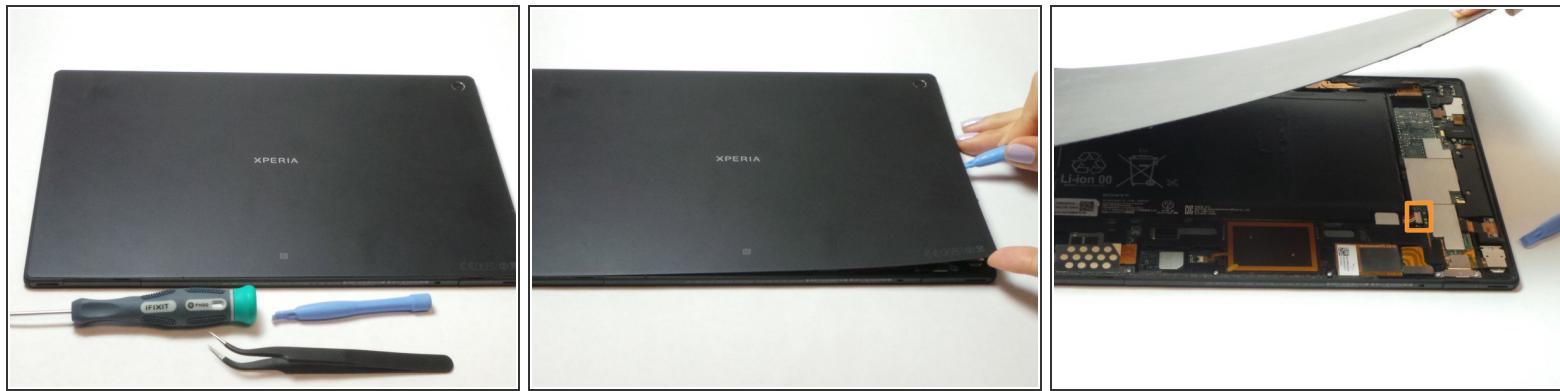
Step 1 — Removing back cover

- Tools you will need is the Phillips #00 precision screwdriver, Plastic Opening Tools, and tweezers.
- Insert plastic opening tool in the corner of device and slide along edges to separate adhesive.
- Remove cover
- Disconnect battery, to avoid electric shock, by pulling up on the white plastic as shown by the orange box.

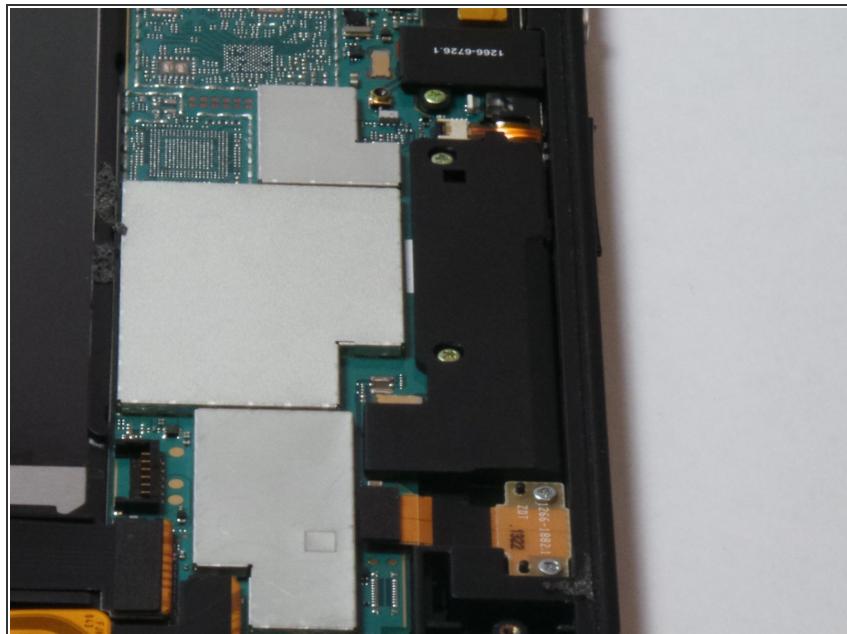
Step 2 — Locate the Volume module

- Locate the volume module.
- Remove both screws using the Philips screwdriver.

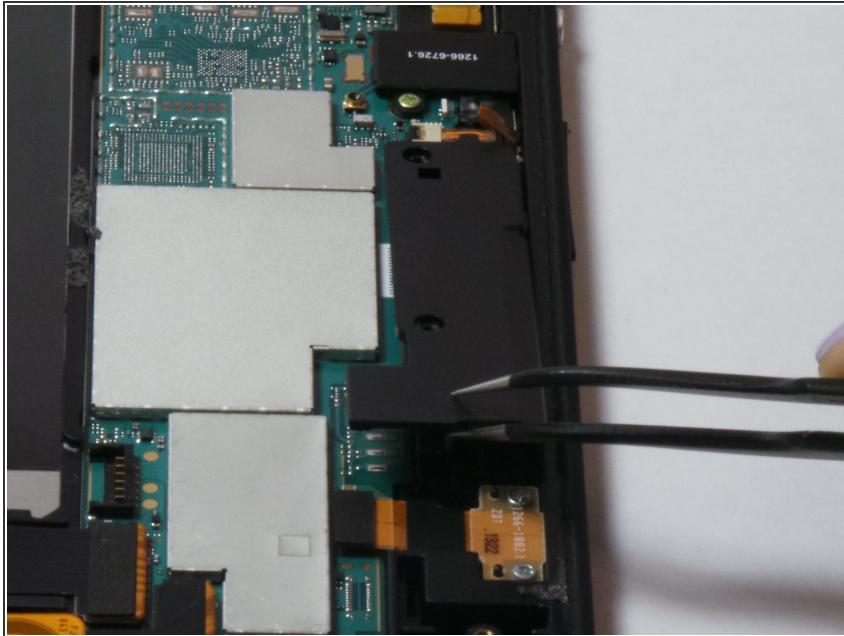
Step 3 — Lift out of Place

- Once both screws are removed grab the tweezers.
- Then lift up on the module.

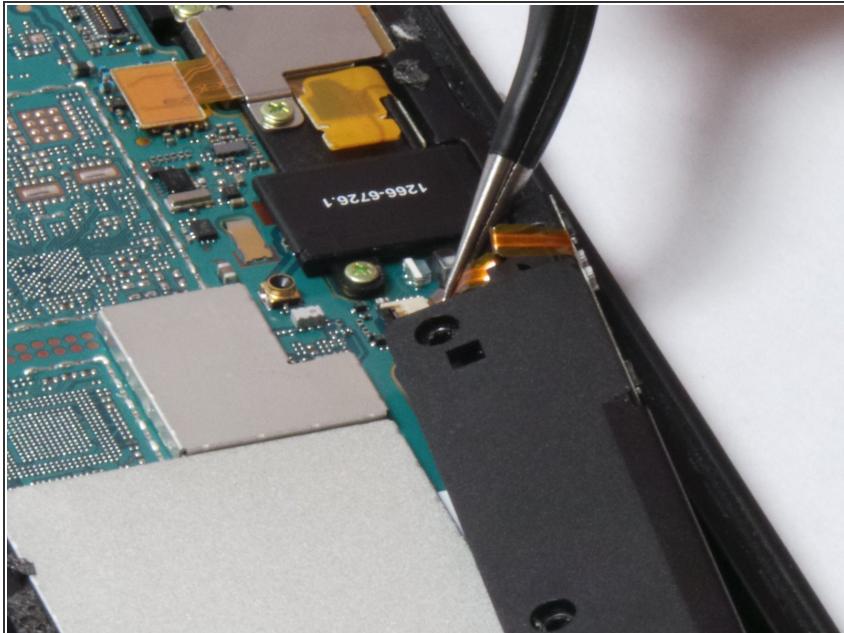
Step 4 — Removing the Electrical tape

- Find the electrical tape connecting the module to the motherboard
- Carefully pull out the electrical tape horizontally and remove the volume module from the device.

To reassemble your device, follow these instructions in reverse order.
