Sony Xperia T2 Ultra Dual Audio Jack Replacement

No audio? Replace the headphone jack!

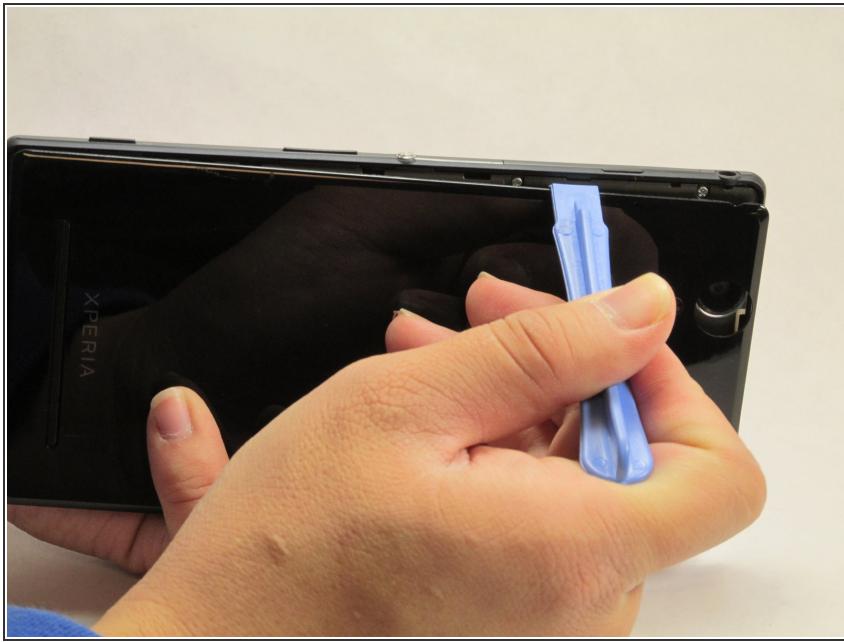
Step 1 — Rear Case

- Using the spudger, pry open the back cover by starting alongside the edge of the back cover.

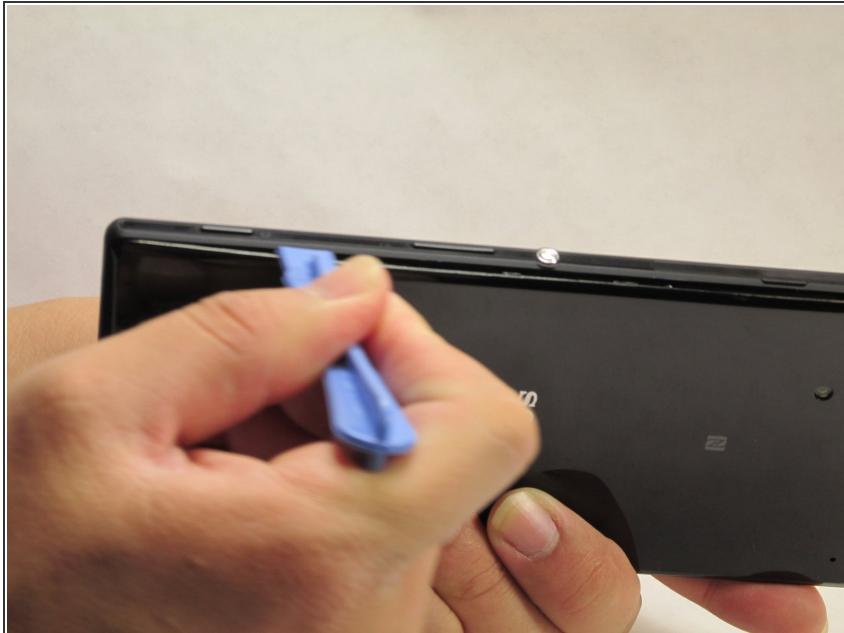
Step 2

- Once the part of the back cover has been opened up. Slide the spudger to pry completely detach the cover from the phone.

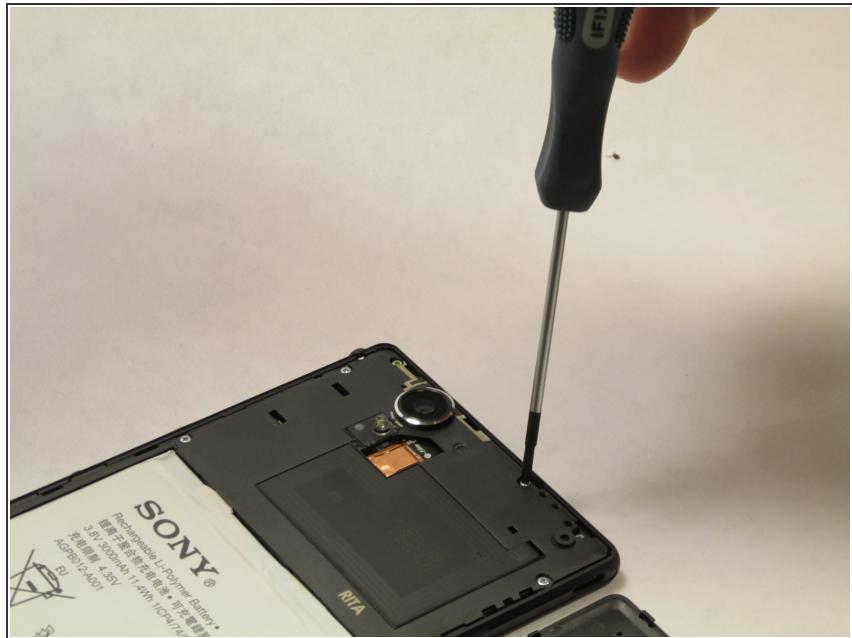
Step 3 — Removing the internal cover

- Using the Phillips #00 Precision screwdriver, take out 8 silver screws (3.15mm) and 5 gold screws (3.9mm) for a total of all the screws attached to the flat plate. 3 of the gold screws are located at the top of the phone and the other 2 screws are located at the bottom of the phone.

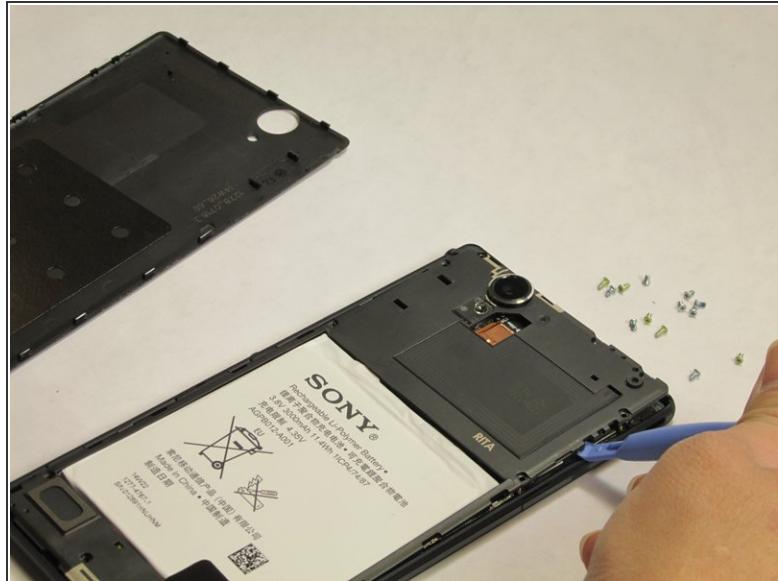
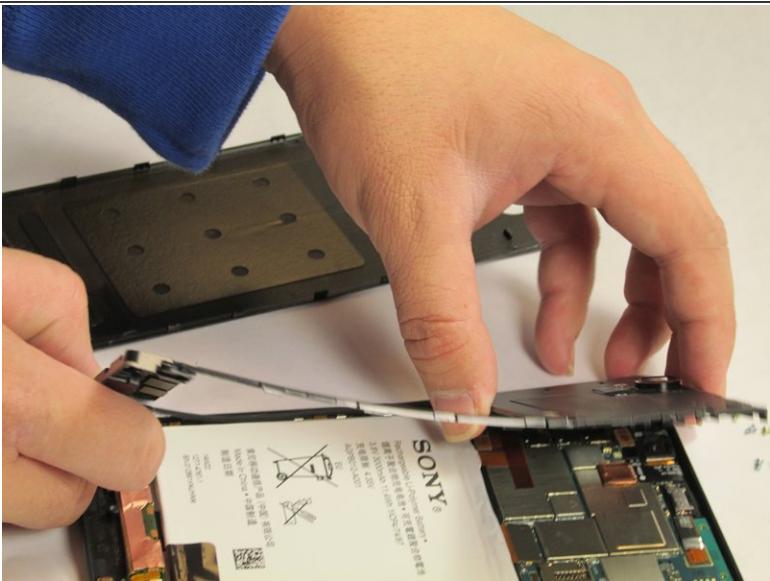
Step 4

- To remove the internal cover, use the plastic spudger tool and pry the cover from the phone as shown in the picture.

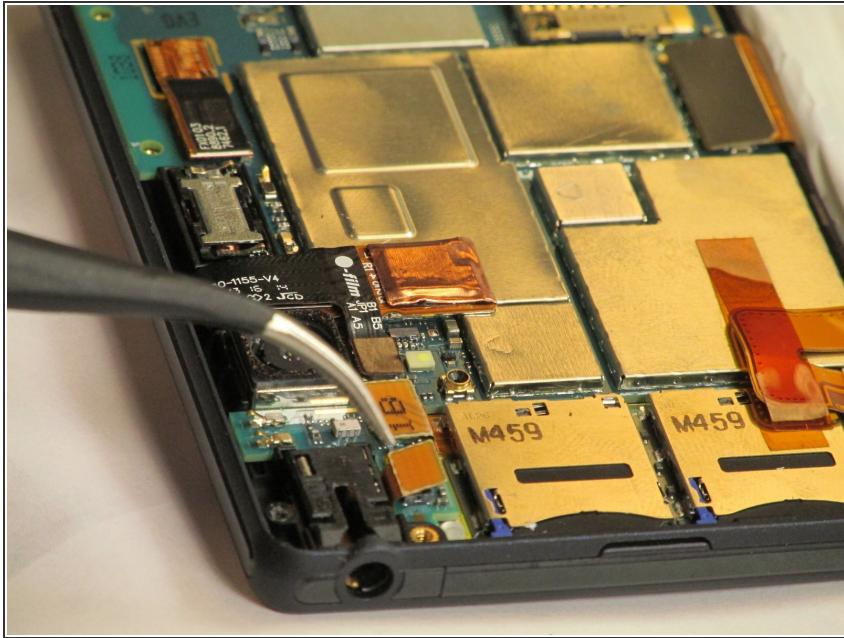
Step 5 — Removing chip

- Using tweezers, locate the audio jack as shown and pull out the chip connected to the motherboard.

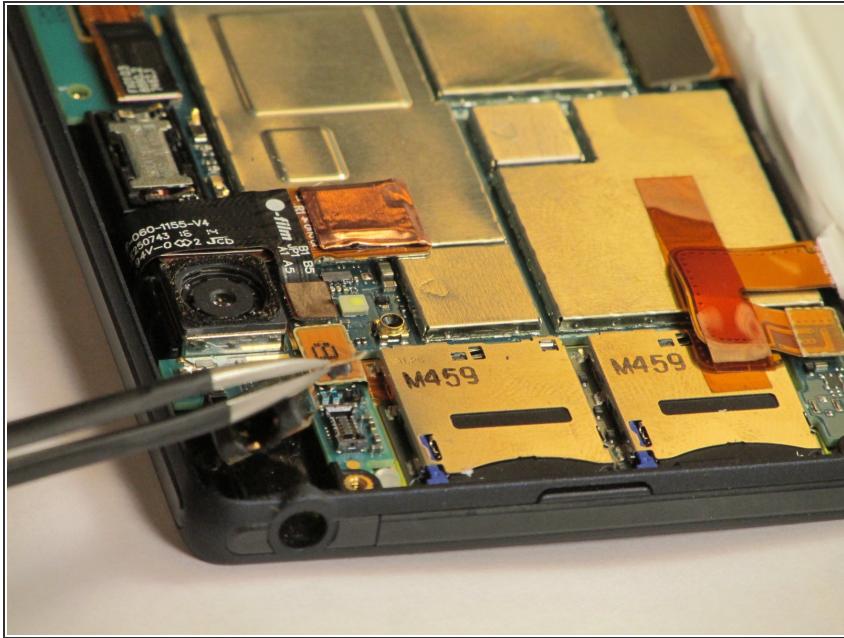
Step 6 — Remove audio jack

- Carefully remove the audio jack by using the tweezers and pull firmly straight out of the motherboard.
